May 7<sup>th</sup>, 2012

**Project: Simon Rodia Watts Towers**

**Re: Ground Penetrating Radar Investigation to Detect Subsurface Voids**

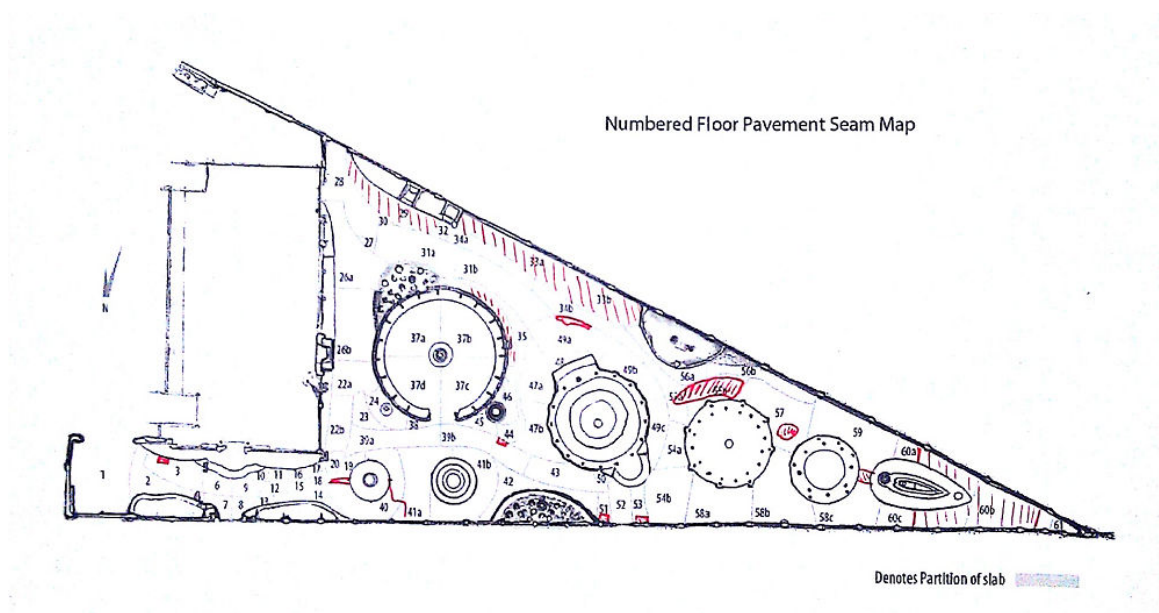
Areas of concern marked in red to be explained on the following pages. The numbers above each screen shot and photo are referring to the slab sections on this map.

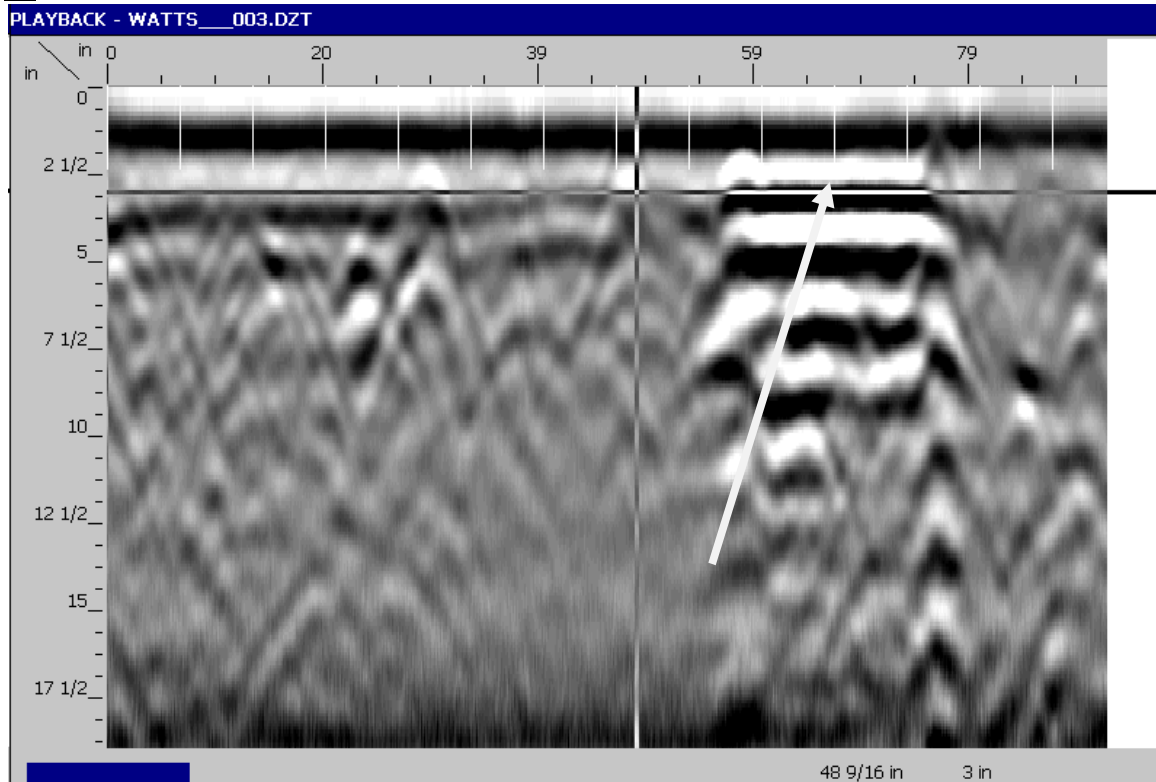
The screen shot above shows the void in slab section #3 at a depth of 3". The void is represented by the black band at the bottom of the slab. The change in conductivity from the slab to the air below causes a negative reflection which forms the black band.

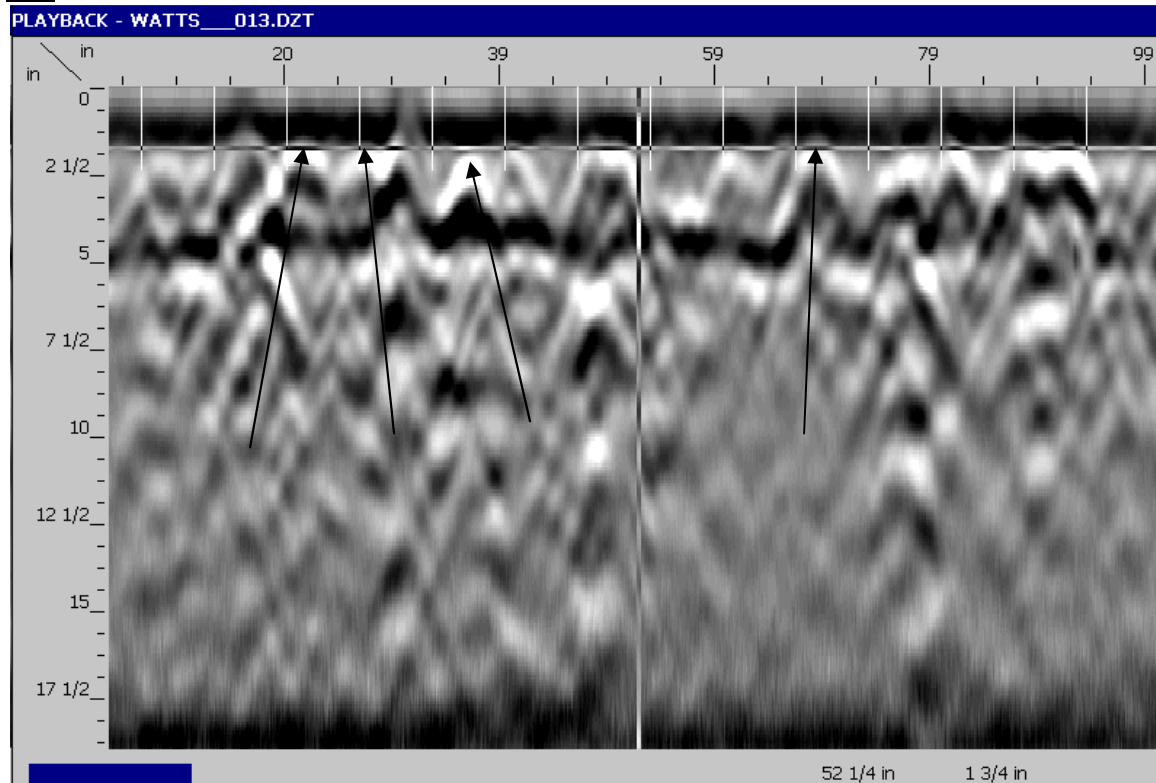
## #29

The screen shot above shows the data from slab section #29. This concrete is different than most of the other sections. There are many metallic reflections inside of the concrete beginning at a depth of  $1\frac{3}{4}$ ". This is not a wire mesh or reinforcing; they appear to be random reflections due to the material or aggregate in the concrete. These were found throughout this section. The arrows are pointing out several of these reflections. These reflections made the concrete thickness very difficult to determine.

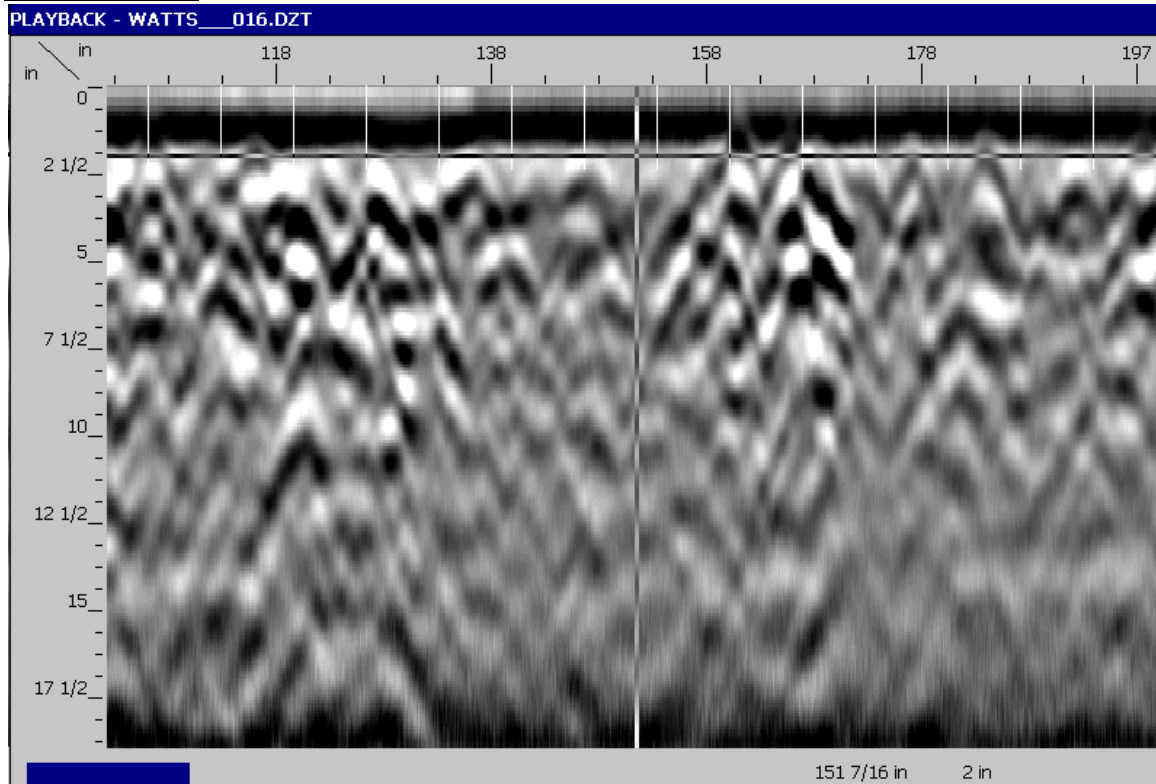
### #33a and #33b

The above screen shot is from slab sections #33a and #33b. This section also contains random reflective material inside of the concrete beginning at a depth of  $1 \frac{3}{4}$ ". We were unable to determine the concrete thickness in this area.

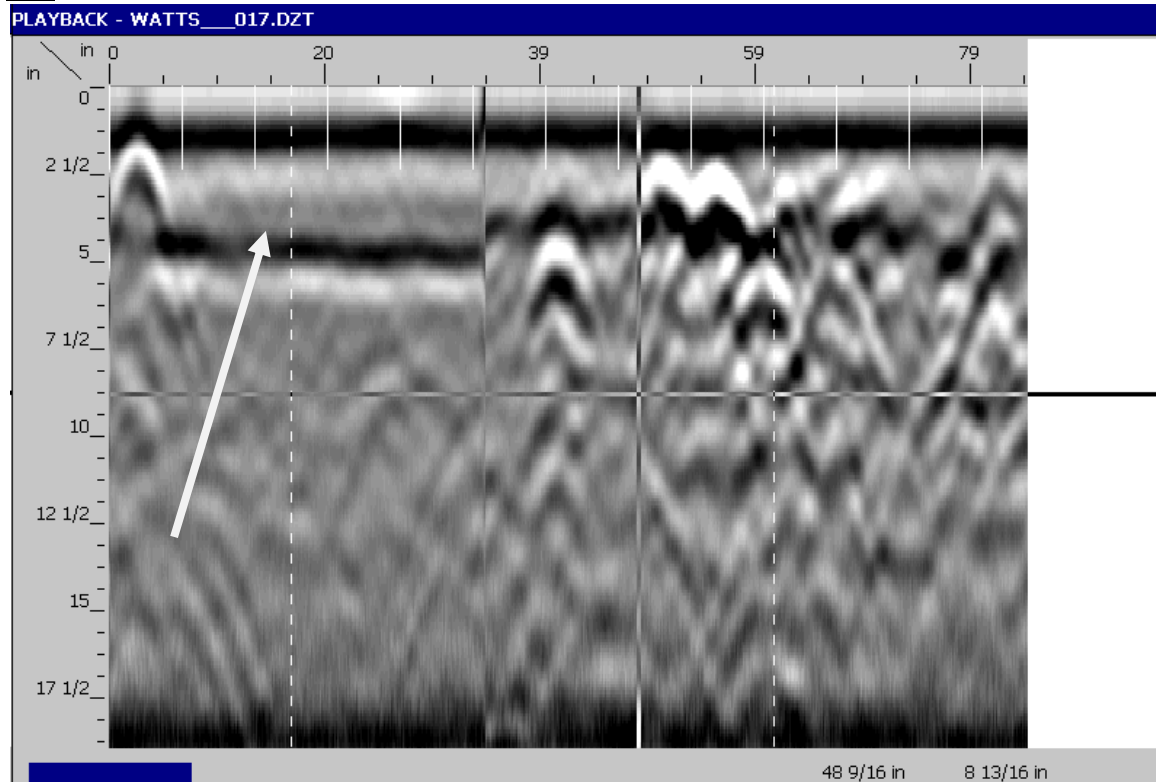
### #36

The above screen shot shows data from slab sections #35 and #36. The left side of the data shows the typical consistent concrete in section #35. The white arrow is pointing out the horizontal black band that represents the bottom of the slab. The change from the slab to the soil below causes the black band reaction which is how the slab thickness was calculated. The right side of the data was collected from area #36. This section of concrete contains metallic reflections in the concrete's aggregate mix.

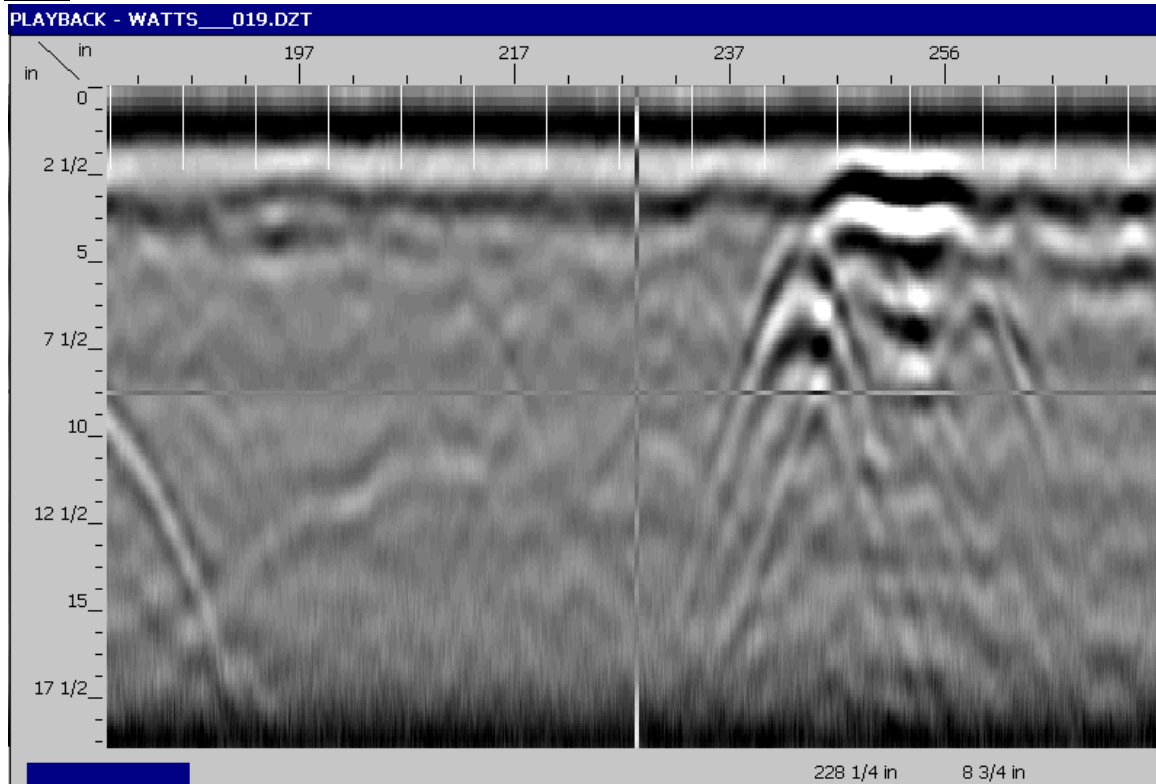
**#39b**

The above screen shot shows the void that was found in slab section #39b at a depth of 2.75". Its location is shown in the following pictures.

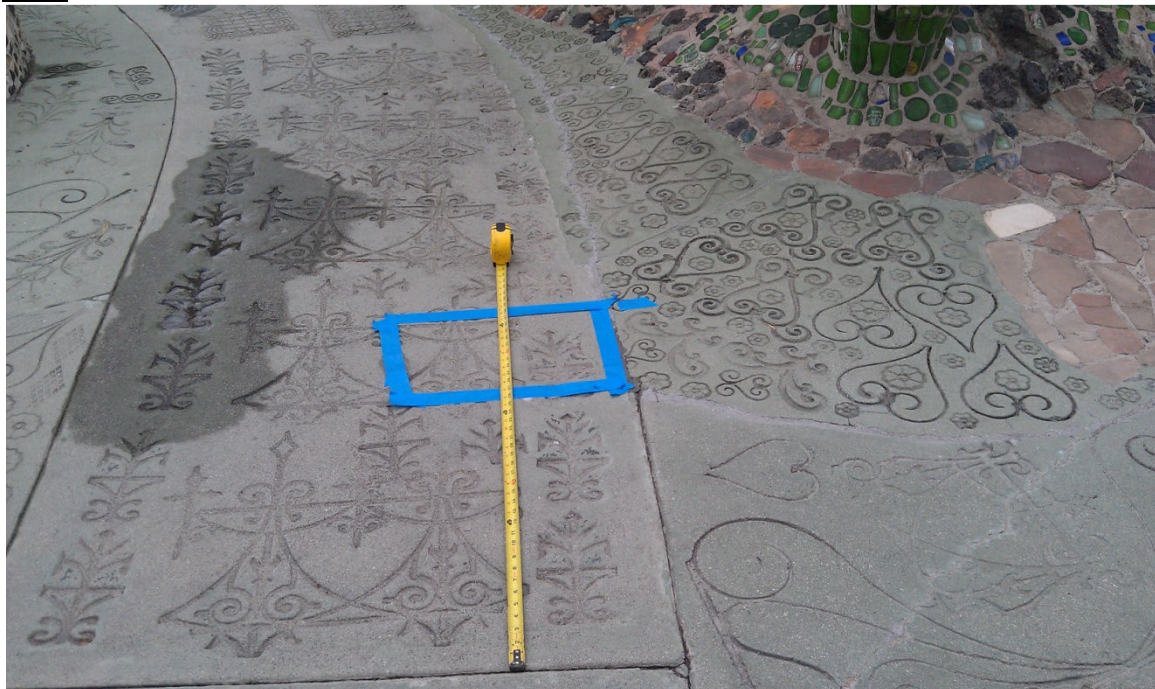
**#39b**

This is the void in slab section #39b.

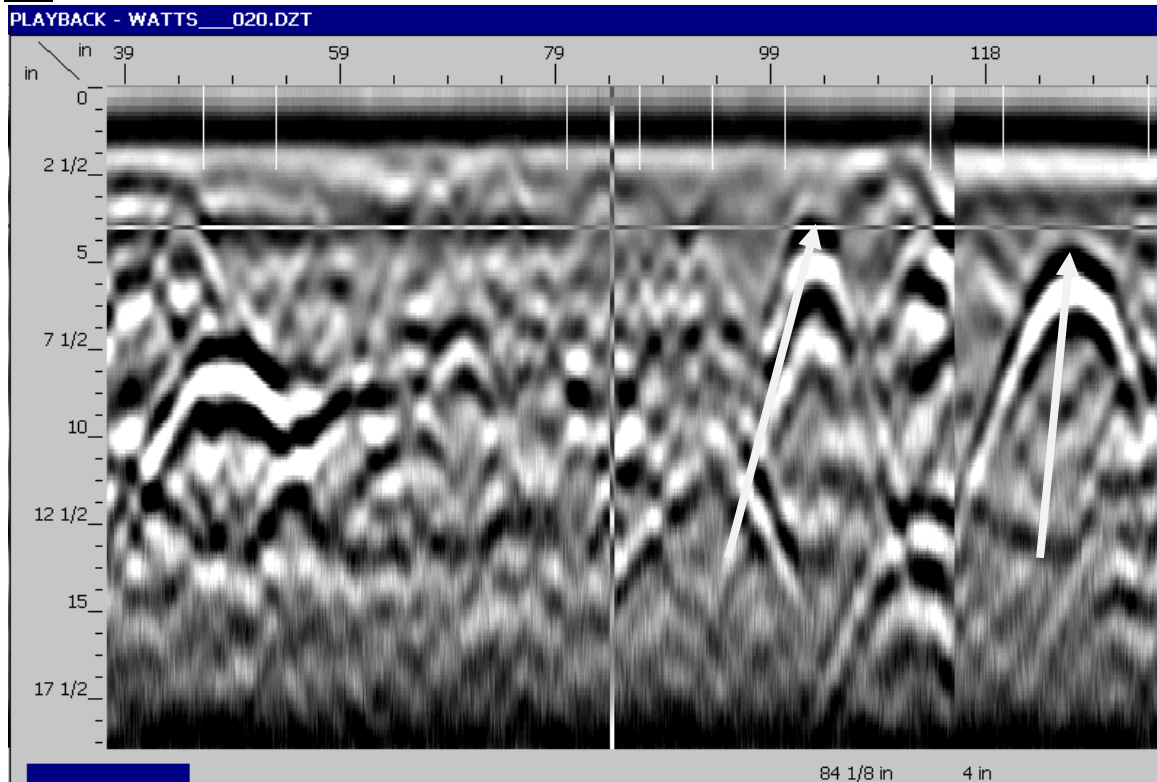
**#40**

The above screen shot shows both voids that were found in slab section #40. They will be explained further on the following pictures.

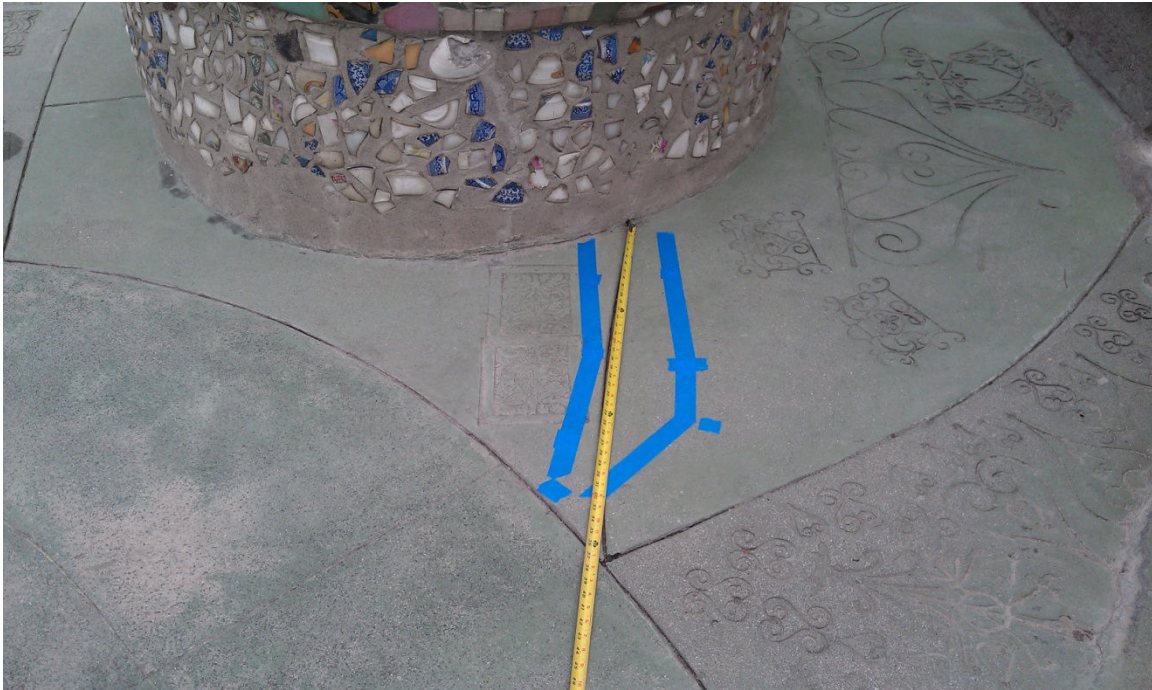
**#40**

This is the first, smaller void in slab section #40 at a depth of 4".

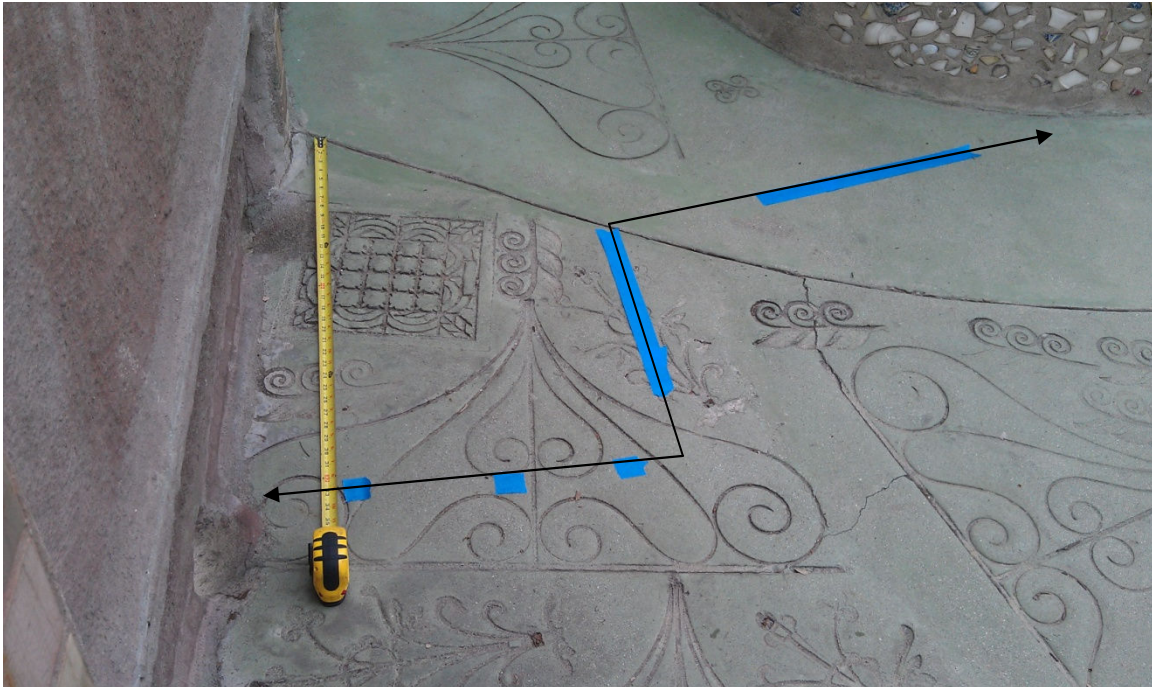
**#40**

This is the other void that was found in section #40 and crossing into #41a. It appeared to be possibly a pipe directly below the slab rather than a void. It is only about 2" wide and follows the path of the arrows in the photo.

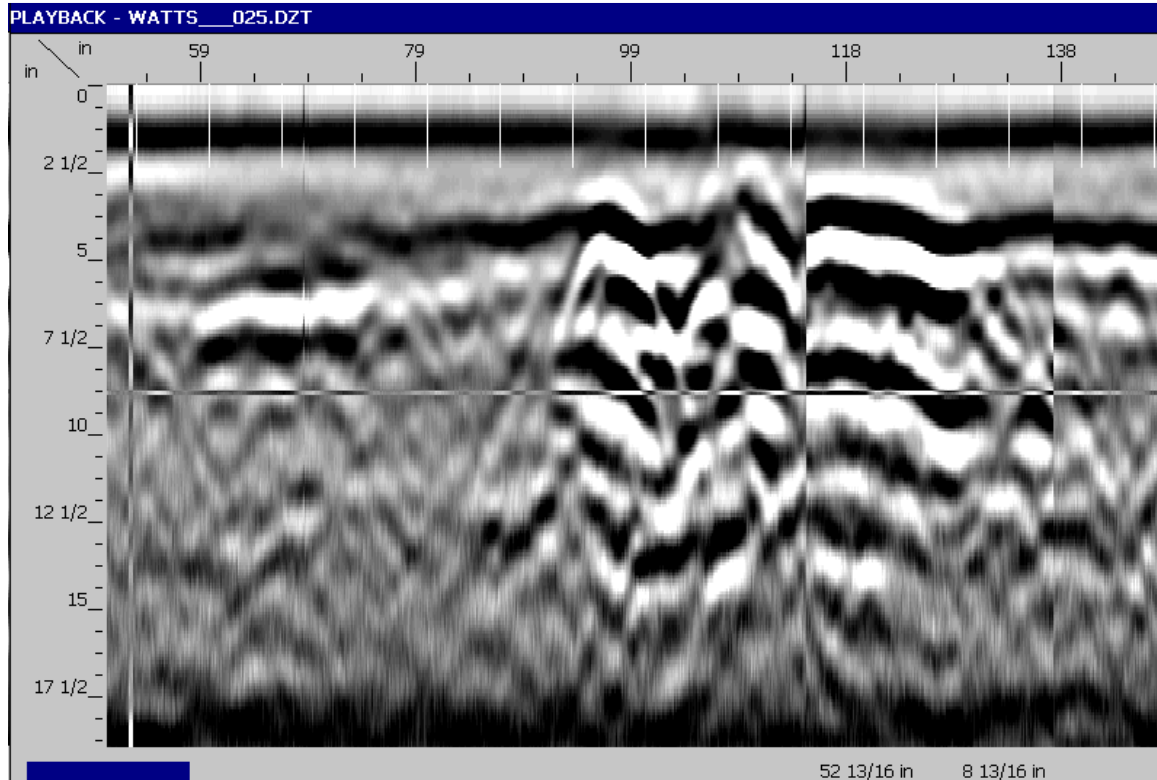
#49a

The above screen shot shows the void that was found directly below the slab in slab section #49a. The following photos will show its location.

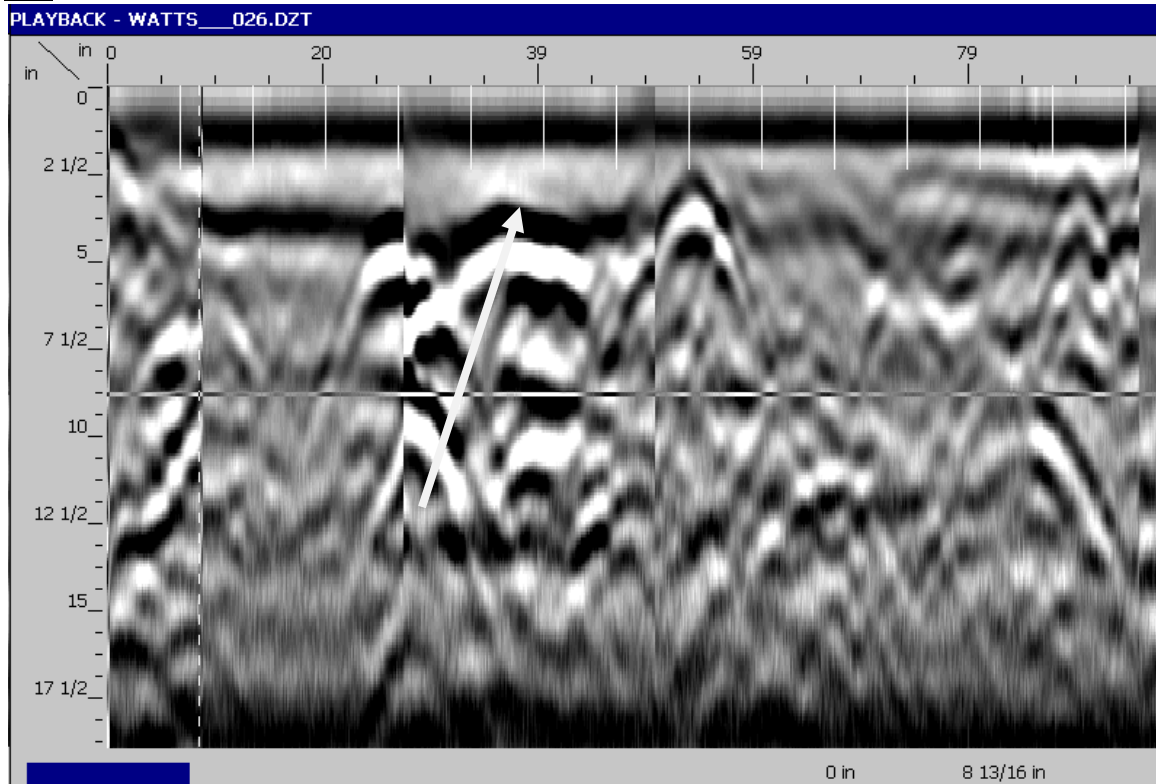
**#51**

The screen shot above shows the void in slab section #51 directly below the slab at a depth of 3.25".

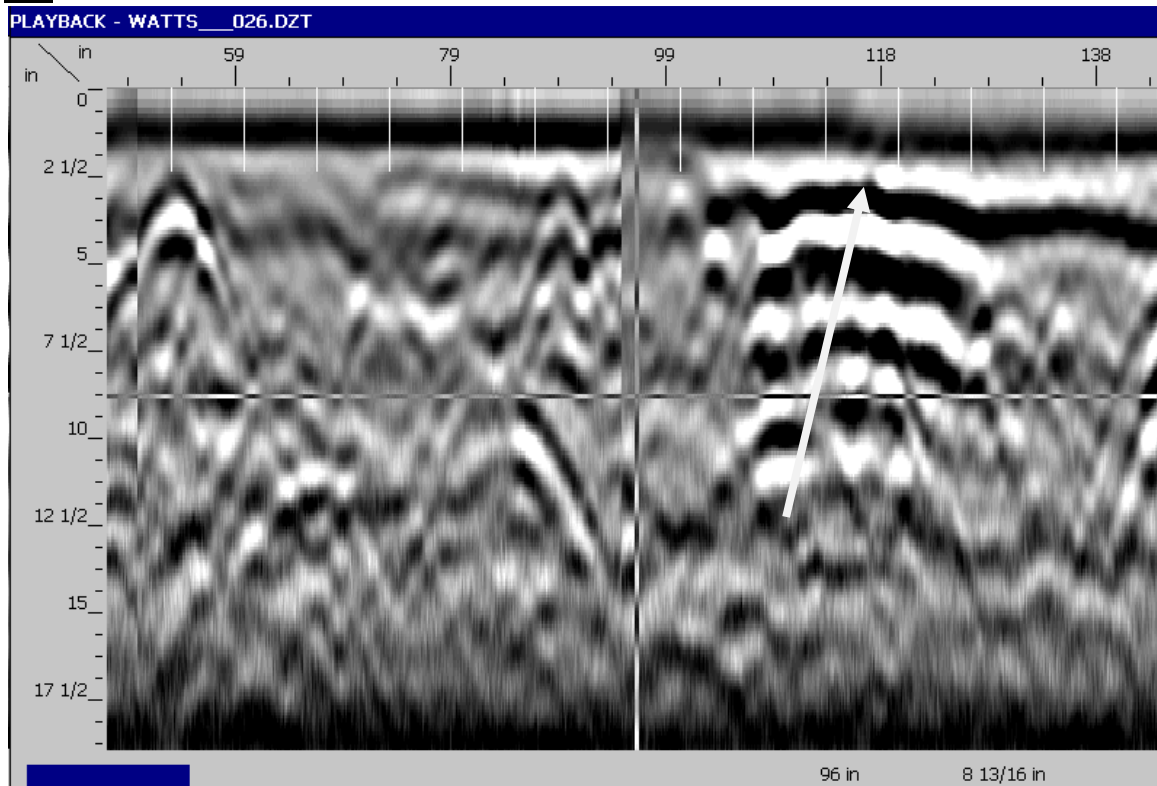
**#53**

The above screen shot shows the void in slab section #53 directly below the slab at a depth of 3.25".

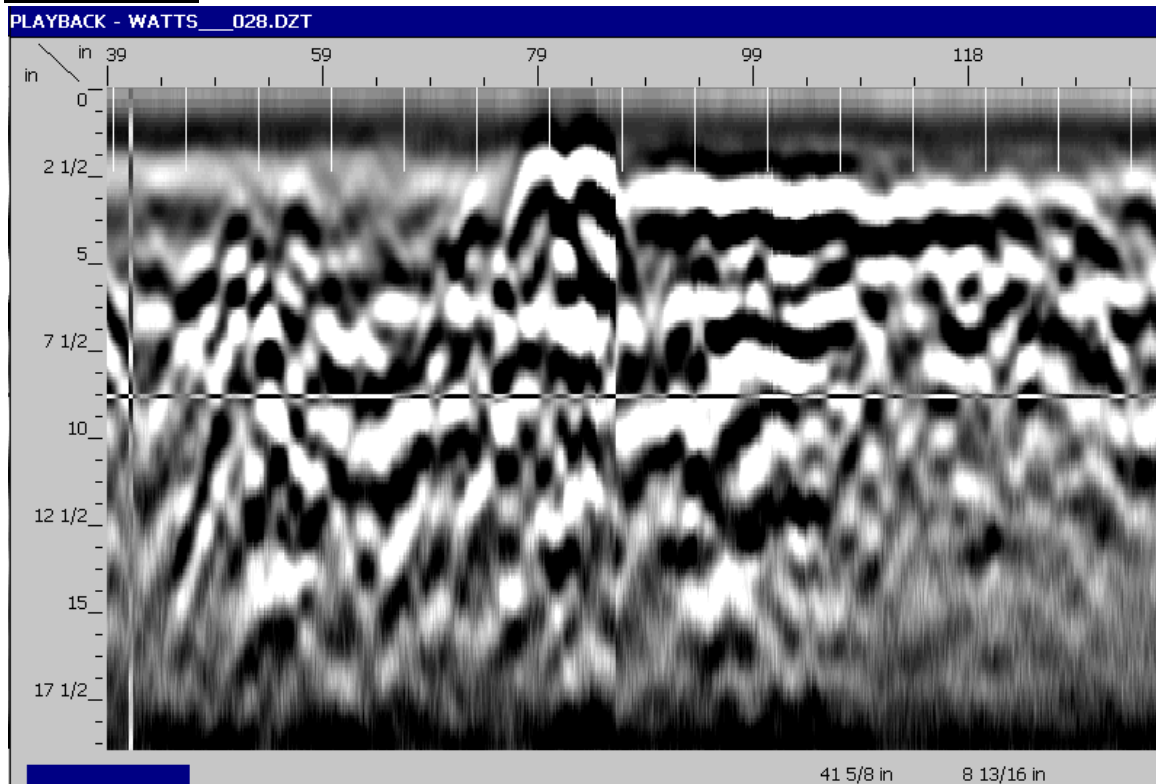
### #55a and #55b

The above screen shot shows slab sections #55a and #55b. This area does not contain a void. This concrete appears very different from most of the surrounding sections. It contains very reflective or metallic aggregate beginning at a depth of  $1 \frac{3}{4}$ ". This area is shown in the next two photos.

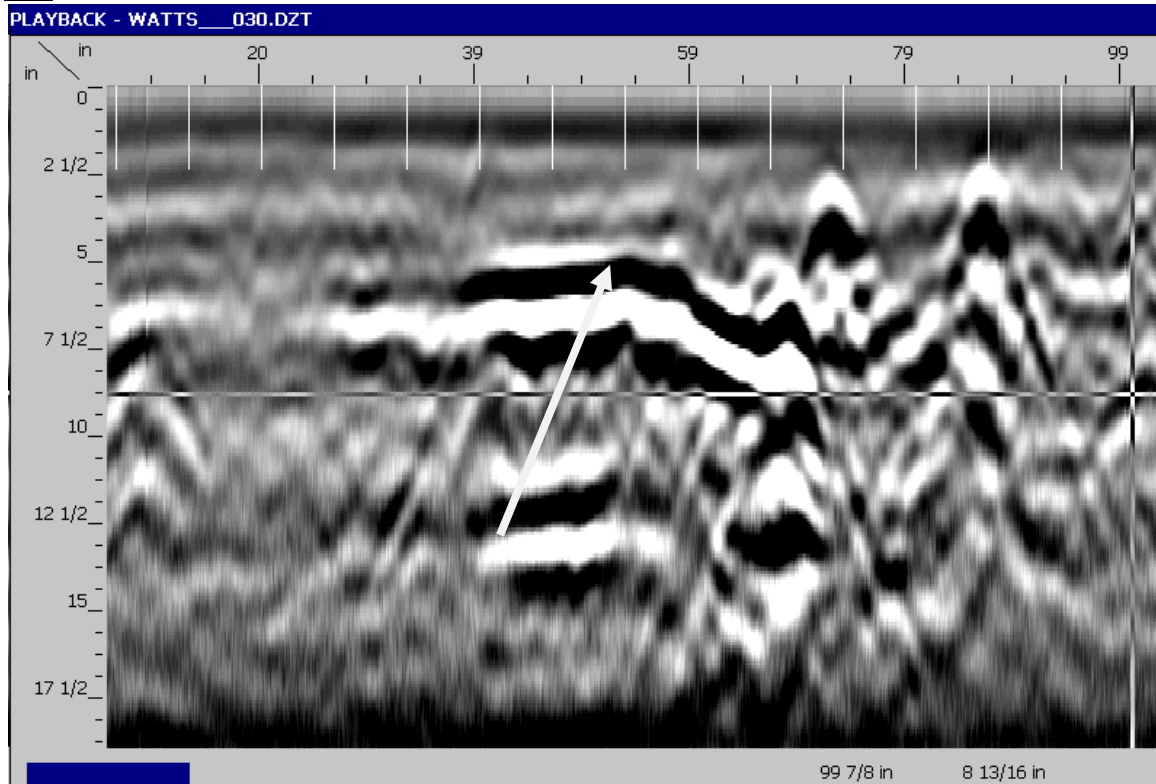
**#57**

The above screen shot shows the void below slab section #57. This is the most significant void we found. We cannot give void thicknesses but this void appeared to be the brightest of the voids we found.

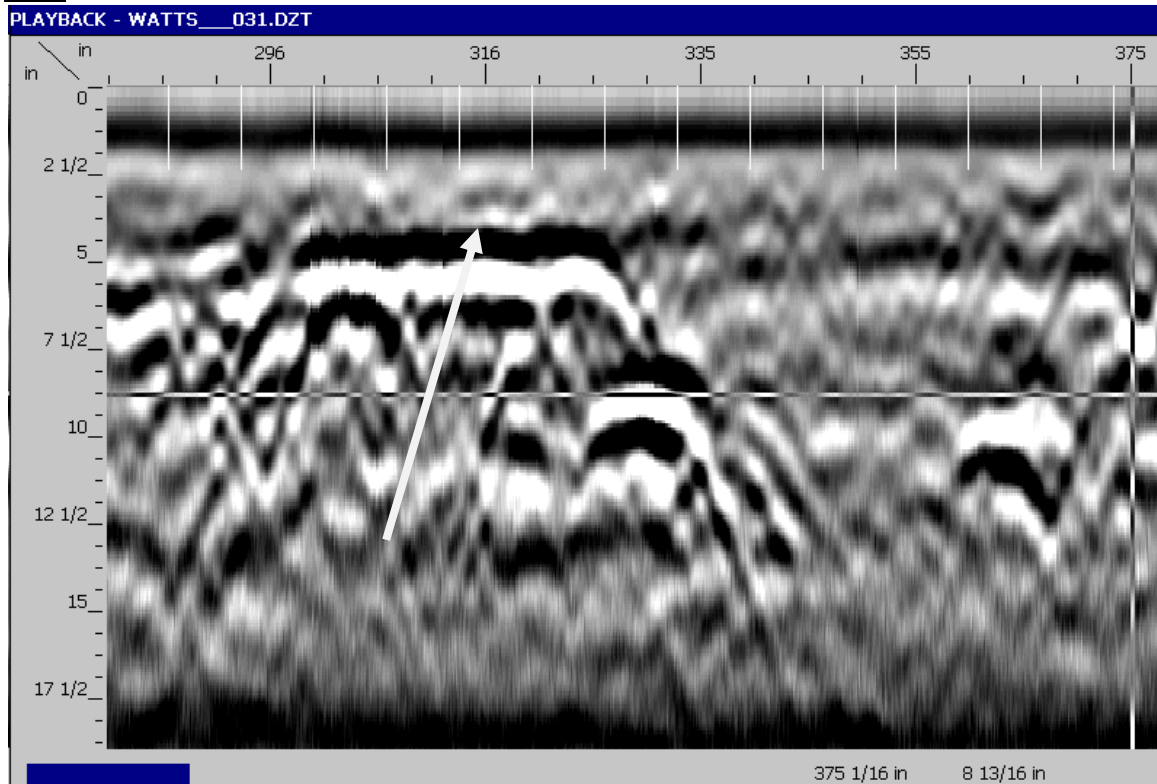
**#58c**

The above screen shot shows the void that was found below the slab in slab section #58c at a depth of 4.5".

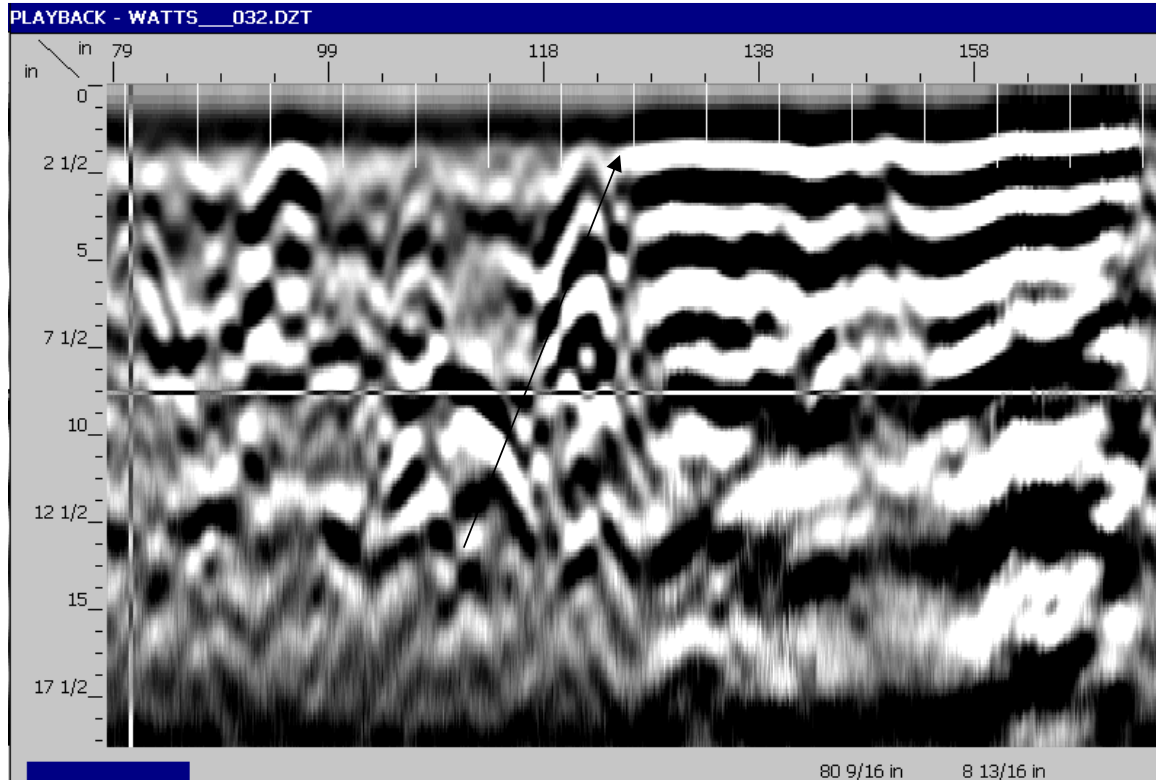
**#60a, #60b and #60c**

The above screen shot shows an area in #60a and #60c where the slab or concrete aggregate changes. The right side of this data contains what appears to be almost solid metal reflection at a depth of  $1 \frac{3}{4}$ ". We believe this is due to a different concrete being used that contains a very reflective or conductive material.

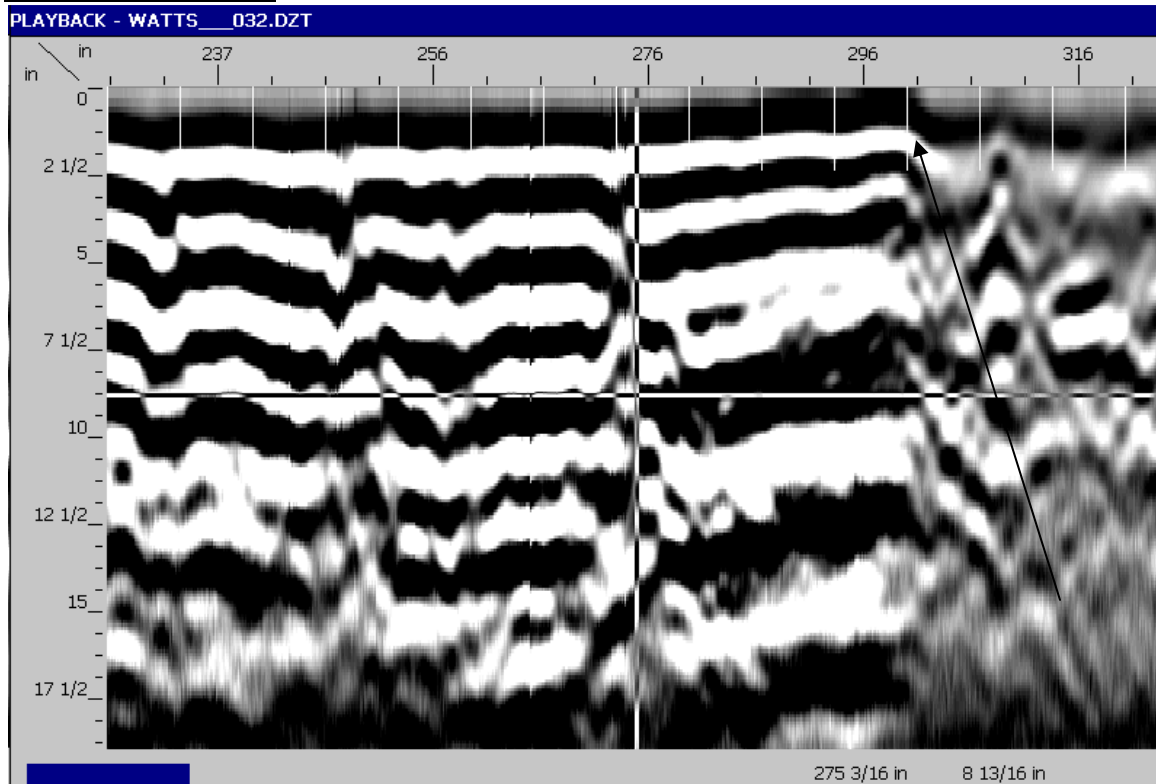
**#60a, #60b and #60c**

The above screen shot shows where the reflective area ends in area #60b.

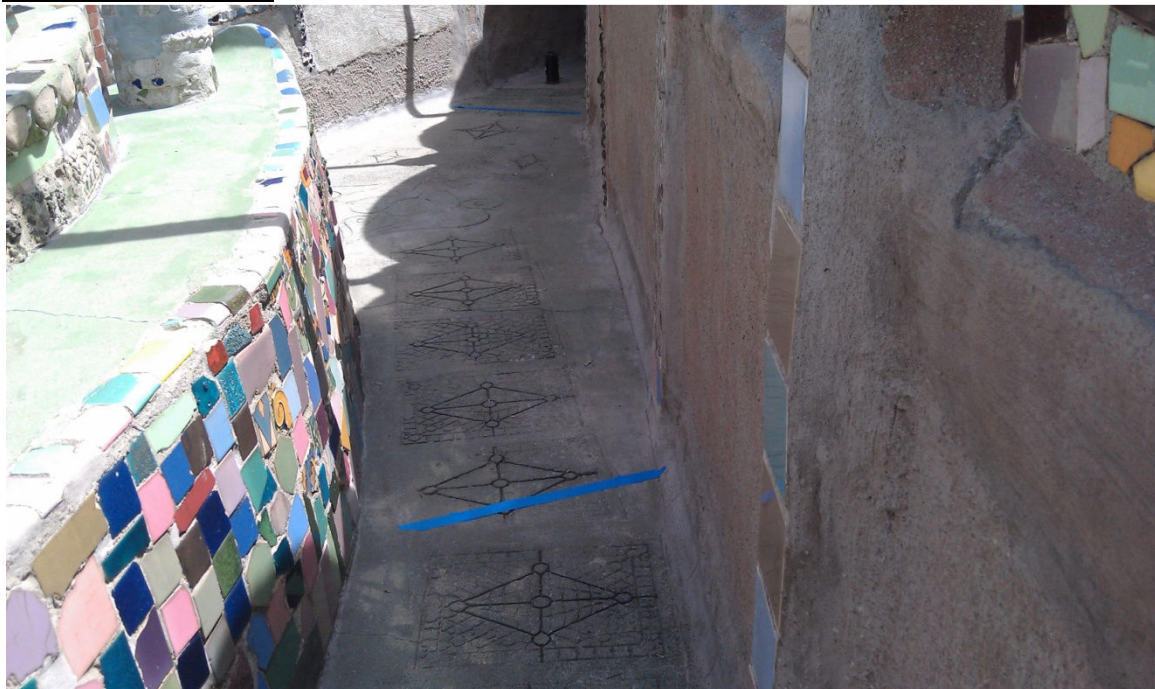
**#60a, #60b and #60c**

The area between the two pieces of blue tape is where the concrete contains the reflective material.

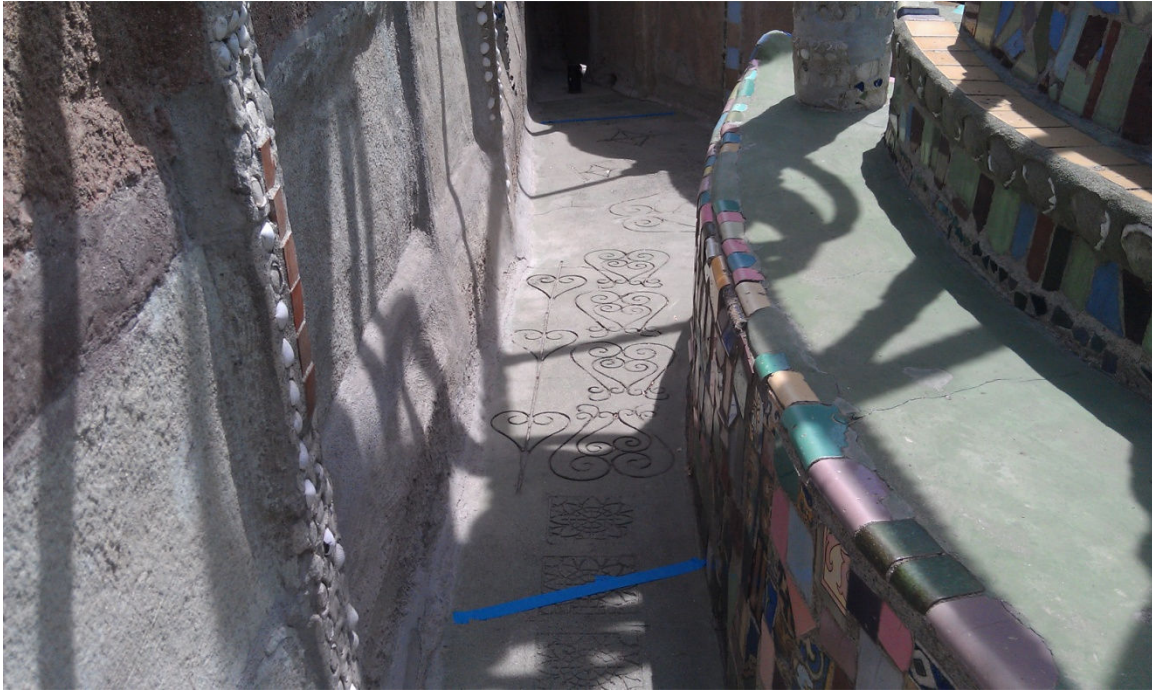
**#60a, #60b and #60c**

The area between the two pieces of blue tape is where the concrete contains the reflective material.
