WATTS TOWERS CONSERVATION PROGRAM  
SPECIAL REPORT  
EARTHQUAKE DAMAGE - OCTOBER 1-6, 1987  
VANDALISM DAMAGE - SEPTEMBER 14, 1987

BACKGROUND

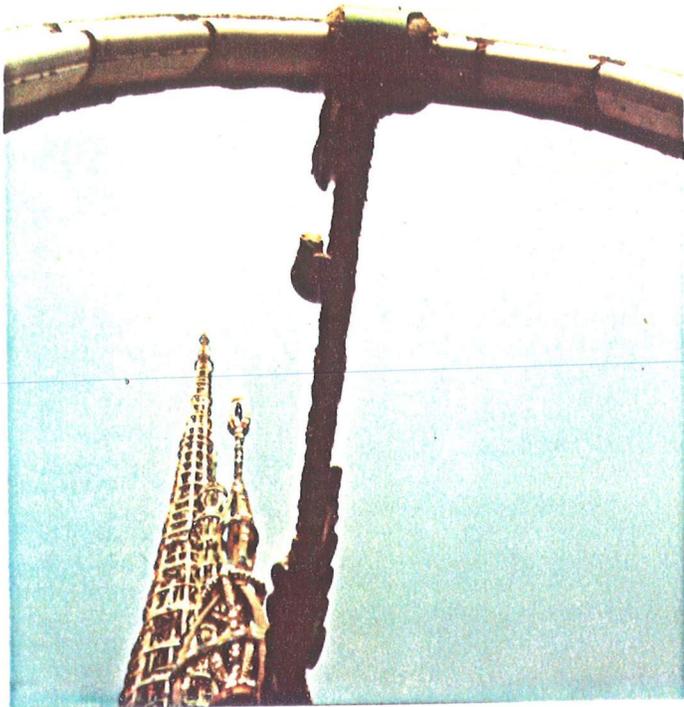
The morning of September 15, the East-to-West overhead connector from the Ship of Marco Polo to the junction of the north and south walls was found to have been damaged, probably by a vandal climbing over the Rodia wall and applying loads to the overhead connector in gaining entry. Photograph #01 shows the overhead which has lost the mortar and decorations, exposing the steel reinforcement still in place. Photograph #03 shows some of the mortar cover and decorations found under the overhead on the patio at the east of the Ship between the north and south walls. Photograph #14 shows the connector (center of photo) and a North-to-South connector after the vandalism.

PHOTOGRAPH #01 VANDALISM DAMAGE  
9/14/87 TO OVERHEAD CONNECTOR  
PHOTOS #01-03 BY M.L. BOYD

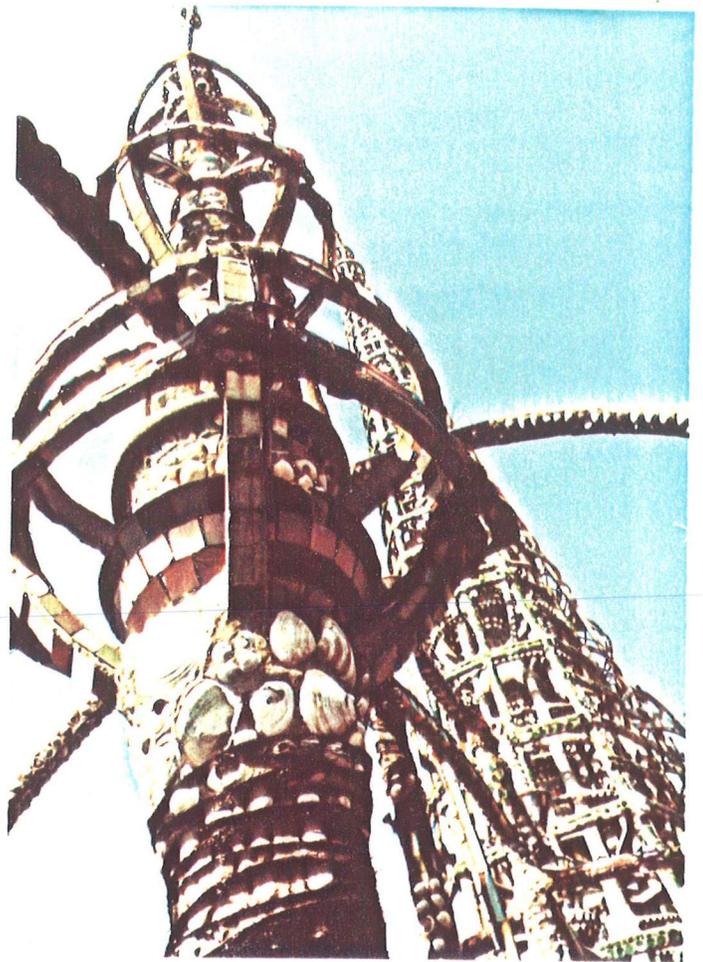
Inspections on October 1, 2, 6, and 9 revealed damage to the superstructure of the spire and additional damage to the overhead connectors from the Ship to the walls. There is a possibility that the earlier vandalism had loosened the mortar, contributing to the subsequent losses during the earthquakes.

The top two feet of the spire were found to have been tilted at a 15 degree angle to the north after the 5.5 earthquake which followed the 6.1 earthquake. Photograph #02 shows the spire top tilted (top of photo).

PHOTOGRAPH #02 EARTHQUAKE DAMAGE  
10/04/87 TO SHIP SPIRE, NOTE TILT  
TO NORTH COMPARED WITH PHOTO #01

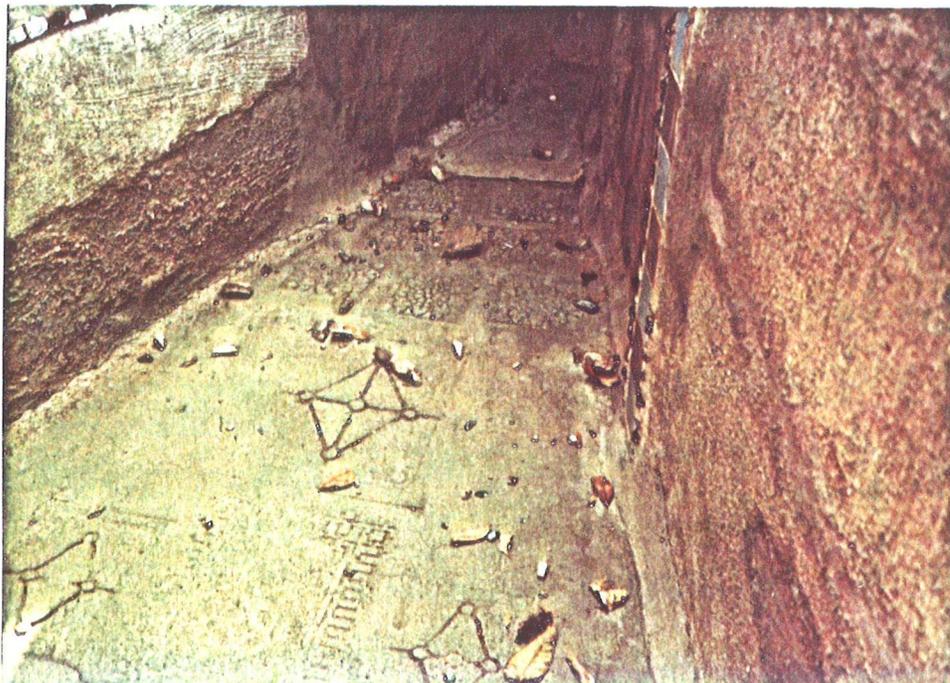
PHOTOGRAPH #03 VANDALISM DAMAGE  
9/14/87 PIECES FROM E-W OVERHEAD  
FALLEN TO PATIO

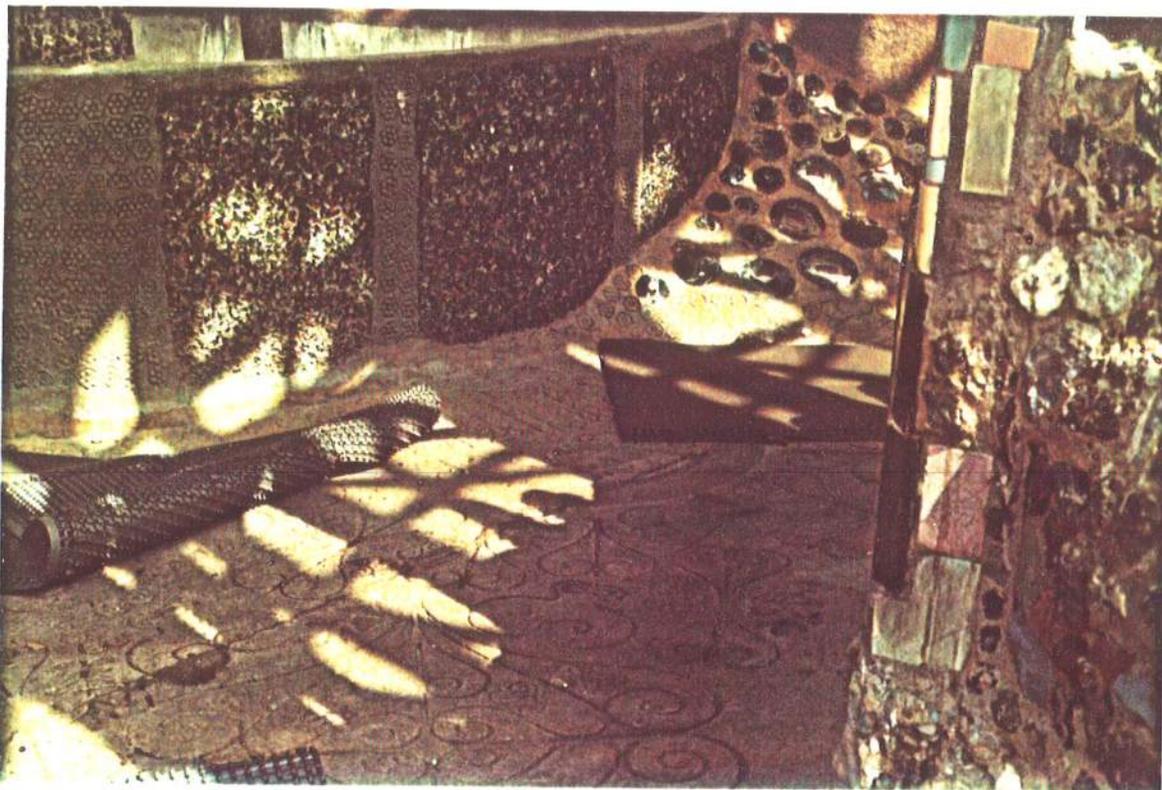
A ten foot long crack was propagated in the patio floor in a ENE to WSW direction between the Center and West Towers by the earthquakes. Photograph #04 shows the crack running from the lower left corner of the photo to the center near the black patio cover.

PHOTOGRAPH #04 EARTHQUAKE DAMAGE 10/04 TO PATIO FLOOR BETWEEN CENTER AND WEST TOWERS PHOTOS BY N.J. GOLDSTONE

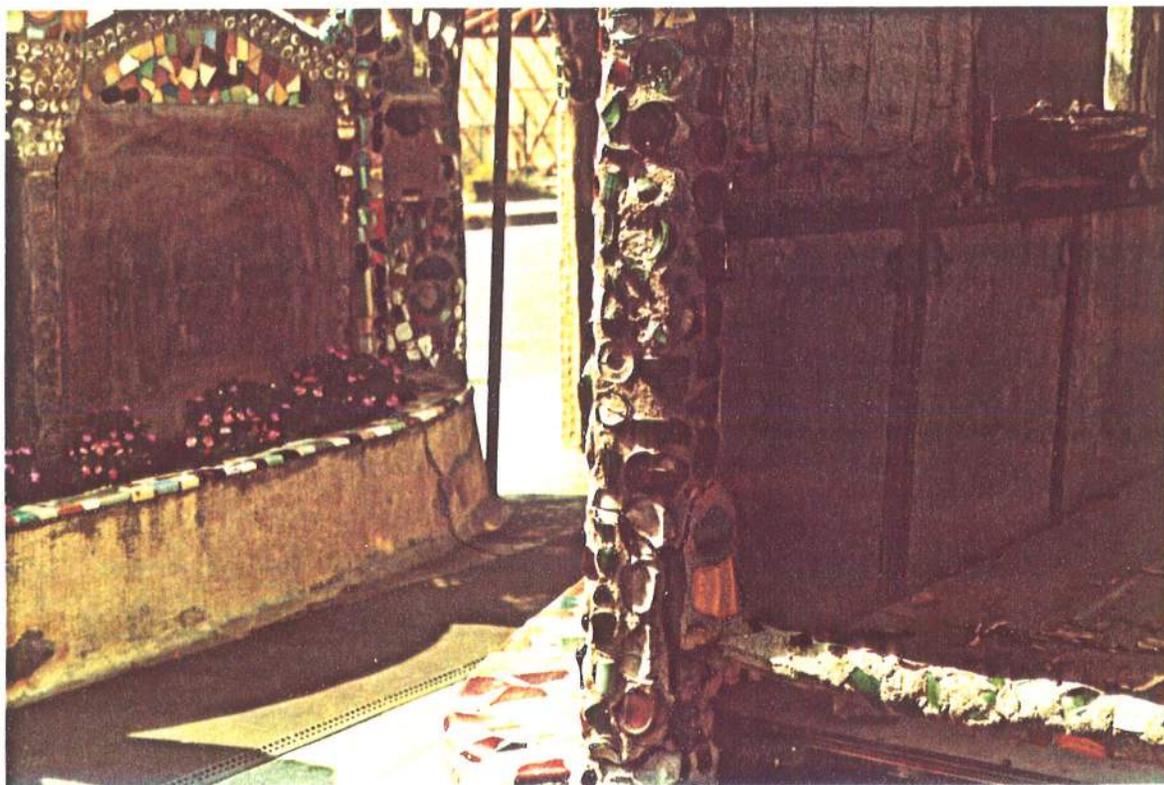
The vertical column at the east end of the facade was severely cracked near the base by the earthquakes. Photograph #05 shows the horizontal and vertical cracks at the bottom center of the photo.

PHOTOGRAPH #05 EARTHQUAKE DAMAGE 10/04 TO RODIA HOUSE FACADE EAST COLUMN, LOWER CENTER OF PHOTOGRAPH.

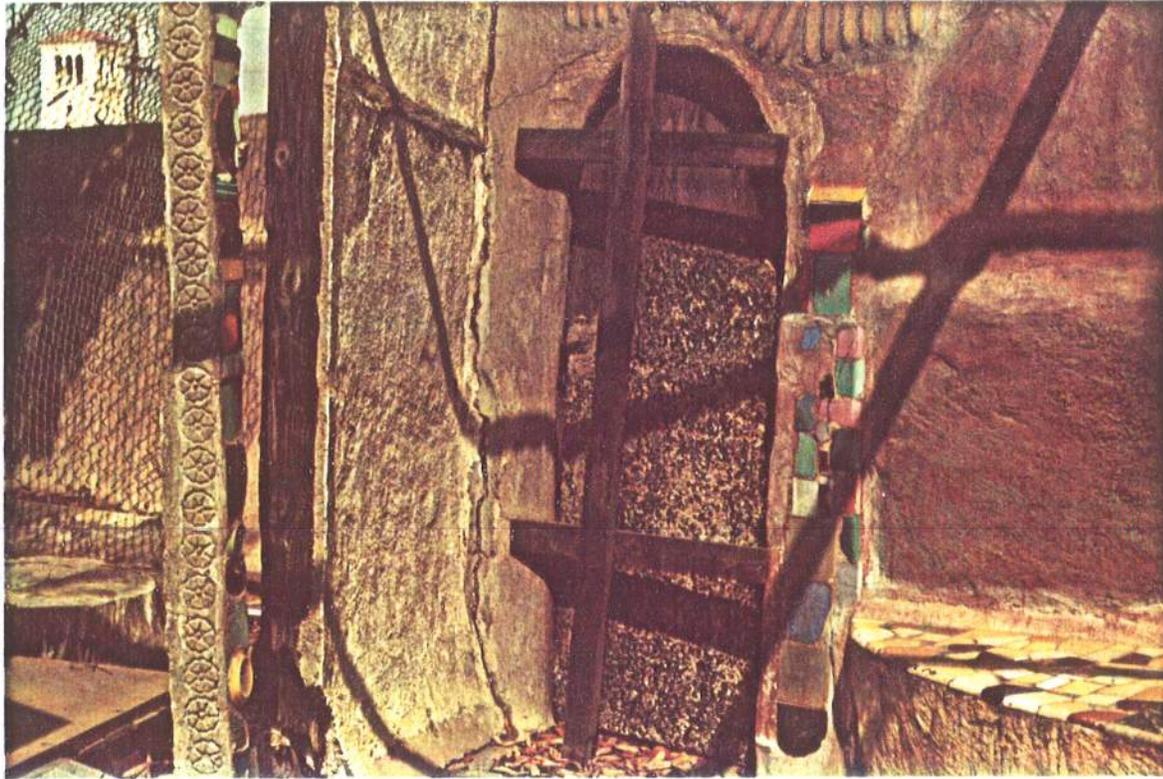
An existing crack at the juncture was widened by the earthquake. Photograph #06 shows the vertical crack, left center of the photograph, left of the rear entry through the north wall.

PHOTOGRAPH #06 EARTHQUAKE DAMAGE 10/04 TO VERTICAL JOINT BETWEEN NORTH WALL AND RODIA HOUSE FACADE

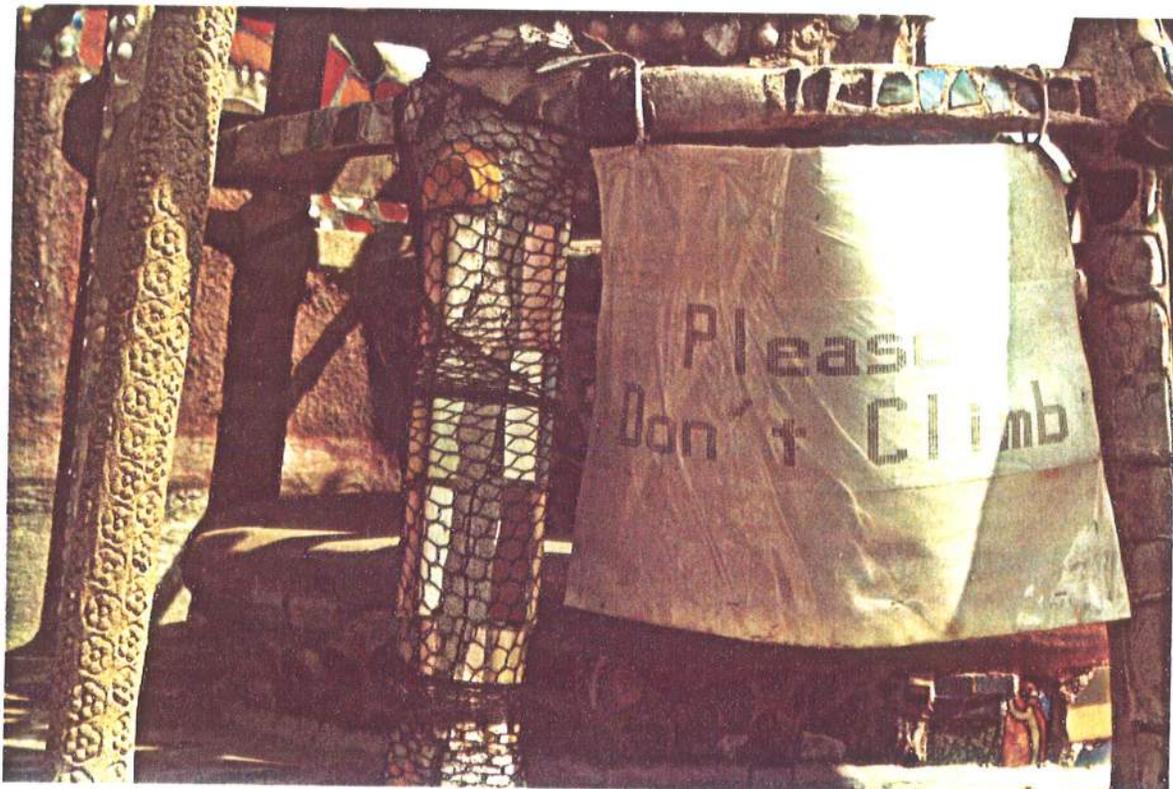
Existing small cracks in three vertical columns of the East Tower were widened and lengthened by the earthquakes. Photographs #07, #08, and #09 show these vertical cracks.

The growth of these cracks before and after the earthquakes has been of considerable concern in the long-term conservation of the sculptures. These three columns were originally repaired in 1979 and re-repaired in 1981 and 1985 by the Office of the State Architect (OSA). The surfaces were waterproofed on February 19, 1985 after the most recent OSA repairs were made on this tower.

PHOTOGRAPH #07 EXISTING CRACK WIDENED BY EARTHQUAKE DAMAGE 10/04 TO EAST TOWER COLUMN #6

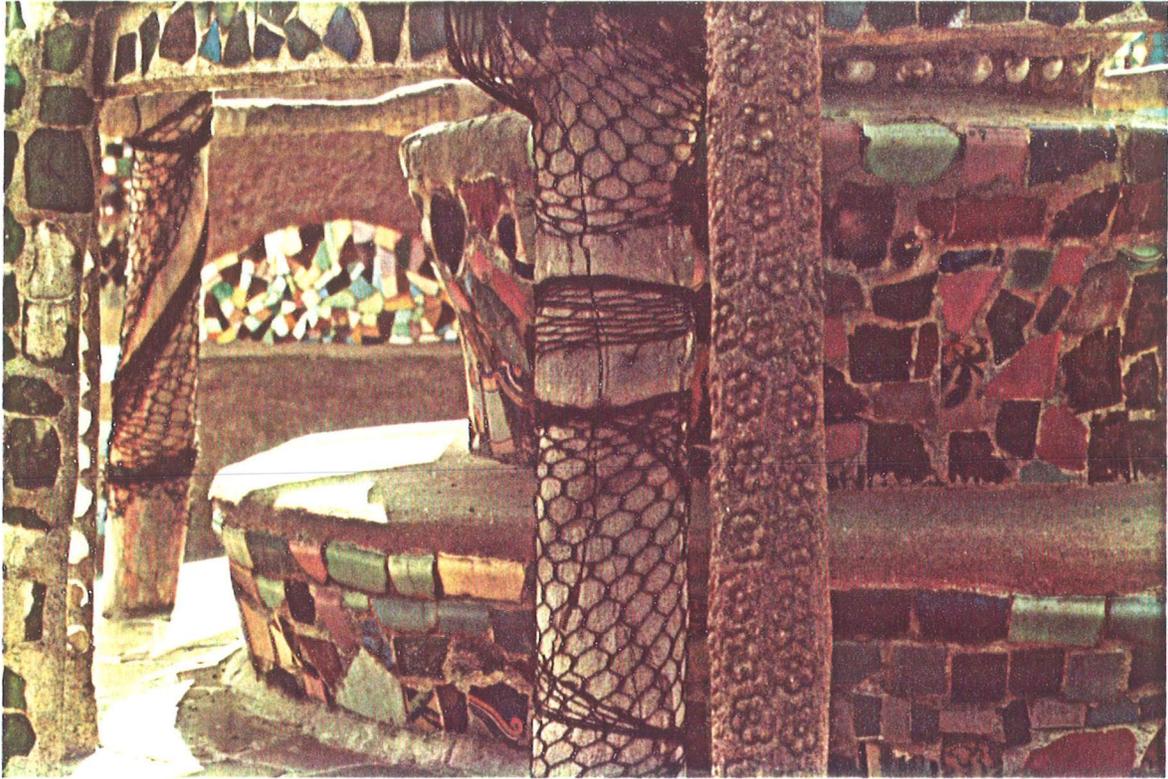
PHOTOGRAPH #08 EXISTING CRACK WIDENED BY EARTHQUAKE DAMAGE  
10/04 TO EAST TOWER COLUMN #8

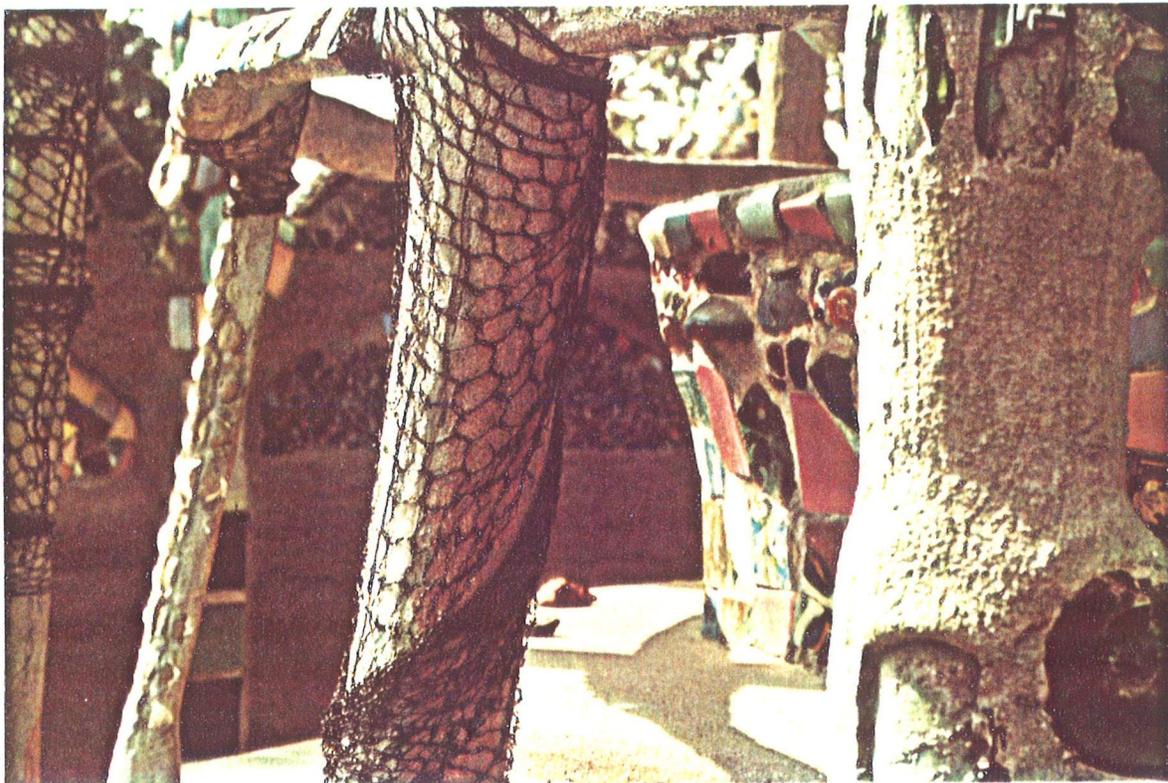
PHOTOGRAPH #09 EXISTING CRACK WIDENED BY EARTHQUAKE DAMAGE  
10/04 TO EAST TOWER COLUMN #2

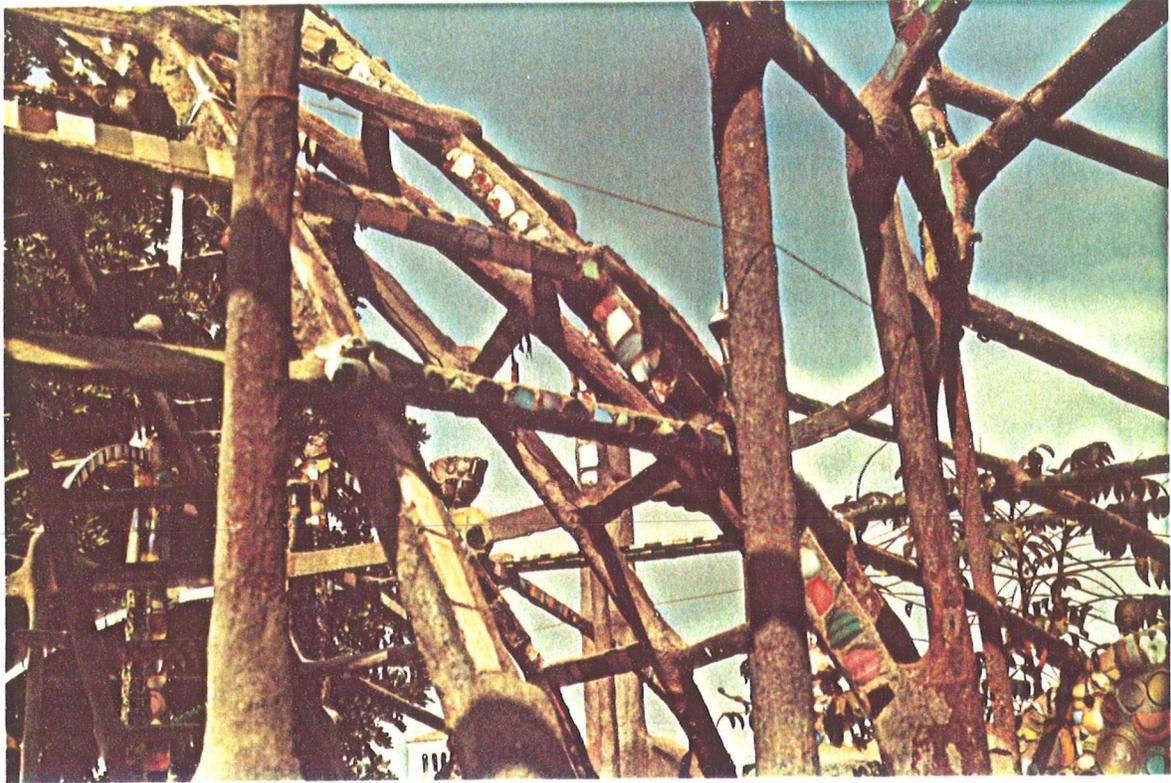
Existing cracks in a long, arched column in the Gazebo was widened by the earthquakes. Photograph #10 shows the 6-foot long crack running from the lower center (rear) to the upper left-center of the photo.

The growth of this crack before and after the earthquakes has also been of considerable concern in the long-term conservation of the sculptures. The Gazebo was originally repaired in 1978 by the City of Los Angeles contractor and re-repaired in May 1985 by the Office of the State Architect (OSA). The surfaces were waterproofed in May 1985 after the most recent OSA repairs were made on this tower. Other cracks had developed before the earthquake and are also of concern.

PHOTOGRAPH #10 EXISTING CRACK WIDENED BY EARTHQUAKE DAMAGE 10/04 TO GAZEBO ARCHED COLUMN #2, CENTER REAR OF PHOTO

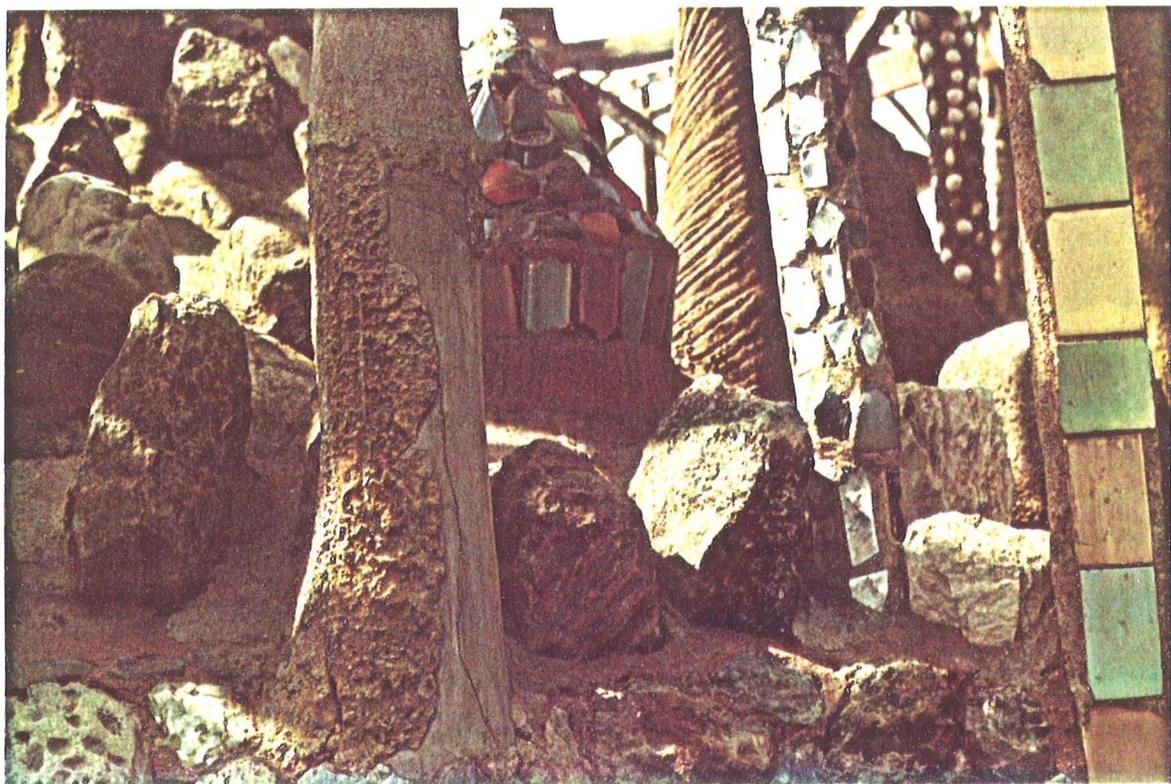
Existing small cracks in vertical columns of the Center Tower were widened and lengthened by the earthquakes. Photograph #11 shows one such vertical crack.

PHOTOGRAPH #11 EXISTING CRACK WIDENED BY EARTHQUAKE DAMAGE 10/04 TO CENTER TOWER COLUMN #8

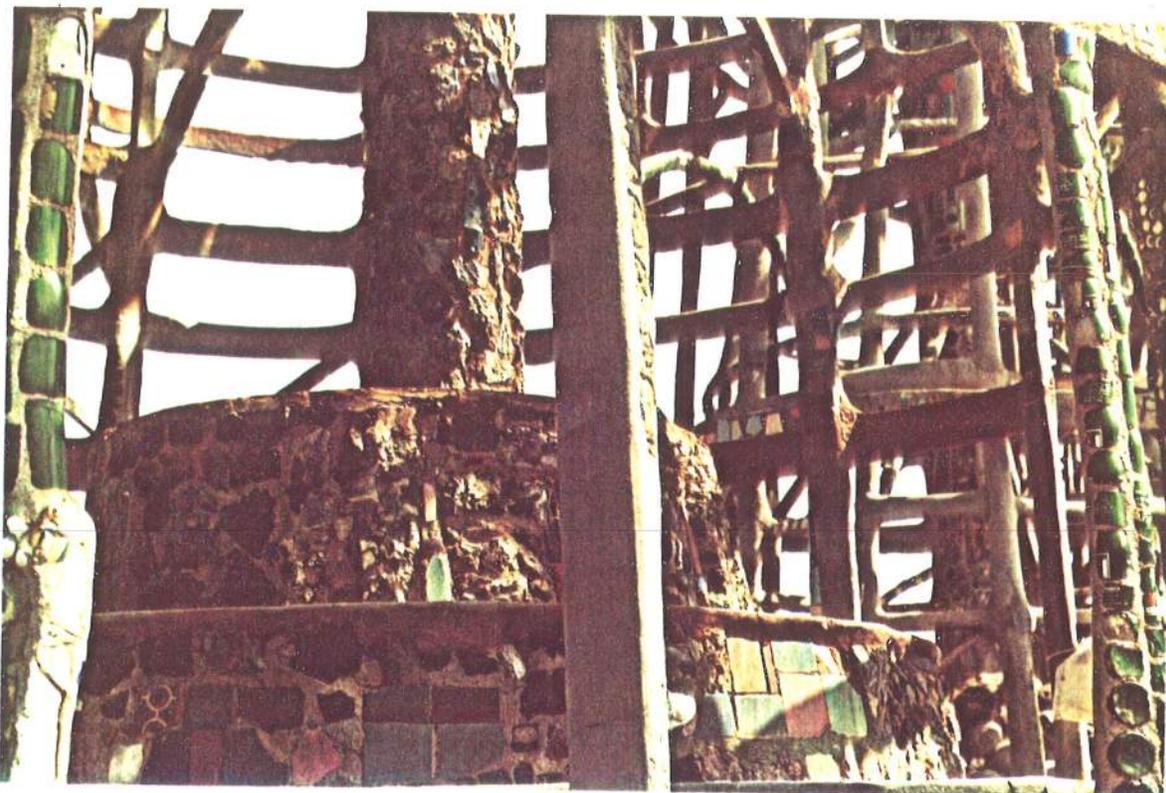
Existing small cracks in two vertical columns of the West Tower were widened and lengthened by the earthquakes. Photographs #12, and #13 show these horizontal cracks.

PHOTOGRAPH #12 EXISTING HORIZONTAL CRACKS WIDENED BY EARTHQUAKE DAMAGE 10/04 TO WEST TOWER COLUMN

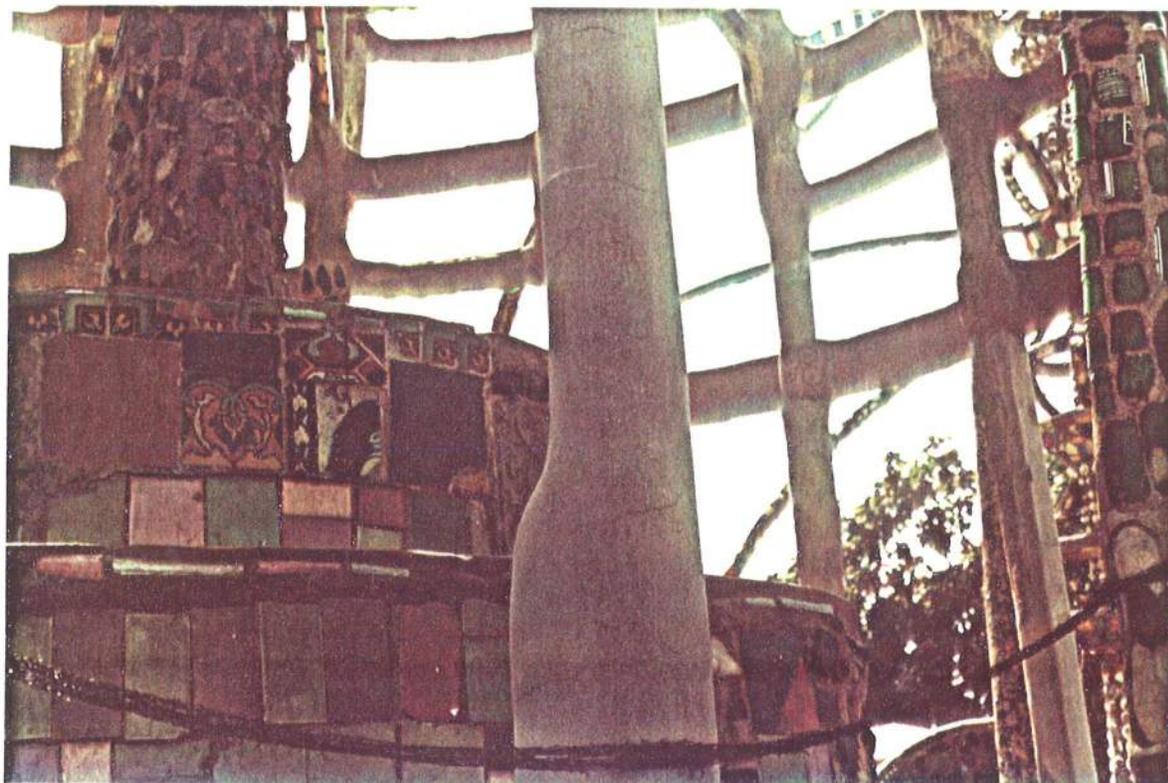
PHOTOGRAPH #13 EXISTING HORIZONTAL CRACKS WIDENED BY EARTHQUAKE DAMAGE 10/04 TO WEST TOWER COLUMN

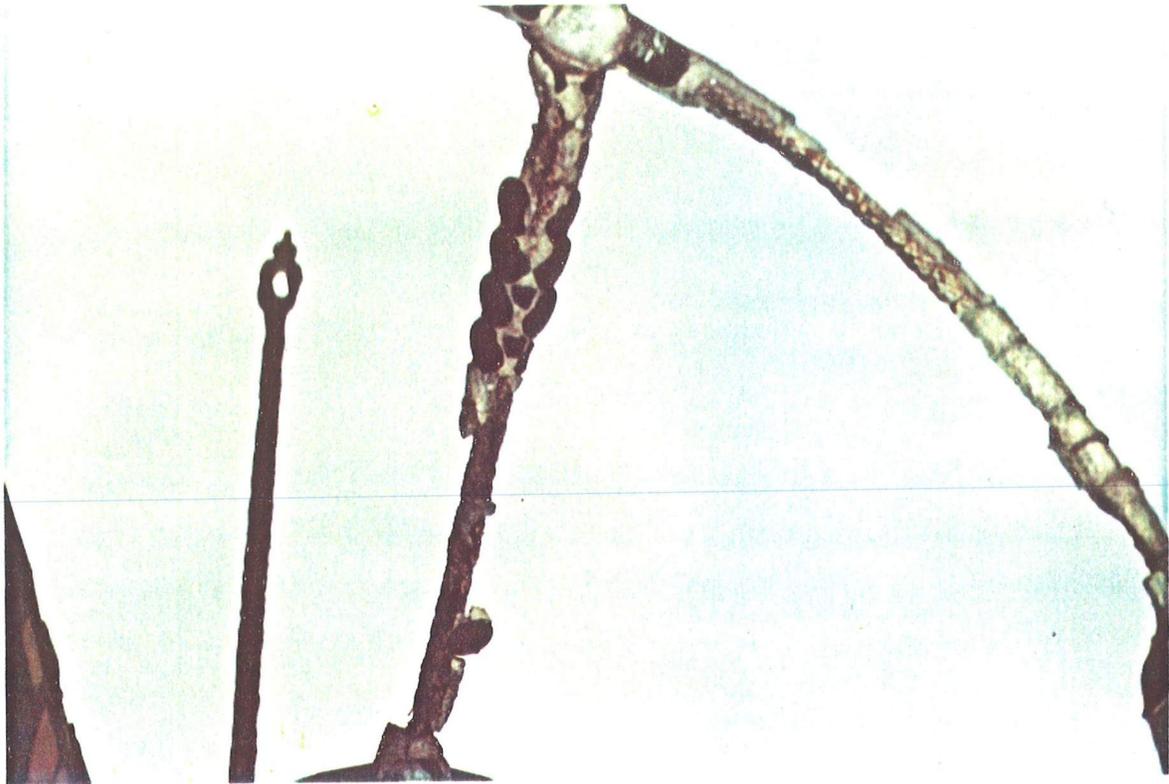
PHOTOGRAPH #14 EARTHQUAKE & VANDALISM DAMAGE TO OVERHEAD CONNECTOR

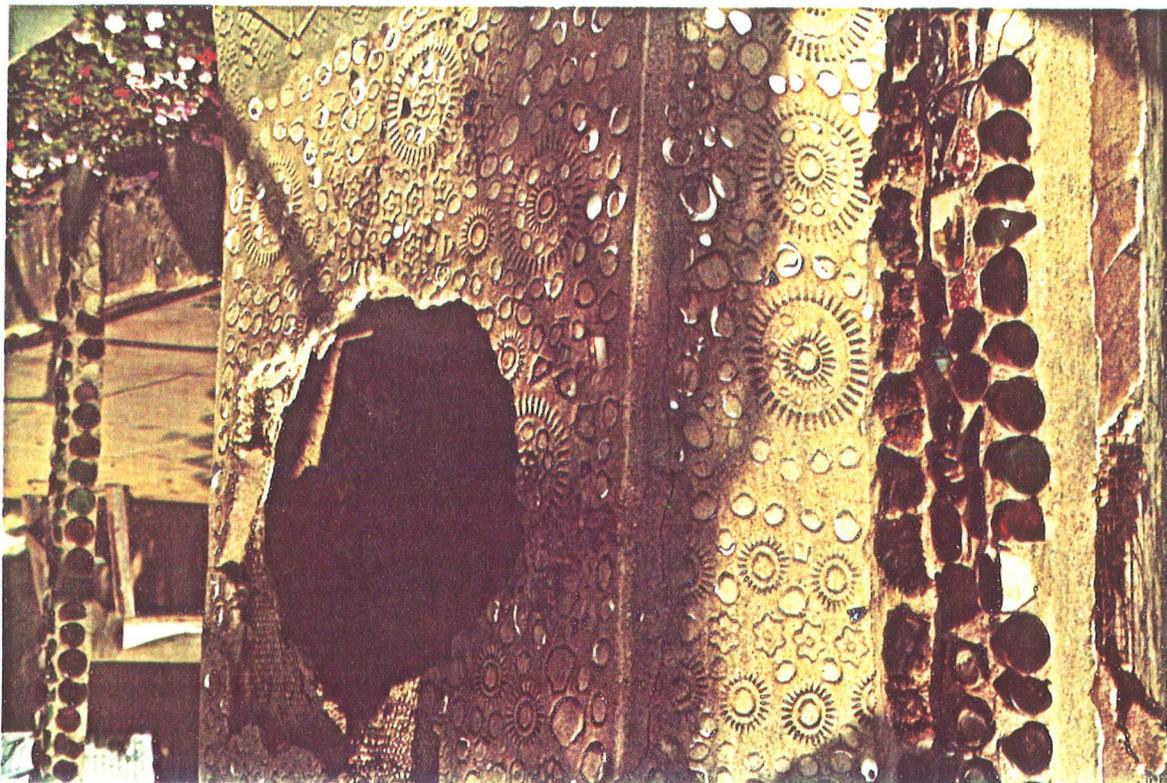
The south and north external surfaces of the chimney show hairline vertical cracks as a result of the earthquakes. Photograph #15 shows the north face of the chimney, right side of photo, with a vertical crack near the intersection with the east face (with large hole).

PHOTOGRAPH #15 EARTHQUAKE DAMAGE 10/06 TO RODIA HOUSE CHIMNEY
