CONSERVATION OF THE SHIP OF MARCO POLO
WATTS TOWERS CONSERVATION PROGRAM

This is a report on the conservation work performed by the Cultural Affairs Department, City of Los Angeles between January 1986 and February 1991 on the Ship of Marco Polo, one of 17 sculptures in the Towers of Simon Rodia State Historic Park at 1765 East 107th Street. The Ship is shown in Figure 1 as it was in 1959.

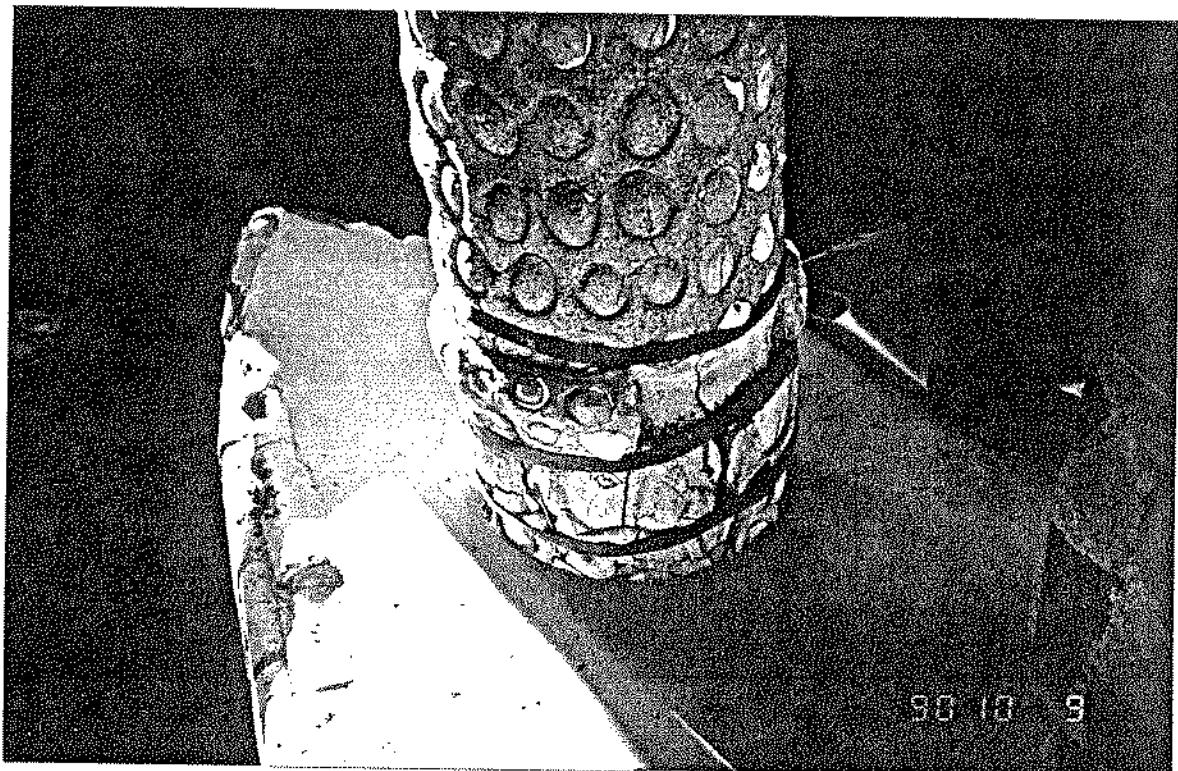
In late 1985, the Ship was in poor condition. Mortar around the supporting base of the main spire was cracked through to the corrugated metal pipe reinforcement in many places (Figure 4). Vertical arcs and horizontal beams encircling the spire had broken and were supported by ropes (Figure 5). A large heart-shaped piece had become dislodged. The main spire swayed in the wind because mortar on the base of the spire had separated from the steel pipe which supports the spire. Two large earthquakes in October, 1987 caused a failure near the top of the spire, tilting it 15 degrees to the north (Figure 6).

Figure 4.
Baseline photo of main spire base.
Note straps holding mortar in place.
1990.
Temporary stabilization.

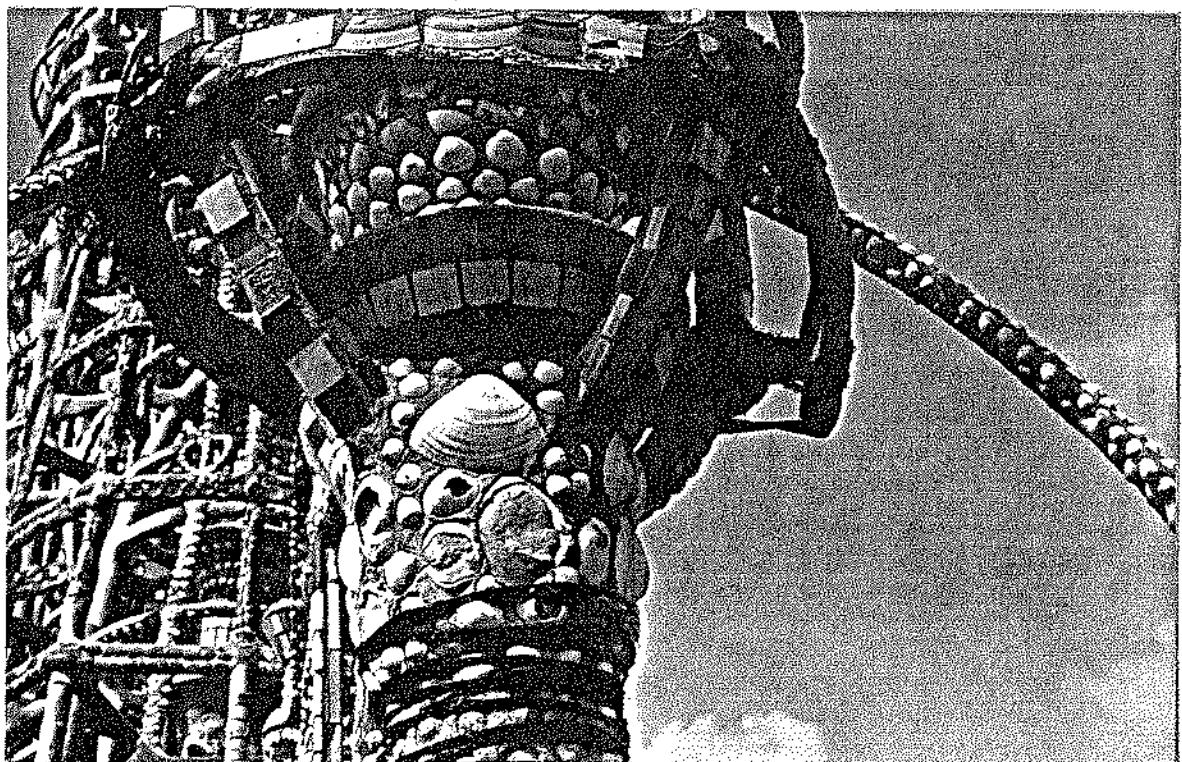
October: 6.1 and 5.5 earthquakes damaged top of main spire. Scaffolding erected on Gazebo for photography.

Figure 6.
Top of main spire after earthquake.
Note tilt of upper portion.
Oct 1987.
Top was supported by sleeve
for temporary stabilization.

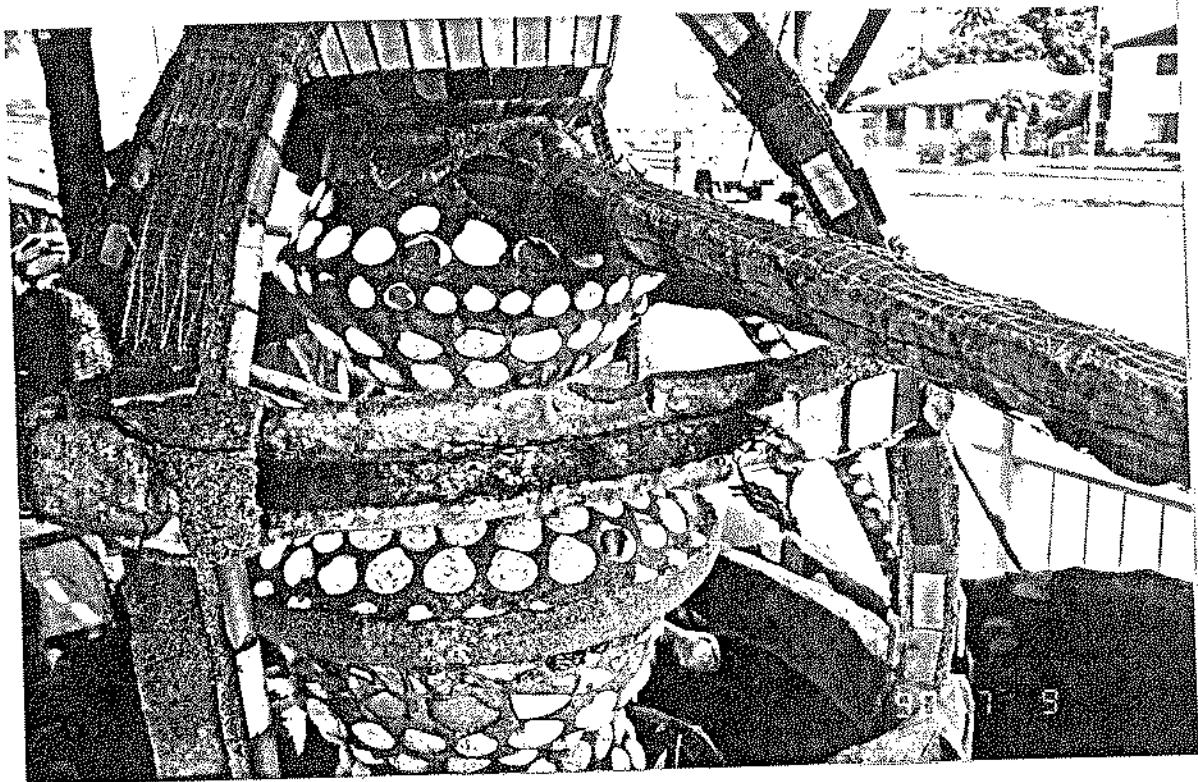
Figure 9.
Main spire band 02 showing loss of
mortar & ornaments.
Jul 1990.
Start of conservation work.

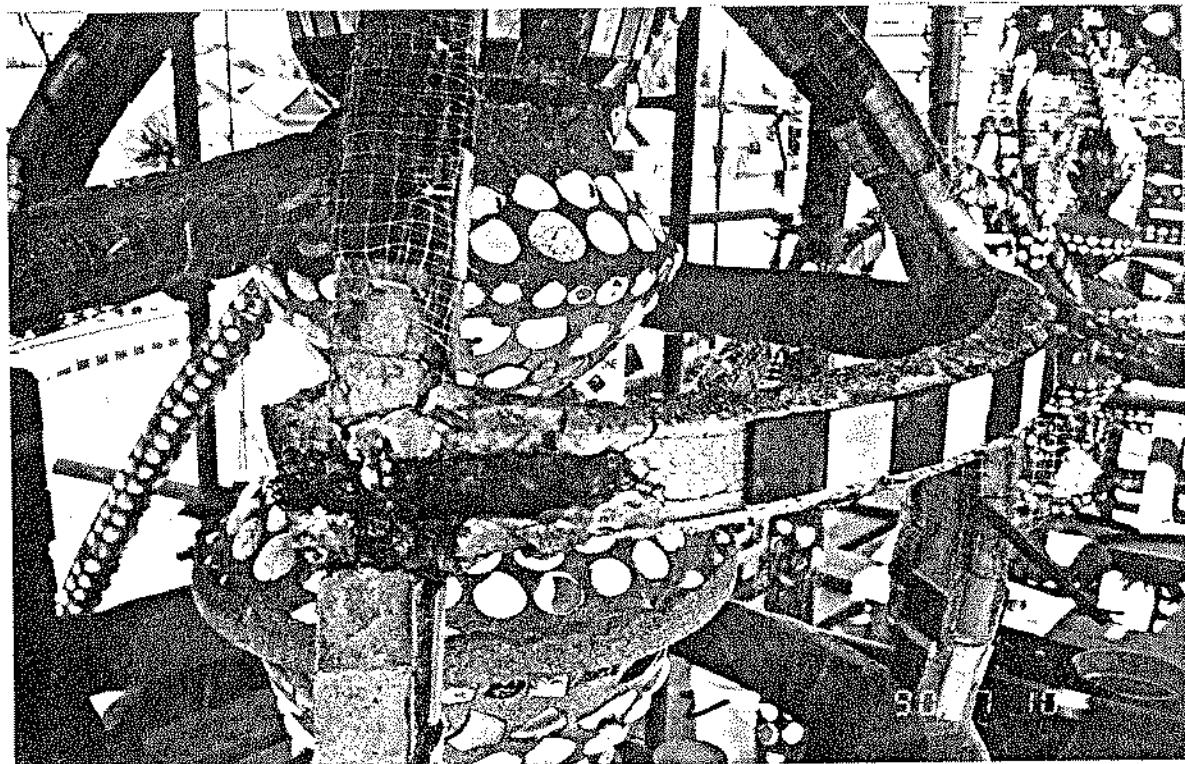
Figure 10.
Main spire band 03 showing mortar
cracks and spalls.
Aug 1990.
Start of conservation work.

August to October: Repair horizontal band 03 and minor vertical arcs.

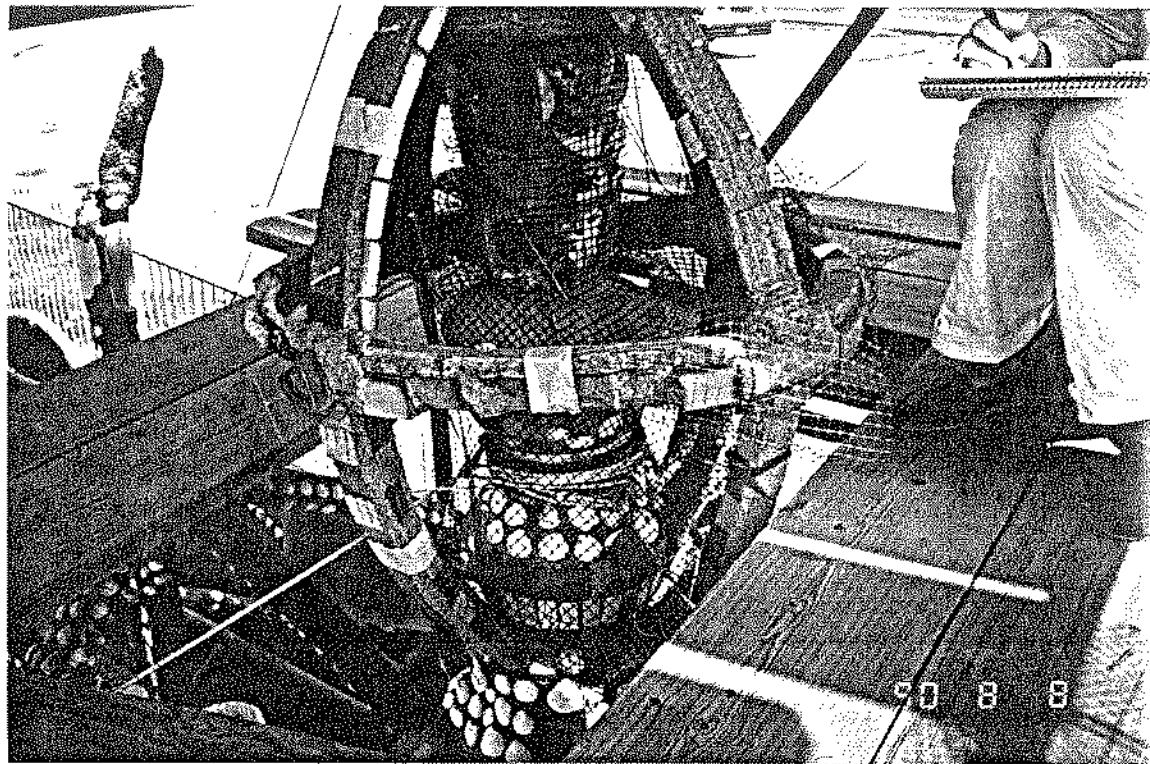
Figure 11.
Main spire band 03 and broken arc.
Note temporary rope supports.
Aug 1990.
Start of conservation work.

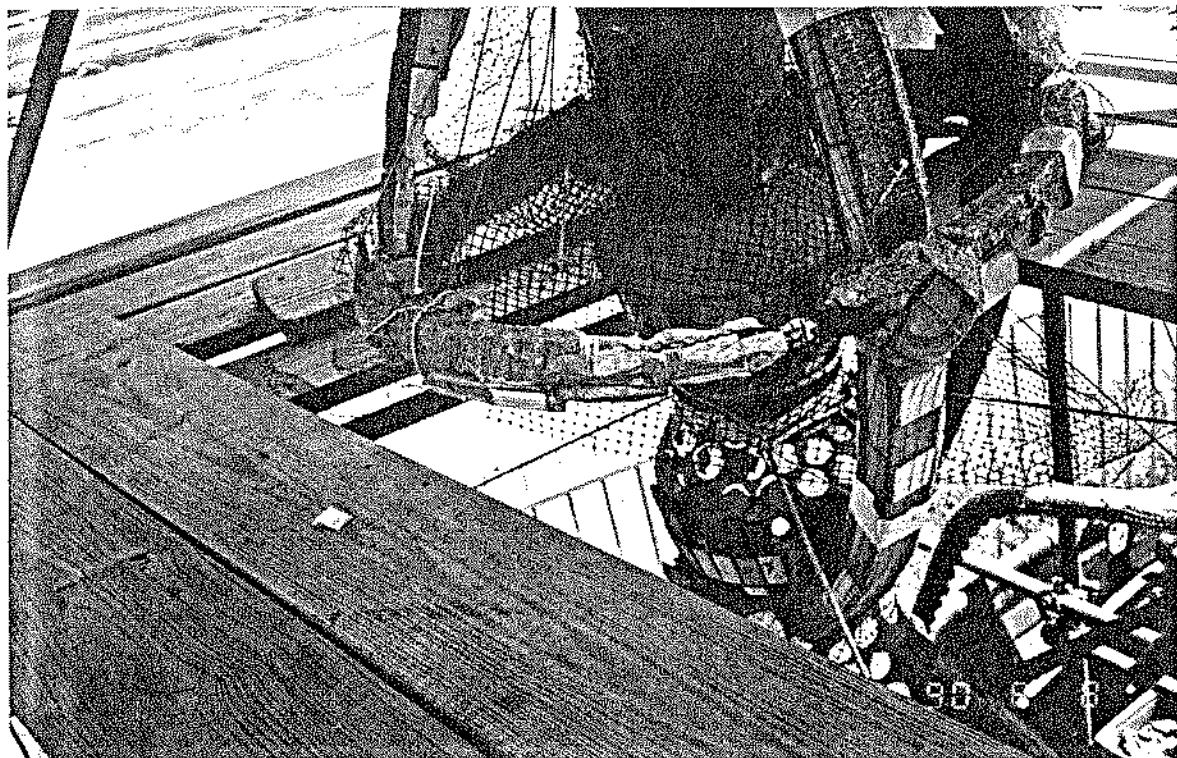
Figure 12.

Broken mortar and separations of mortar from the reinforcements are found at the junctions of band #01 and vertical #02 and band #02 and vertical #02. There are no such failures at the junction of band #03 and vertical #06 which appears to be in good condition throughout.

Main spire arc junction showing failures of mortar and separations of arc ends.

Repairs of the joints will be designed after additional X-ray efforts and analyses of the results. Until that time, temporary crack-filling should be carried out.

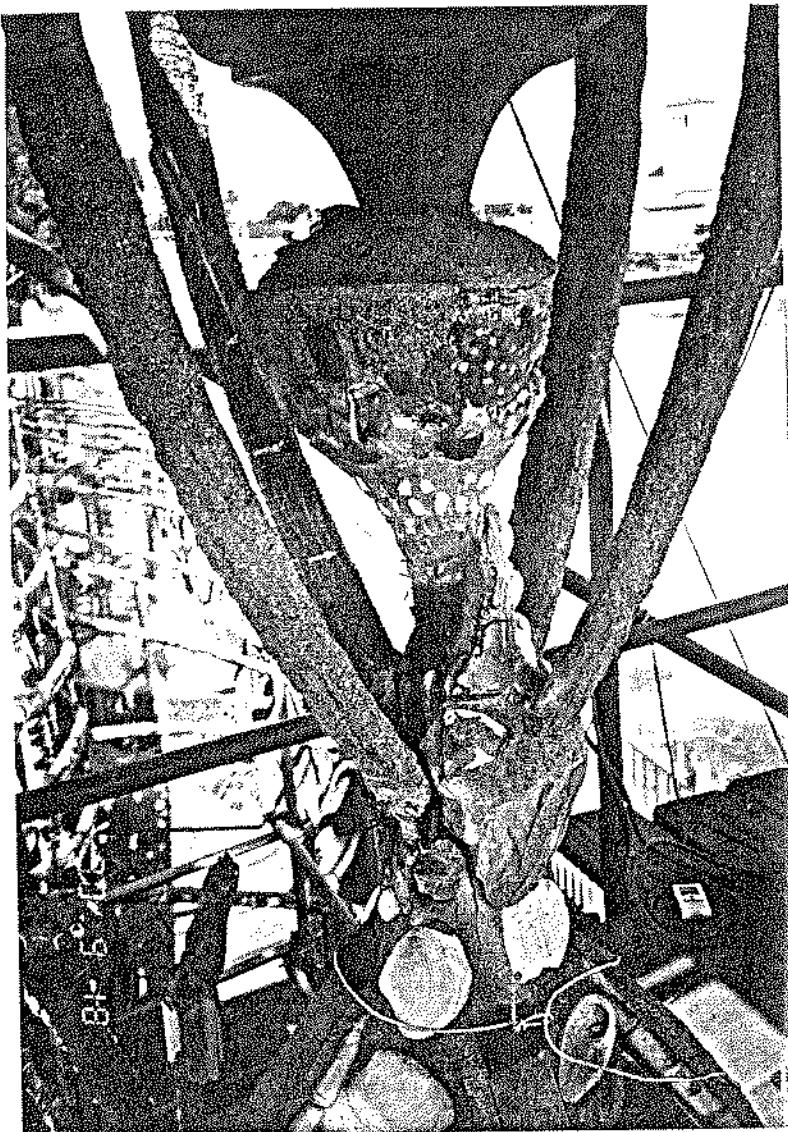
Figure 13.

Main spire arc junction showing failures of mortar, and end separation.

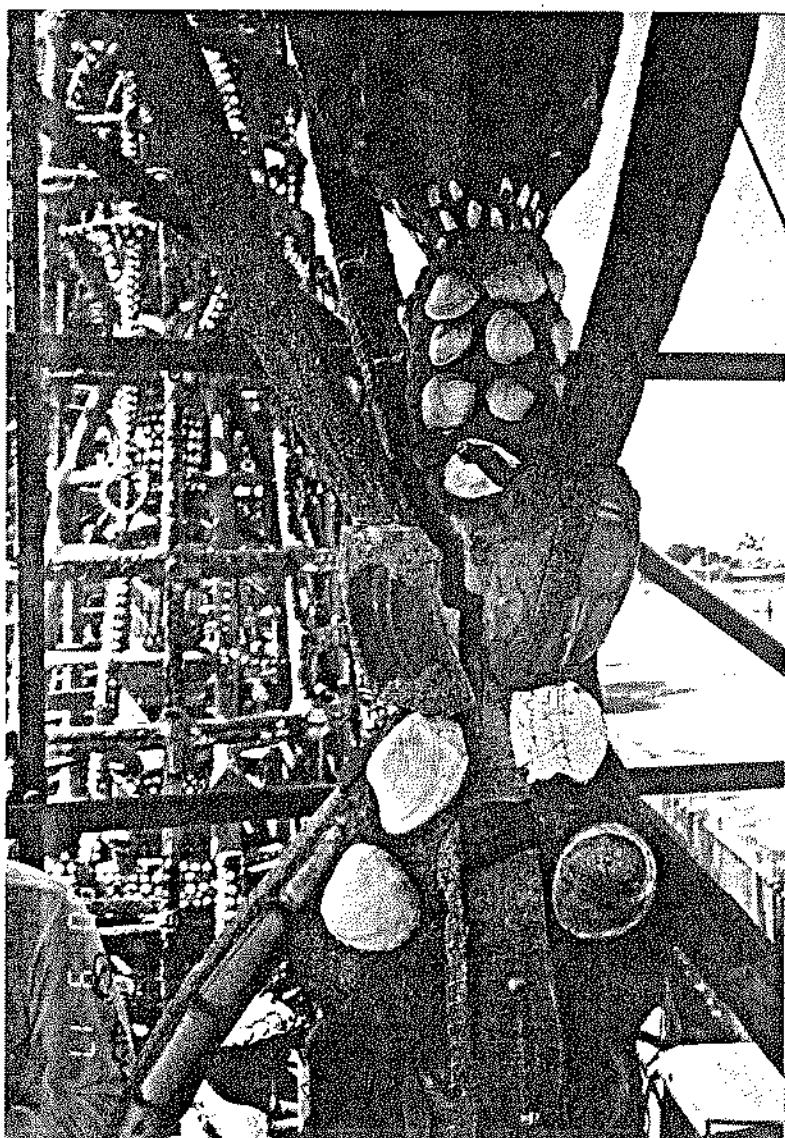
Figure 14.
Main spire arc showing mortar separation from reinforcement.
Jul 1990.
Before conservation, south view.

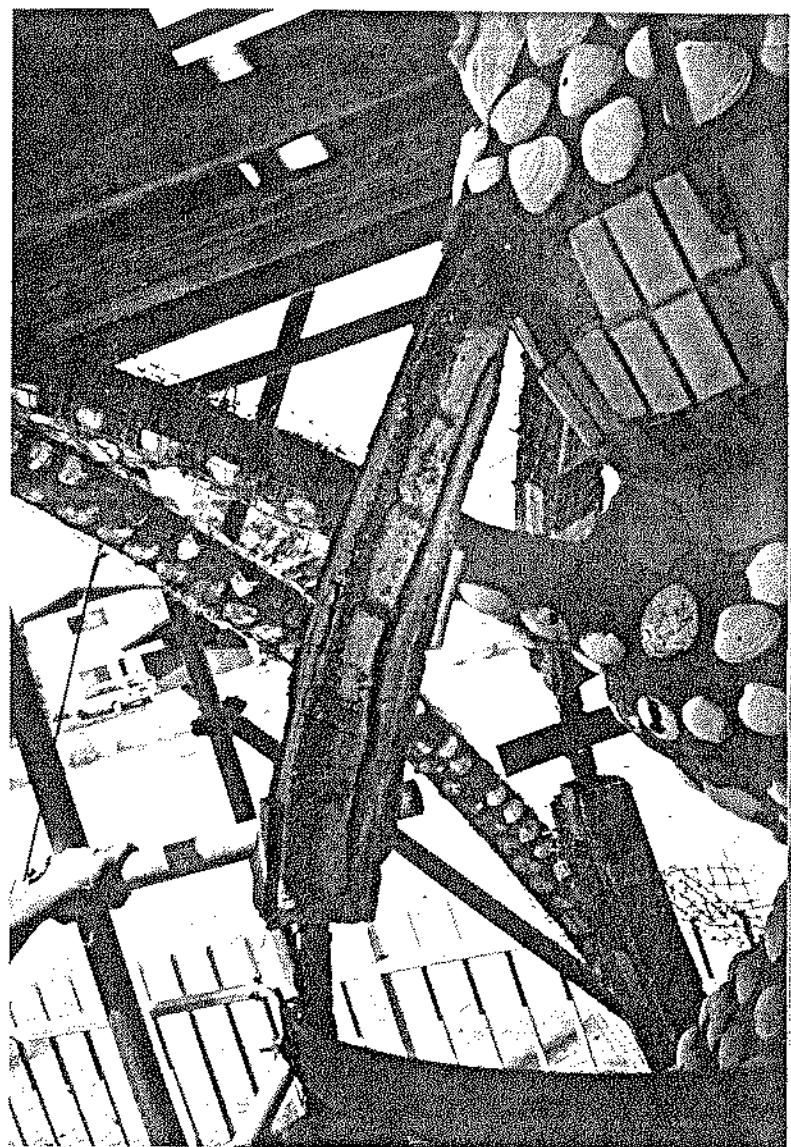
Figure 15.
Bowl on main spire central column,
northwest view.
Oct 1990.
Start of conservation work.

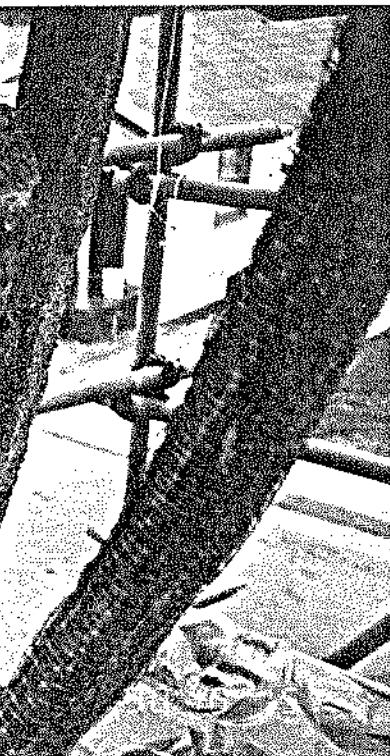
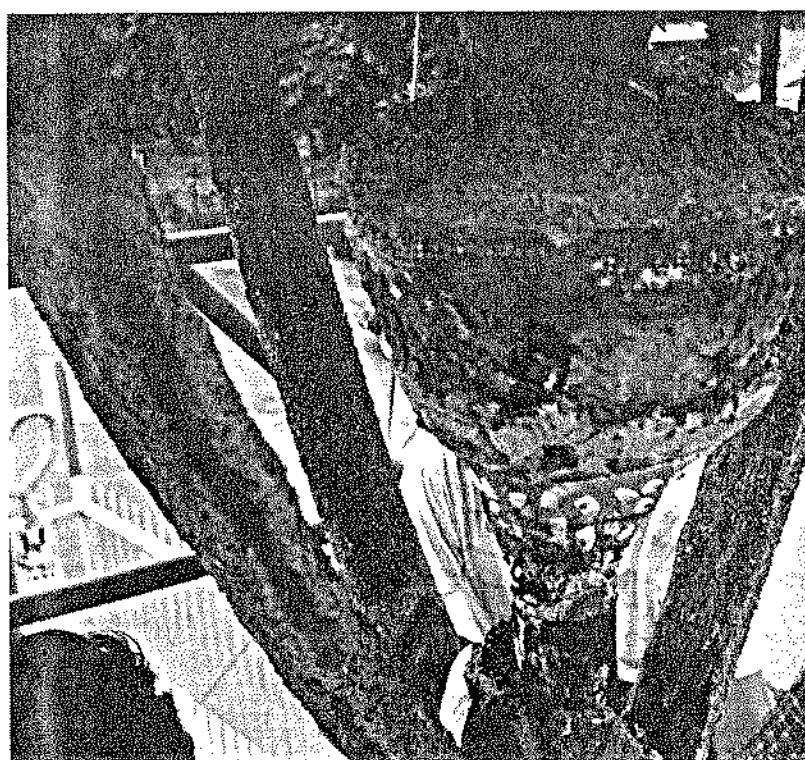
Figure 16.
Main spire top support joint showing
exposed pipe and new mesh.
Oct 1990.
Before conservation completion.

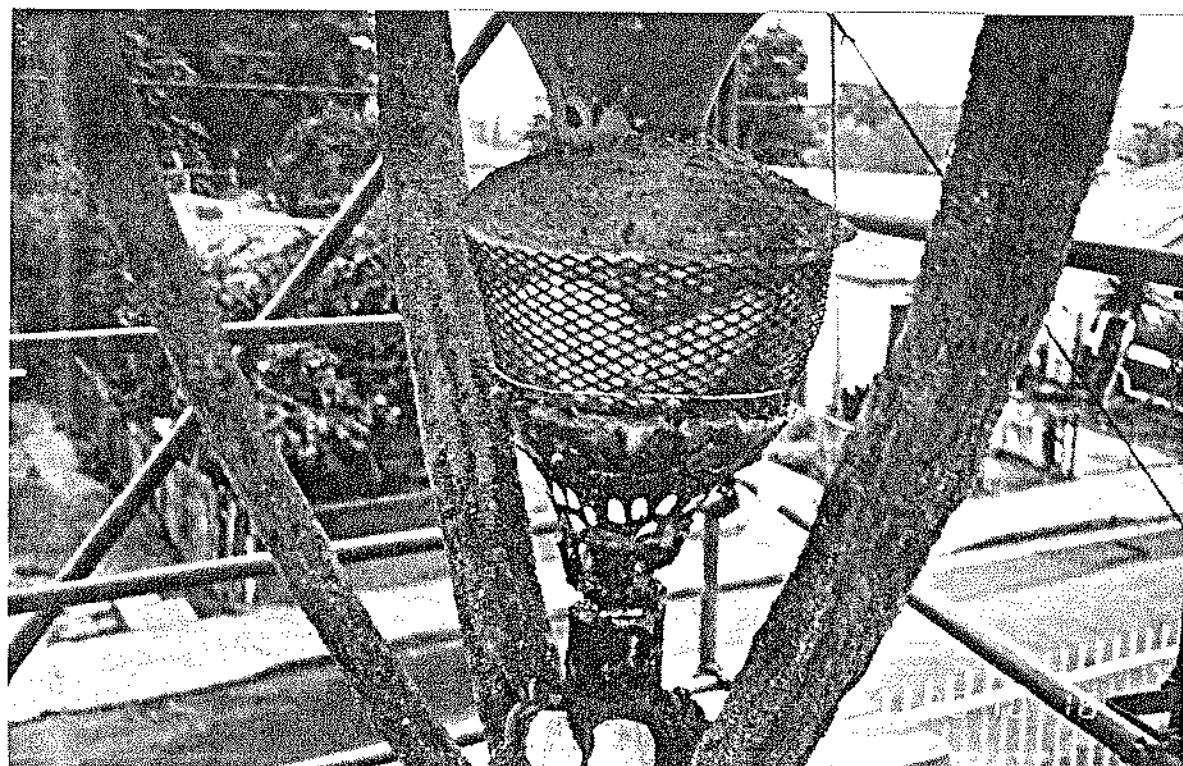
The reinforcement in the tallest spire, Major Vertical 05, is a steel water or sewer pipe with circular, corrugated walls. The larger outside diameter is 9-inches, the smaller outside diameter is 8-inches. The condition of the steel appeared good but there are severe, through-cracks in the mortar cover.

Figure 18.
Base of main spire with restored area
(bottom center), and exposed pipe
(center) prior to derust with Duro.
Oct 1990.
Mortar cover was removed, saved.

October to December: Repair base of main spire.

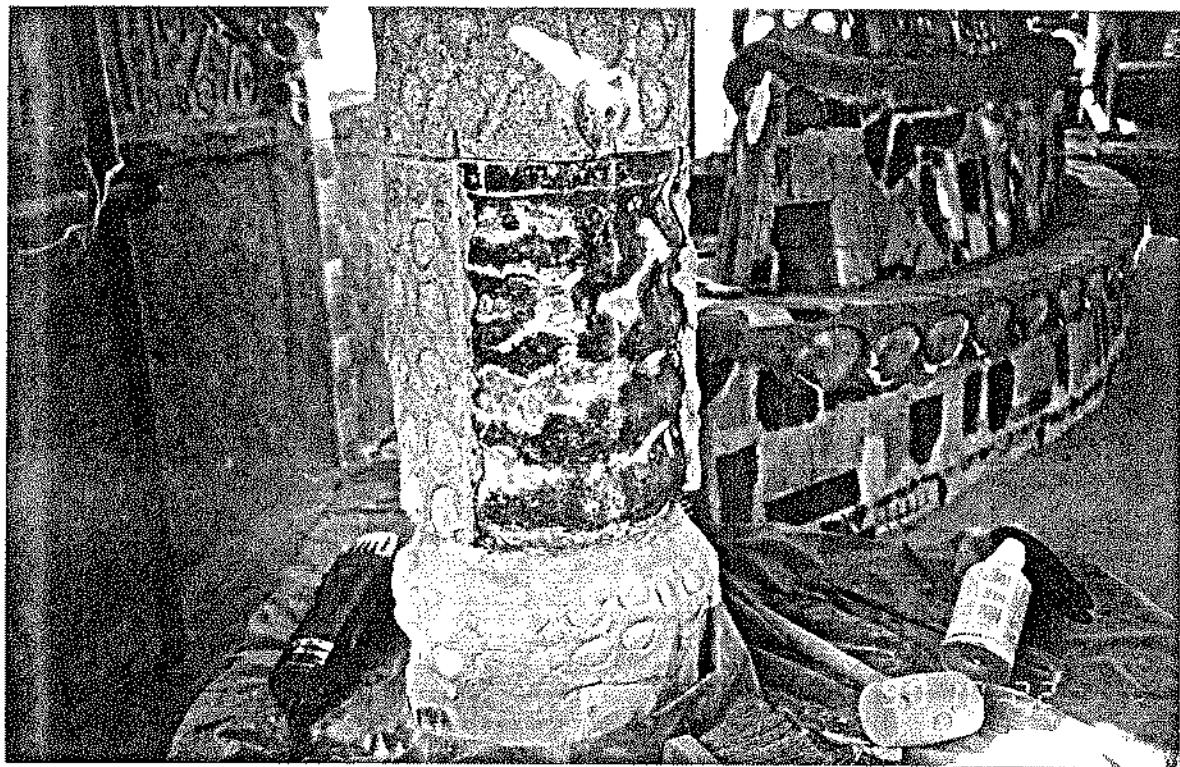
Figure 19.
Base of main spire showing new mesh
over derusted/degreased pipe. Next
was adding new cement over mesh.
Oct 1990.
Note wire tied around mesh & pipe.

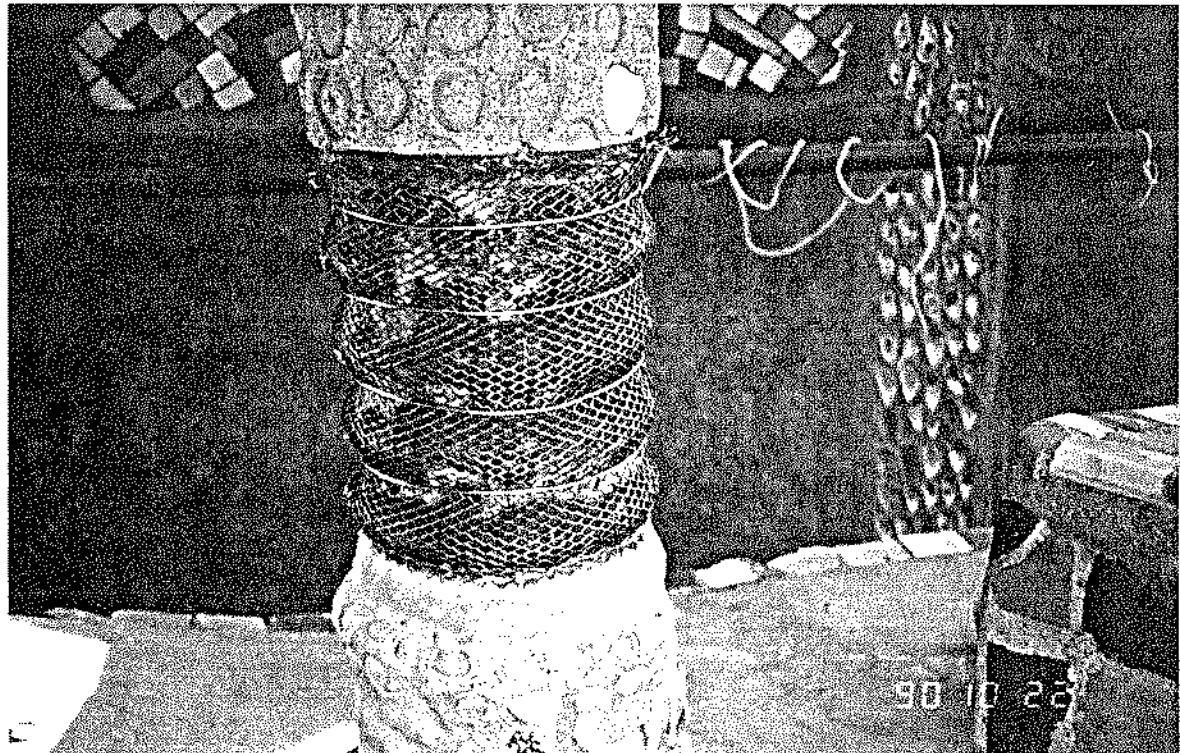
Figure 20.
Main spire band 01 showing new steel
reinforcements and arc connections to
original portions.
May 1990.
Before completion of work.

March to August: Repair horizontal band 01 and minor vertical arcs.

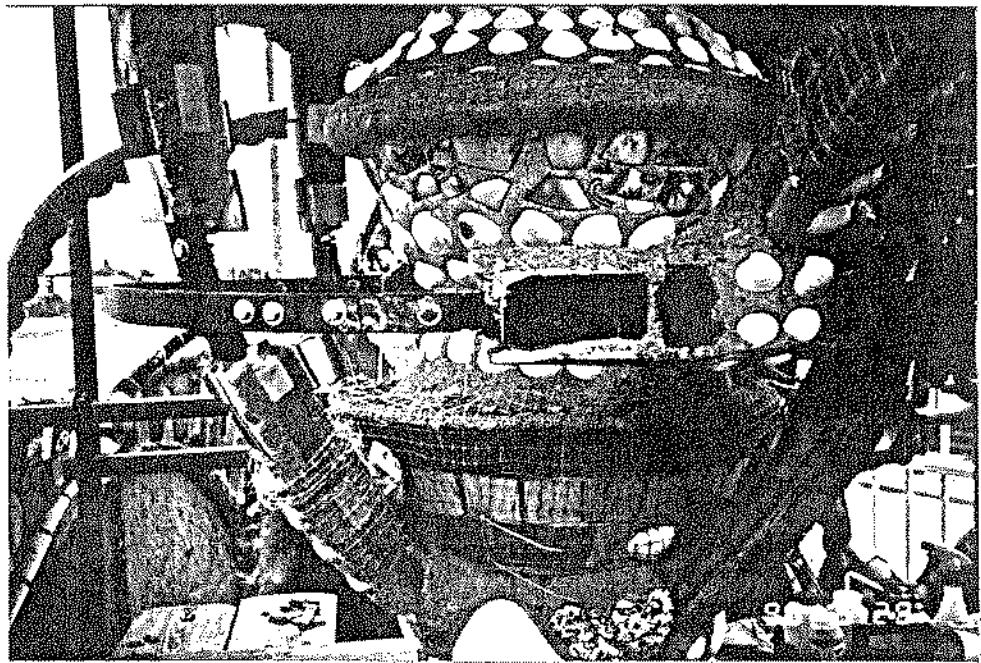
Figure 21.
Main spire band 01 showing new steel
reinforcement and arc connections.
May 1990.
Before completion of work.

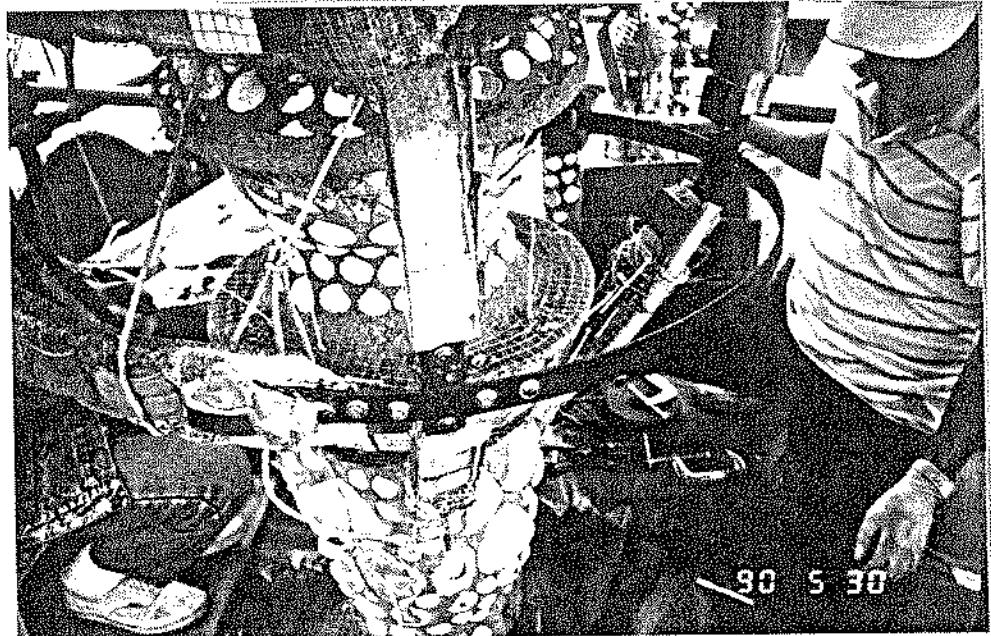
Figure 22.

Main spire band 02 showing new mesh around new steel reinforcement, and connections to arcs.

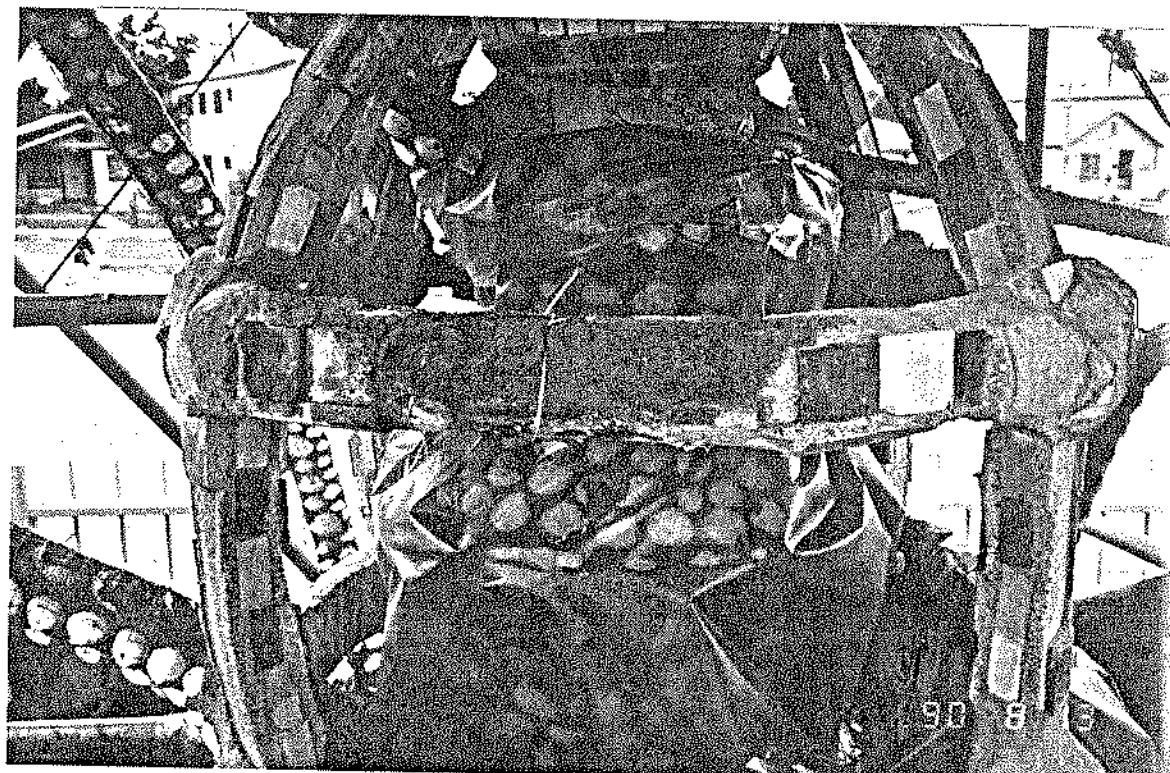
Figure 24.
Main spire band 03 showing new reinforcements and connectors to arcs.
Sep 1990.
During conservation work.

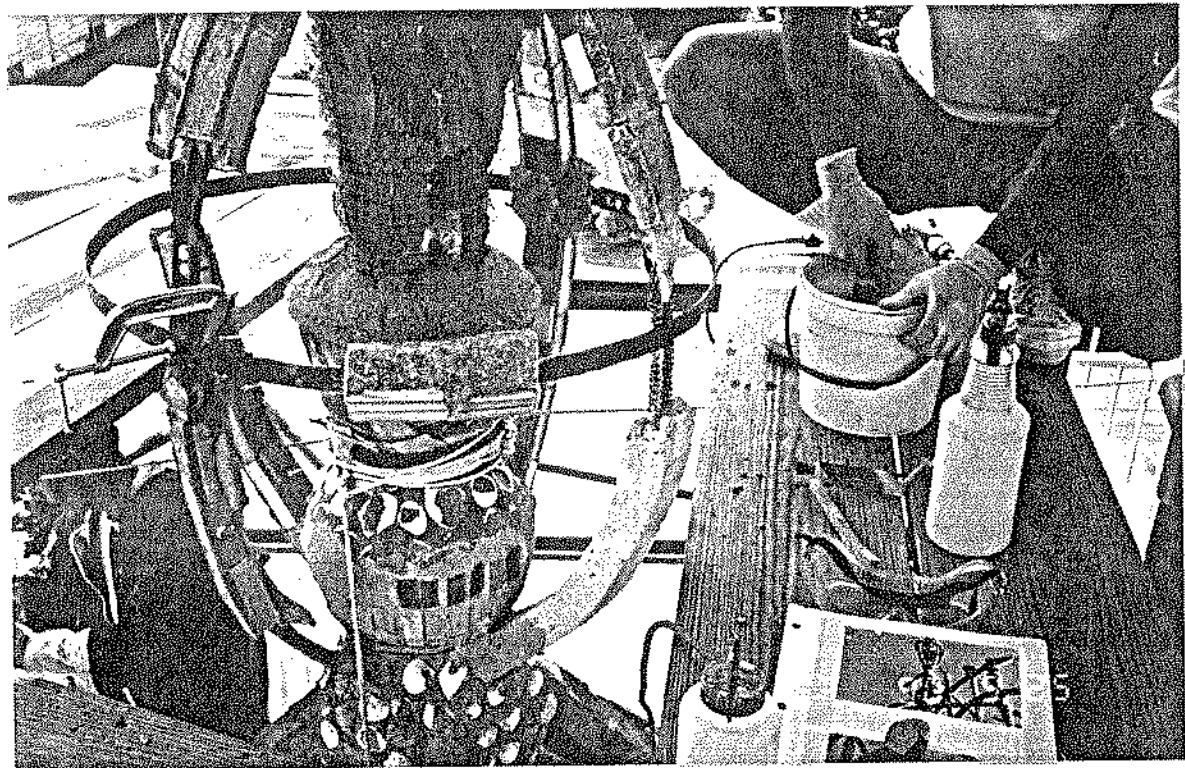
Figure 25.
Main spire ornaments on arc shown re-attached with GE 162 in original locations.
Oct 1990.
Near completion of work.

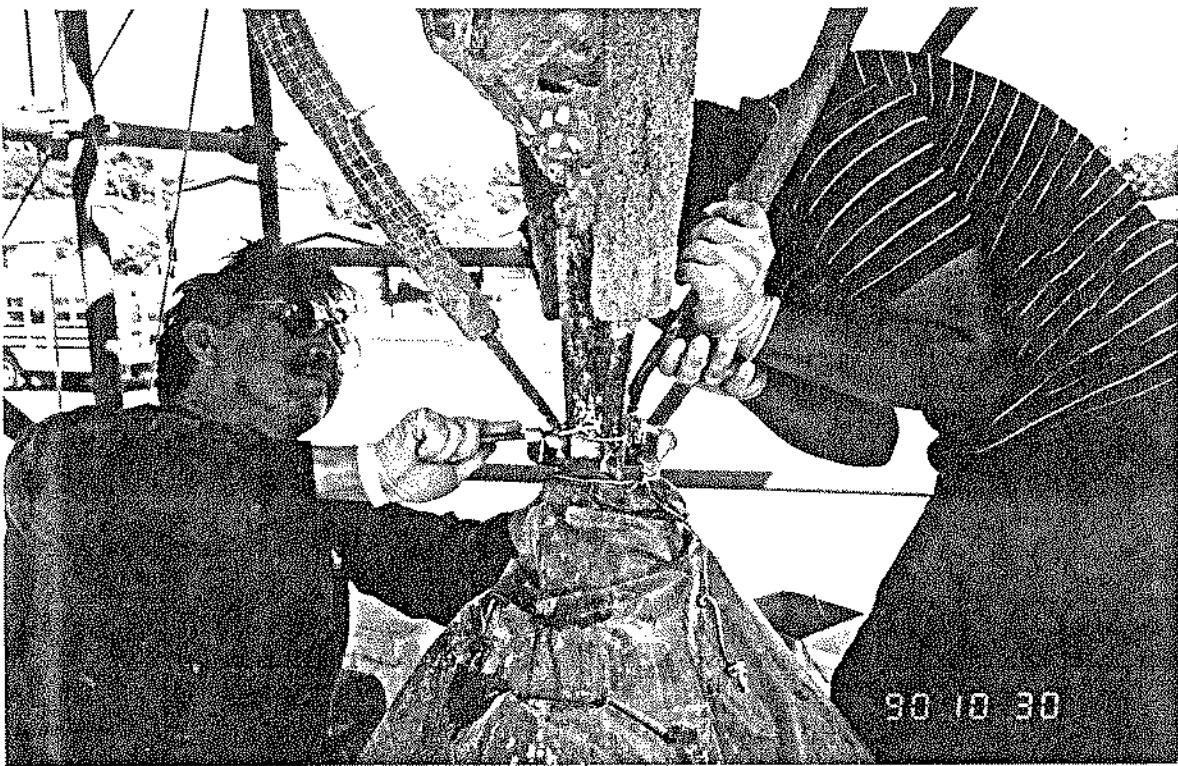
Figure 26.

Main spire arc junction under repair and reattachment to central column.
Oct 1990.

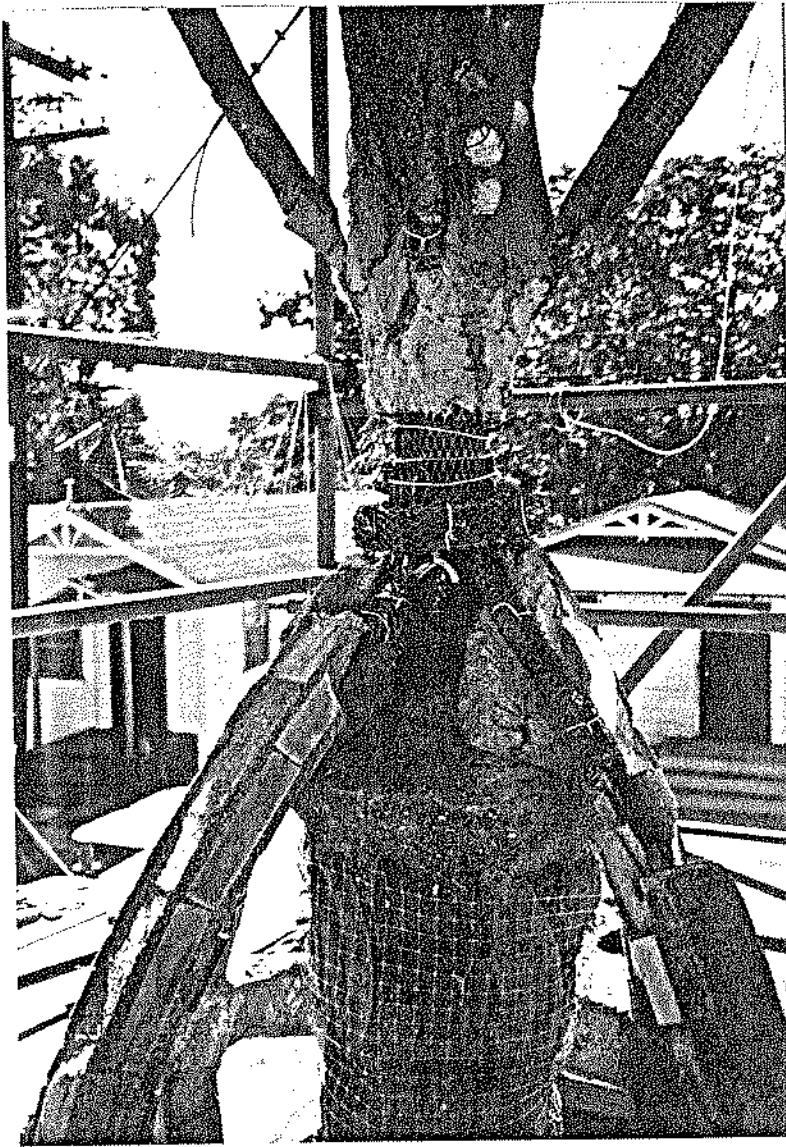
Figure 27.

Main spire arc junction repair using
steel collar around the four arc ends
to prevent separation from column.
Nov 1990.
