THE WATTS TOWERS
CONSERVATION REPORT

THE "A" TOWER

October 16, 1992

prepared by N.J. Bud Goldstone
under contract C85230
for the Cultural Affairs Department, City of Los Angeles

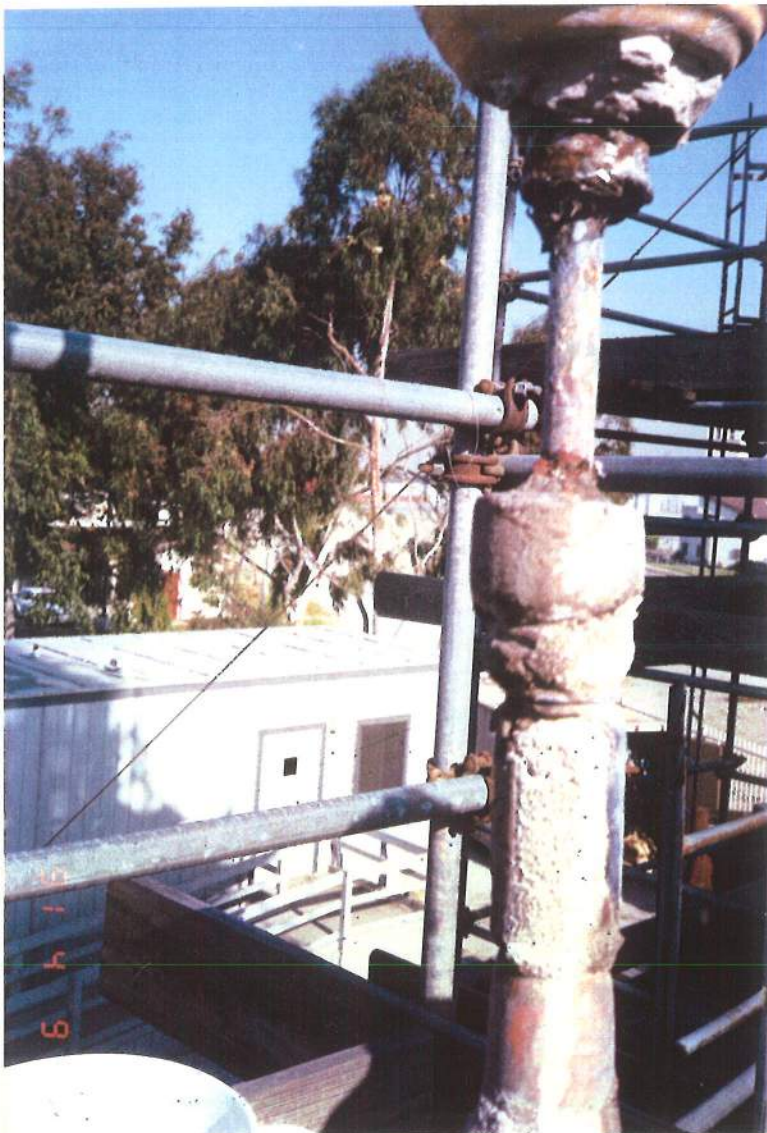
Figure 4.
Steel rebar uncovered near top
of spire on "A" Tower.
Apr 91.
ATO E SE.

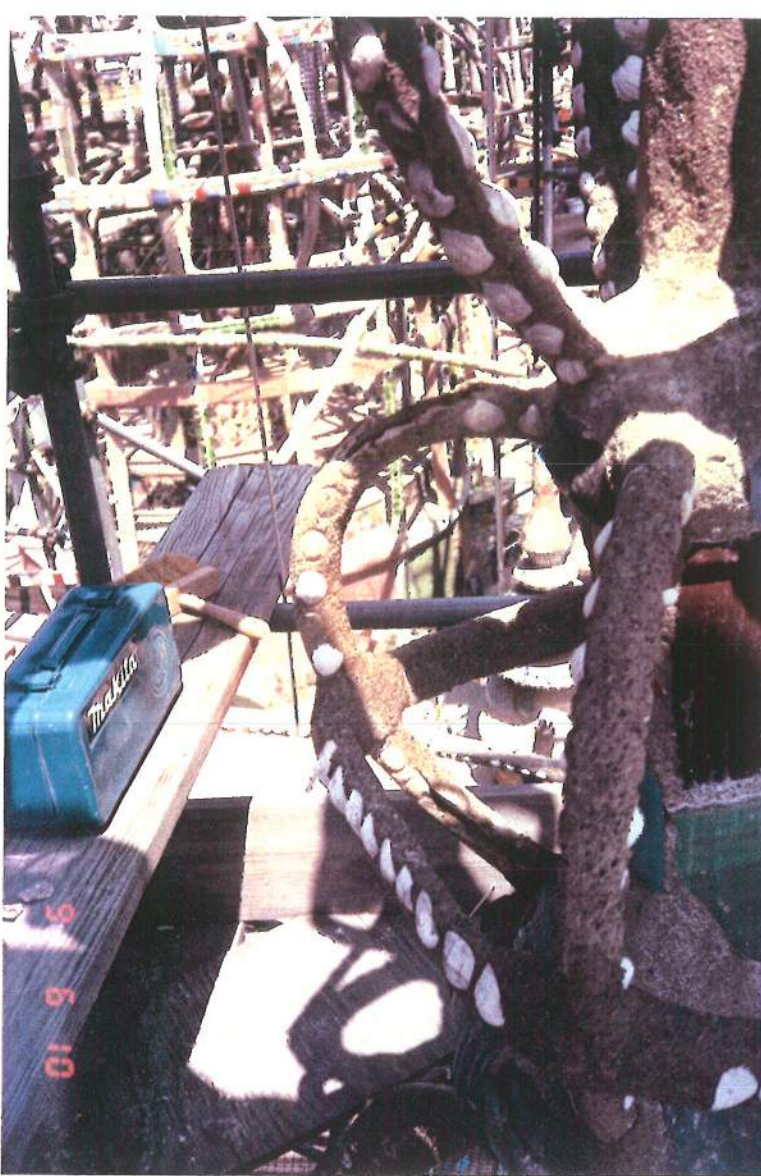
Figure 5. Damage to top of major vertical no. 04, top center of photo. Jun 1991. ATO D NW.

Figure 5.
Damage to top of major vertical
no. 04, top center of photo.
Jun 1991.
ATO D NW.

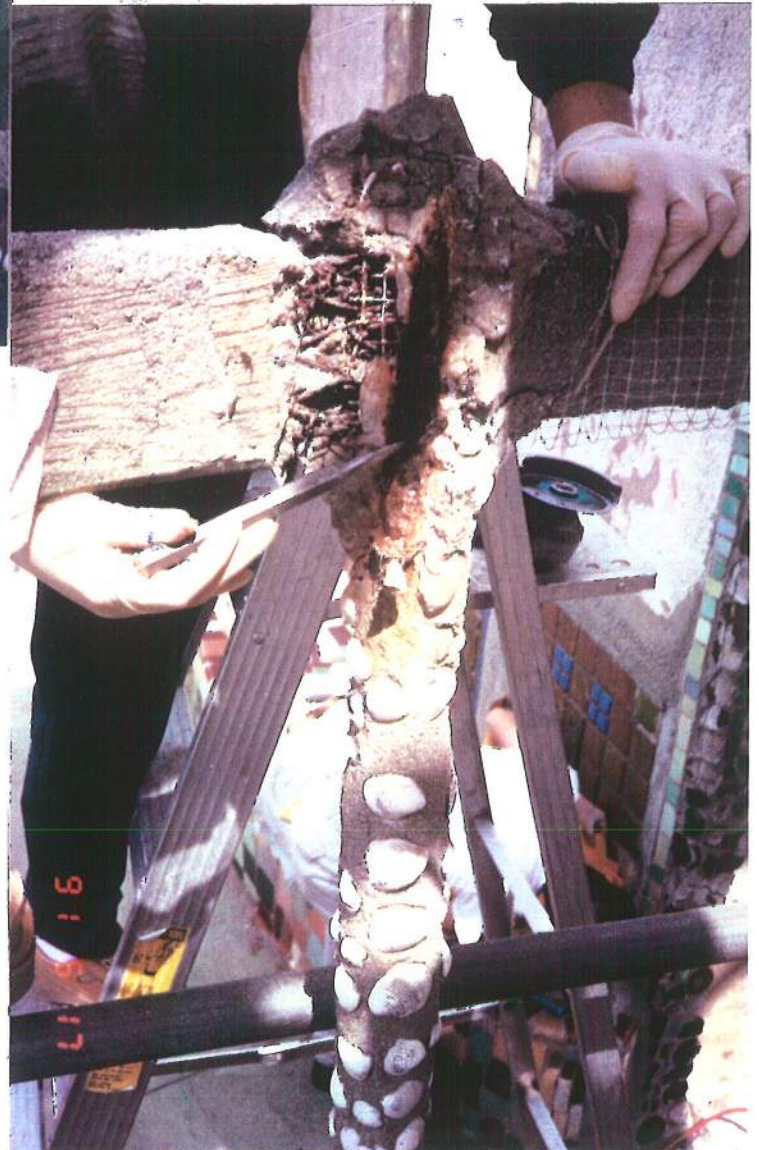
Figure 6. Detail of rusted pipe & mesh at band and vertical joint, major vertical 04 & Band 02. Jun 1991. ATO D SW.

Figure 6.
Detail of rusted pipe & mesh
at band and vertical joint,
major vertical 04 & Band 02.
Jun 1991.
ATO D SW.

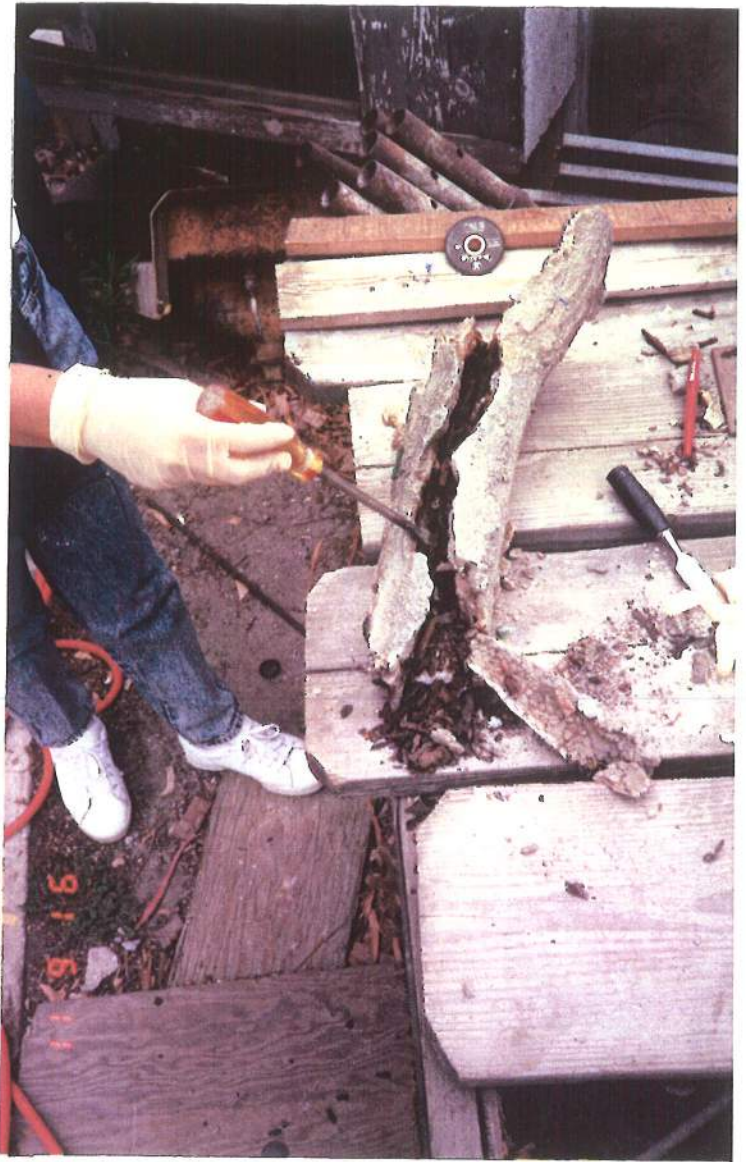
Figure 7. Cut & detached mortar and steel showing cracks and rust on major vertical 04. Jun 1991. ATO C W.

Figure 7.
Cut & detached mortar and steel
showing cracks and rust on
major vertical 04.
Jun 1991.
ATO C W.

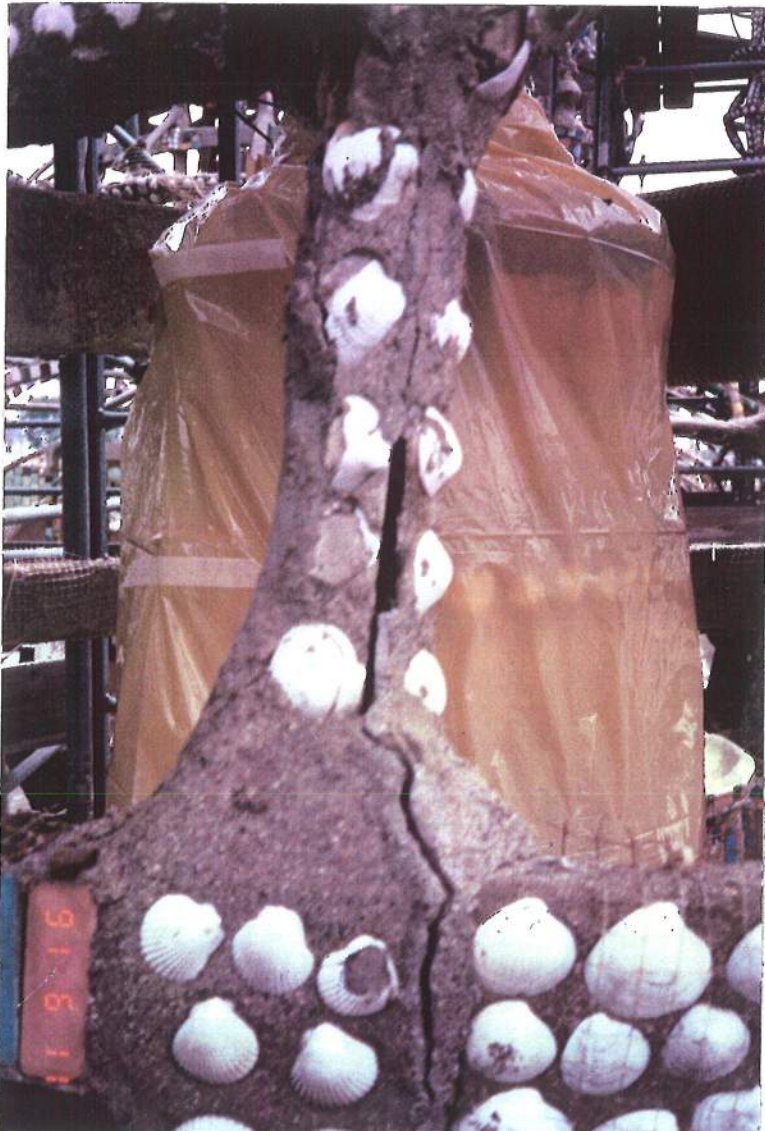
Figure 8. Major crack in vertical 04 before removal & replacement of rebar. Jun 1991. ATP C W.

Figure 8.
Major crack in vertical 04
before removal & replacement
of rebar.
Jun 1991.
ATO C W.

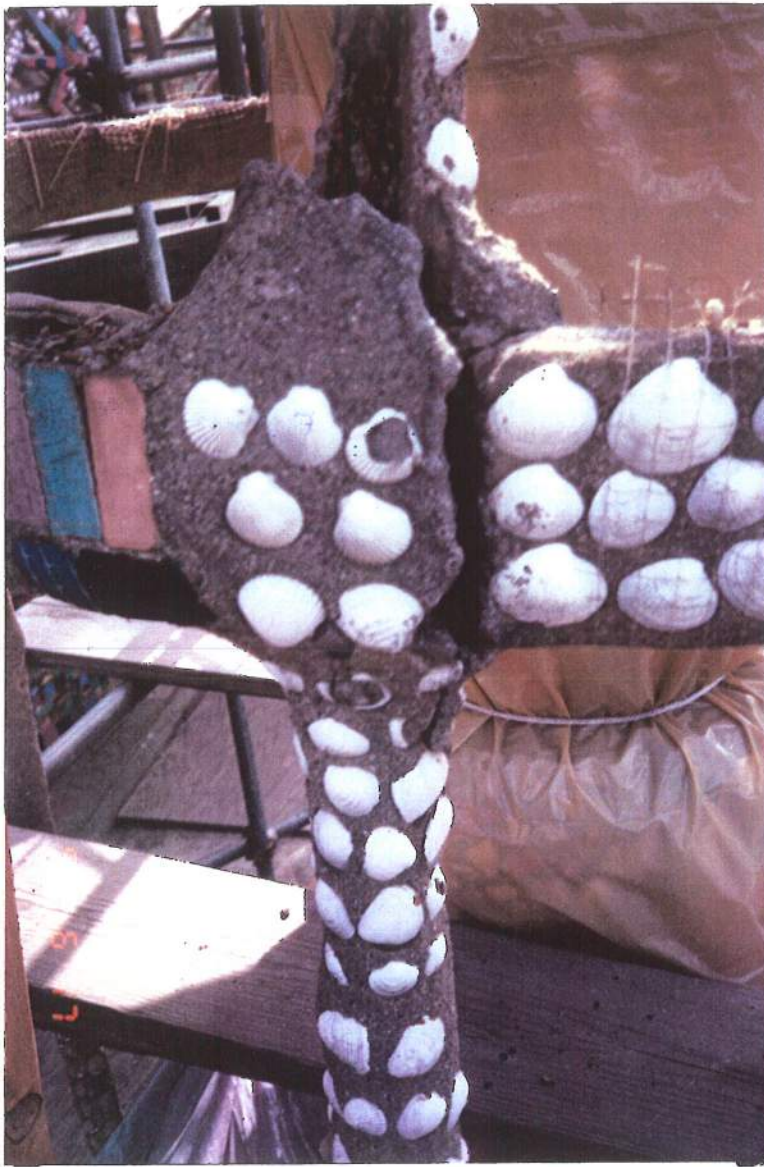
Figure 9. Major crack at Band-to-vertical joint. Jun 1991. ATO C W.

Figure 9.
Major crack at Band-to-vertical
joint.
Jun 1991.
ATO C W.

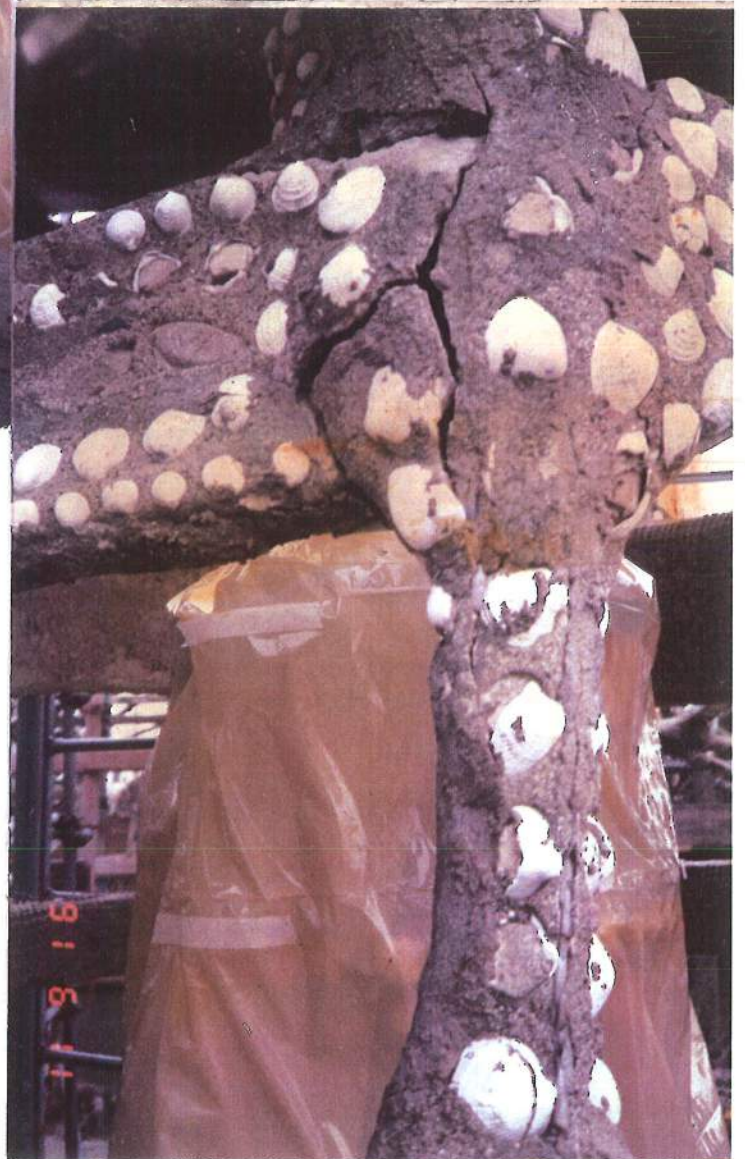
Figure 10. Major cracks at band-to-vertical joint. Jun 1991. ATO C W.

Figure 10.
Major cracks at band-to-vert-
ical joint.
Jun 1991.
ATO C W.

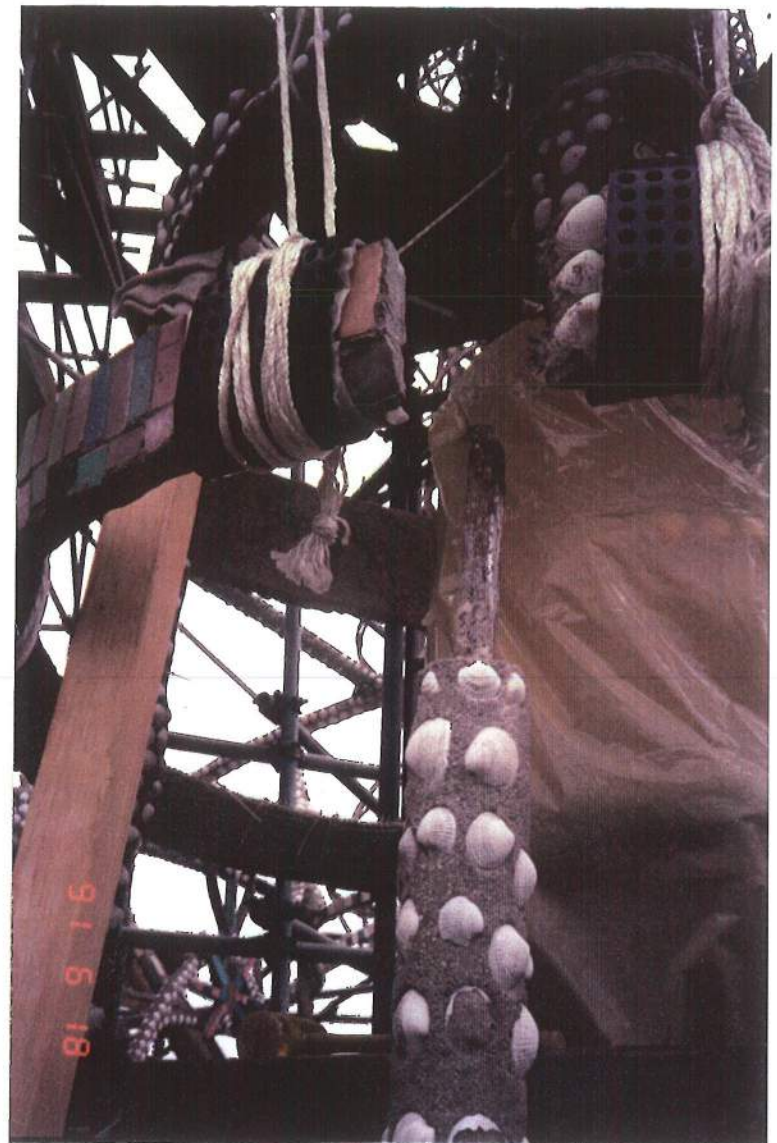
Figure 11. Ends of Band 01 after severing showing rusted rebars and mesh. Jun 1991. ATO C W.

Figure 11.
Ends of Band 01 after severing
showing rusted rebars and mesh.
Jun 1991.
ATO C W.

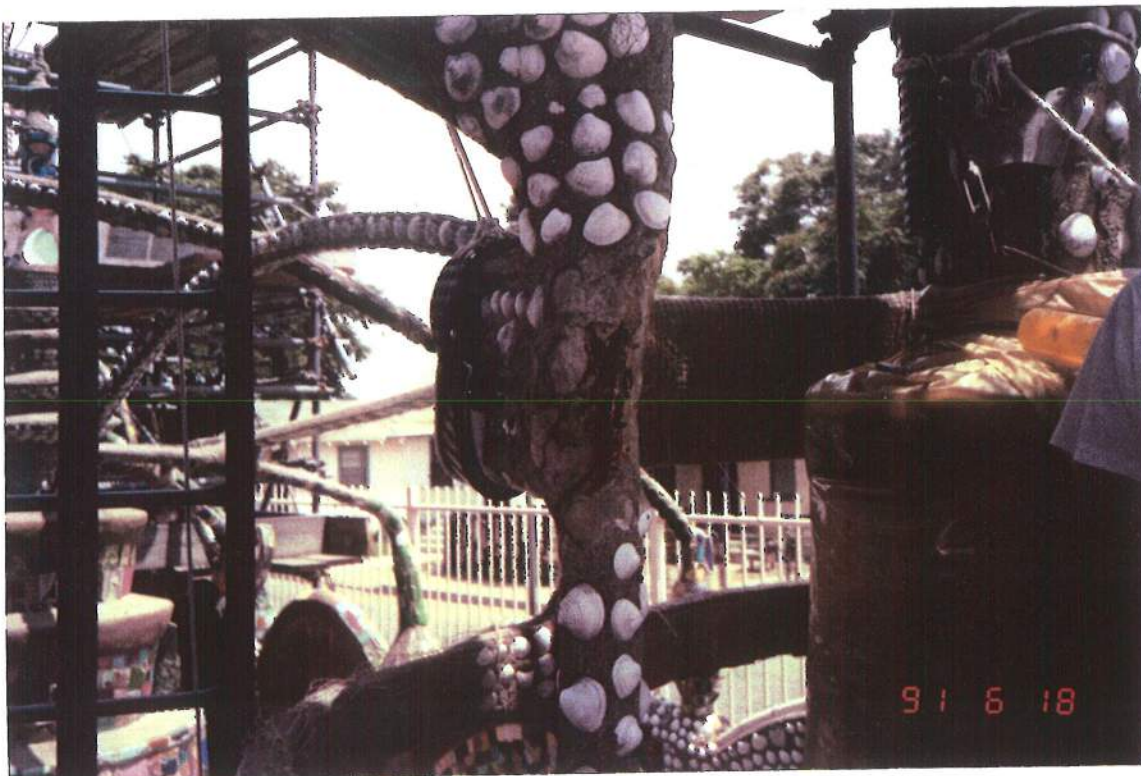
Figure 12. End of band 02 showing rusted rebar and mesh. Jun 1991. ATO C N.

Figure 12.
End of band 02 showing rusted
rebar and mesh.
Jun 1991.
ATO C N.

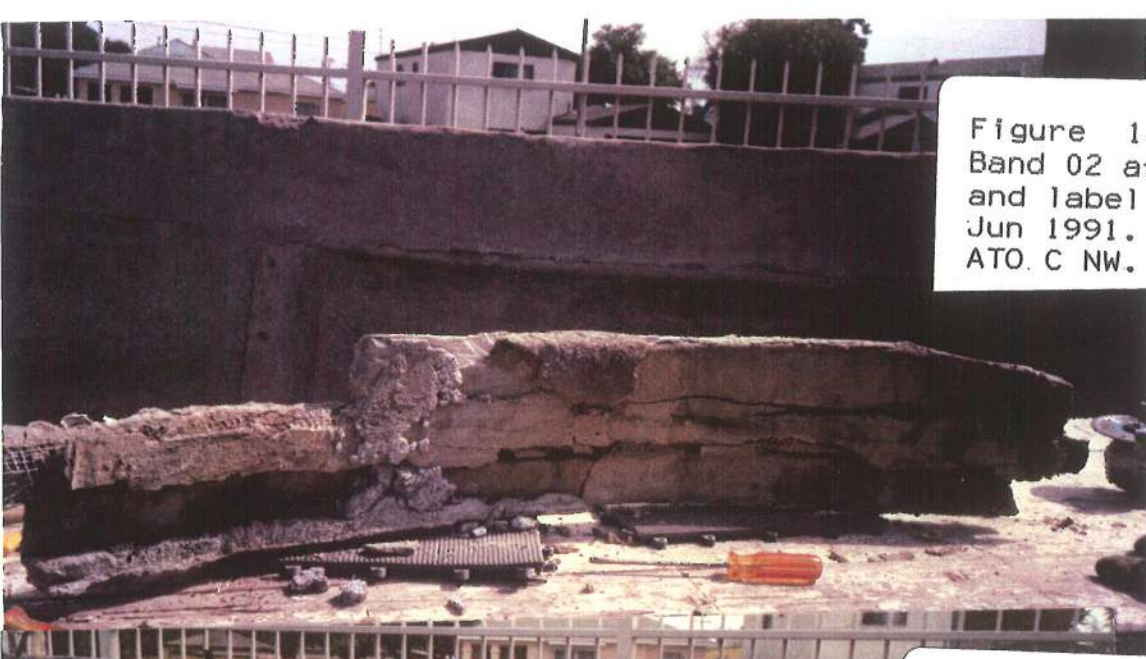
Figure 13. Band 02 after opening cracks and labeling mortar fragments. Jun 1991. ATO C NW.

Figure 13.
Band 02 after opening cracks
and labeling mortar fragments
Jun 1991.
ATO. C NW.

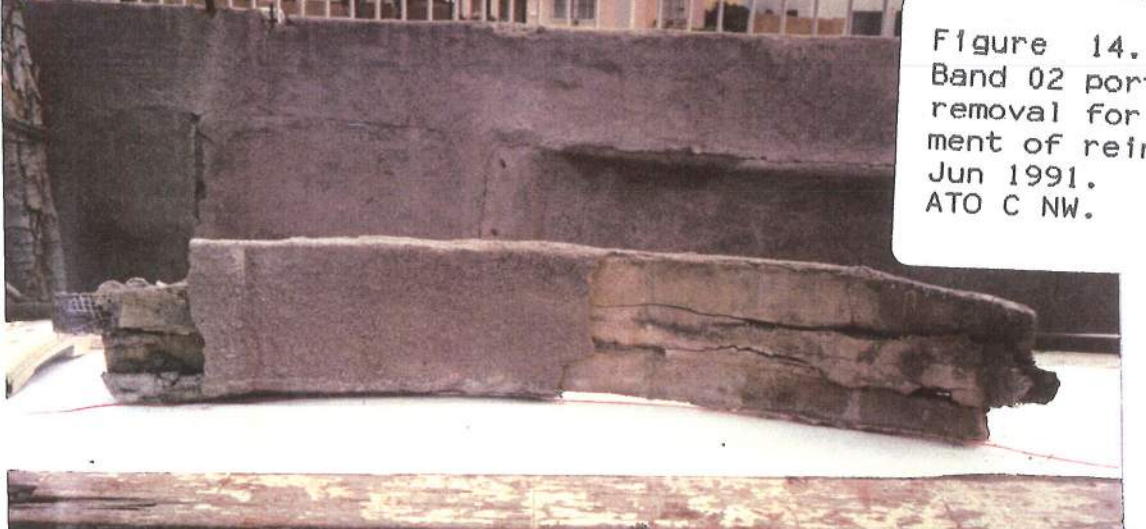
Figure 14. Band 02 portion on bench after removal for repair and replacement of reinforcement. Jun 1991. ATO C NW.

Figure 14.
Band 02 portion on bench after
removal for repair and replace-
ment of reinforcement.
Jun 1991.
ATO C NW.

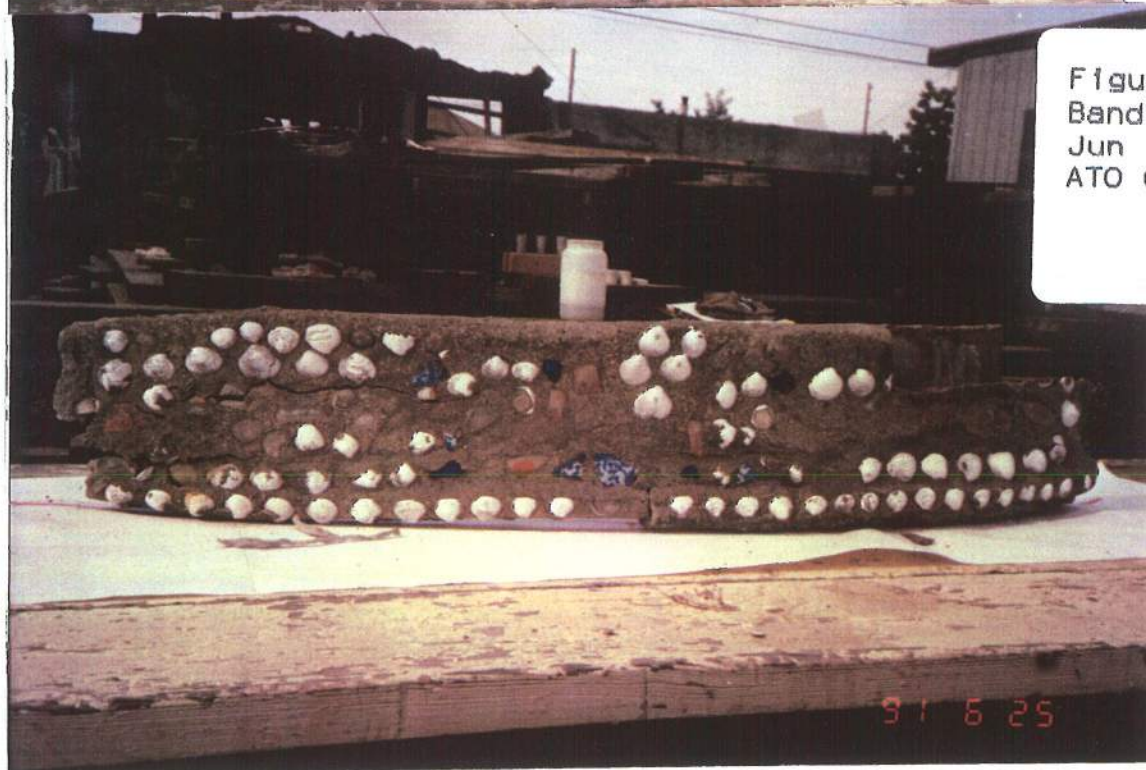
Figure 15. Band 02 before repairs. Jun 1991. ATO C NW.

Figure 15.
Band 02 before repairs.
Jun 1991.
ATO C NW.

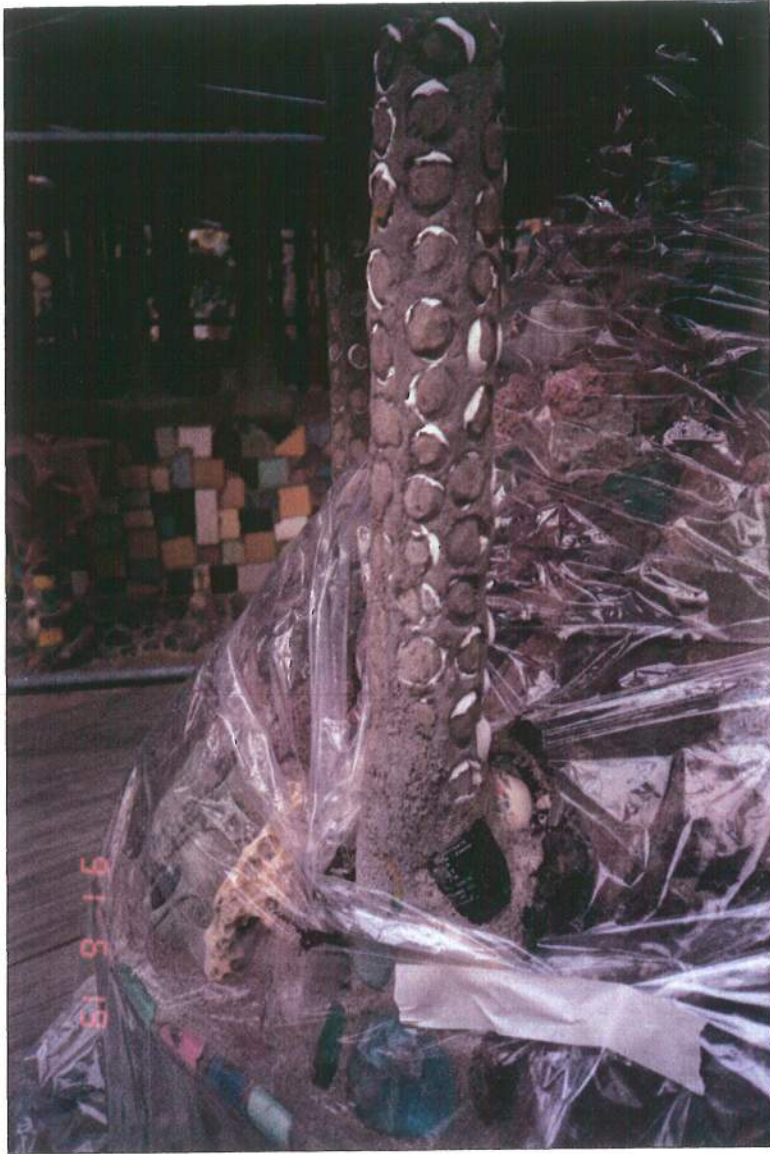
Figure 16. Major vertical 04 before removal of damaged mortar and replacement of steel reinforcement. Jun 1991. ATO B W.

Figure 16.
Major vertical 04 before removal
of damaged mortar and replace-
ment of steel reinforcement.
Jun 1991.
ATO B W.

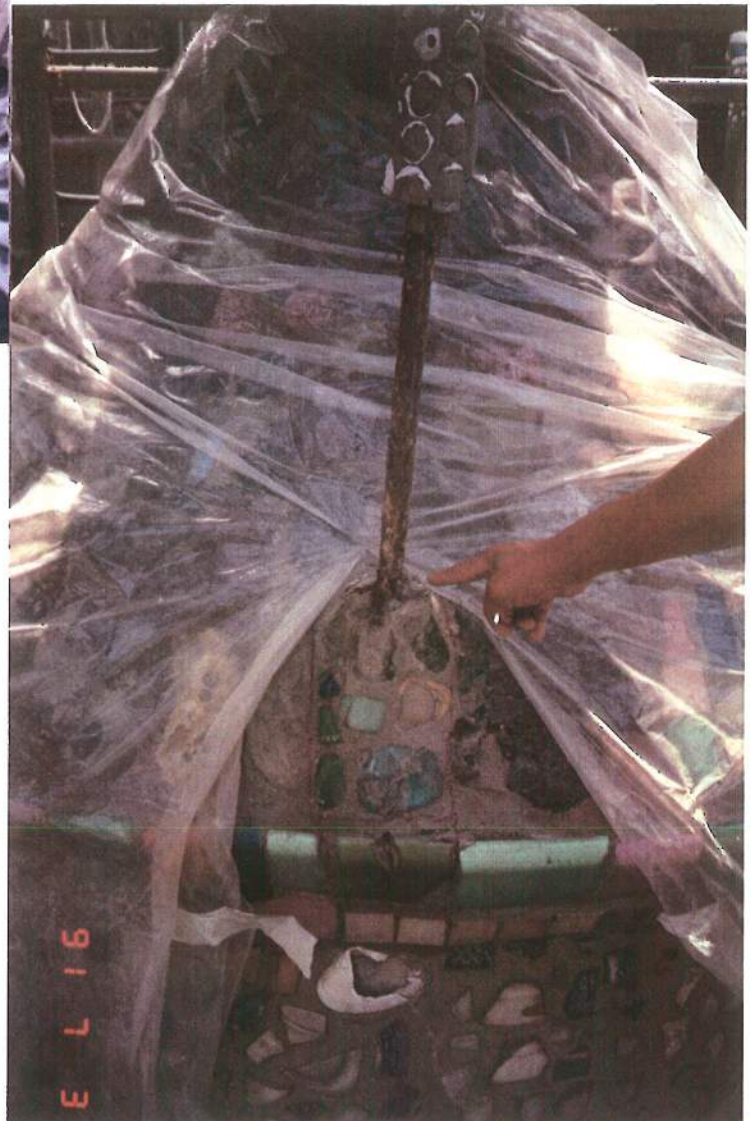
Figure 17. Major vertical 04 base opened for removal of steel rebar and replacement. Jul 1991. ATO A W.

Figure 17.
Major vertical 04 base opened
for removal of steel rebar and
replacement.
Jul 1991.
ATO A W.

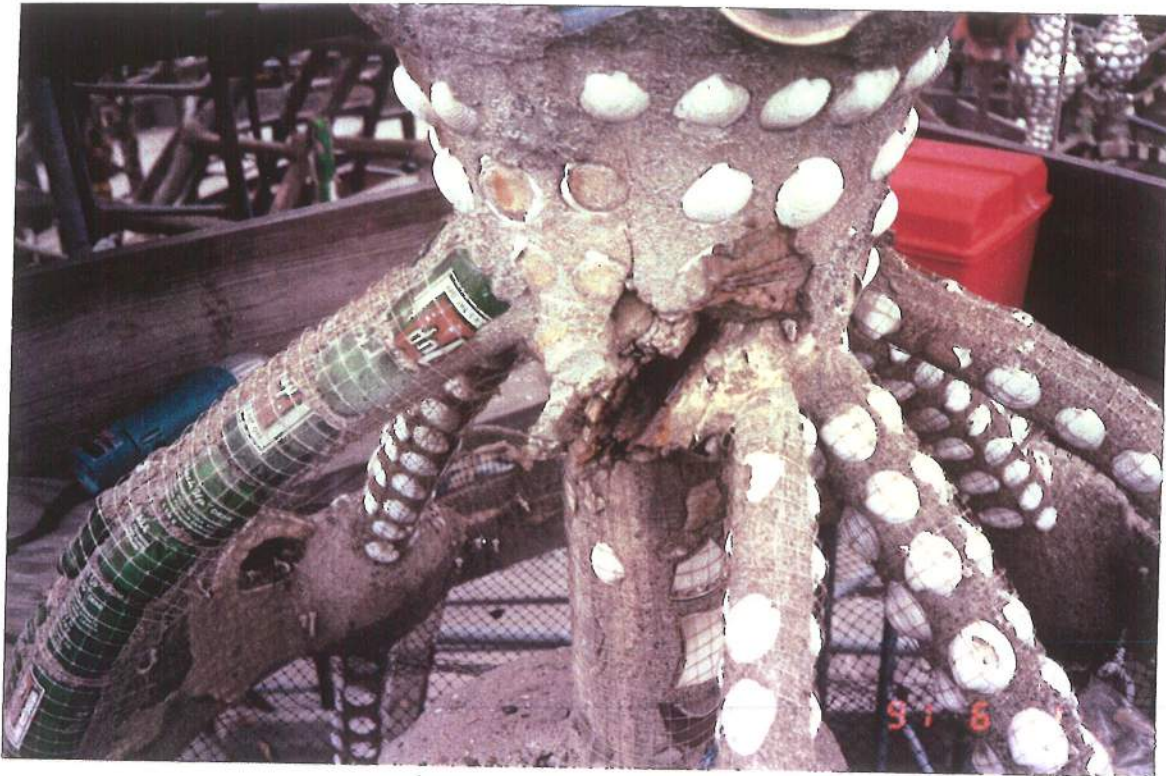
Figure 28. Top joint after removal of major vertical 04 for replacement. Jun 1991. ATO D SW.

Figure 28.
Top joint after removal
of major vertical 04
for replacement.
Jun 1991.
ATO D SW.

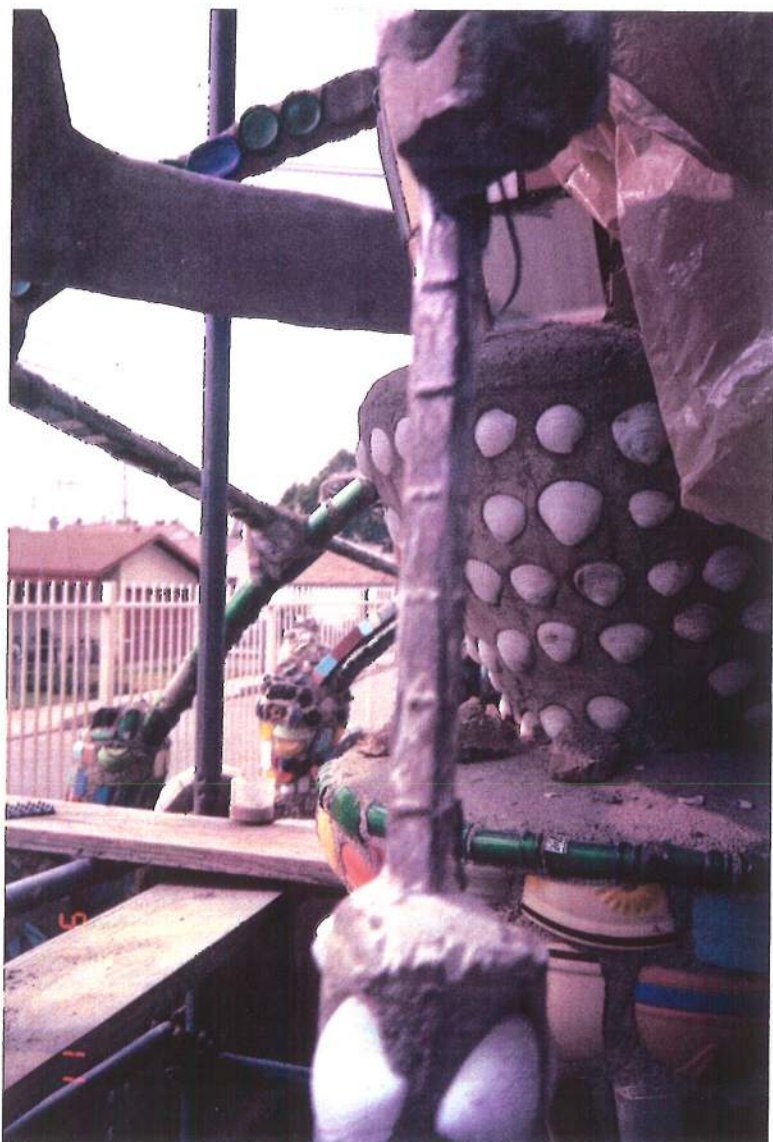
Figure 29. Rodia rebar major vertical 02 exposed for cleaning and repair of mortar at Maj Band 01. Dec 1991. ATO B E.

Figure 29.
Rodia rebar major vert-
ical 02 exposed for
cleaning and repair of
mortar at Maj Band 01.
Dec 1991. ATO B E.

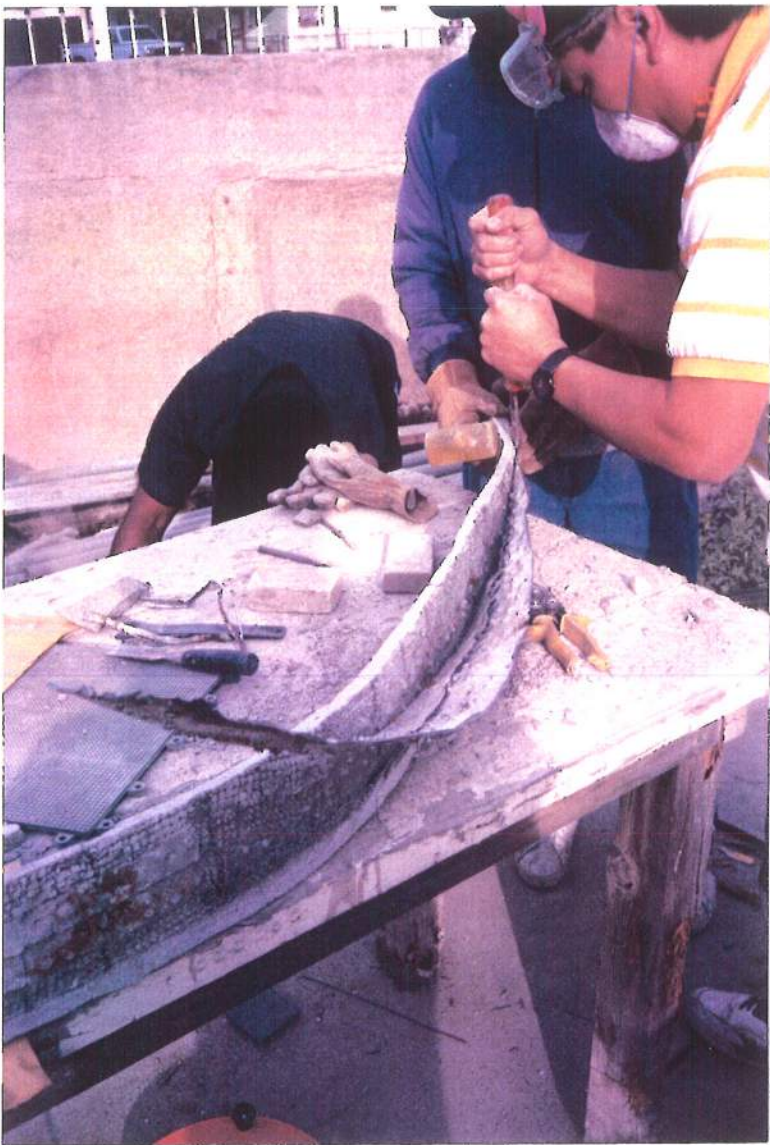
Figure 30. Damaged sheet metal rebar being removed on bench from Maj Band 01. Dec 1991. ATO B N.

Figure 30.
Damaged sheet metal rebar
being removed on bench
from Maj Band 01.
Dec 1991.
ATO B N.

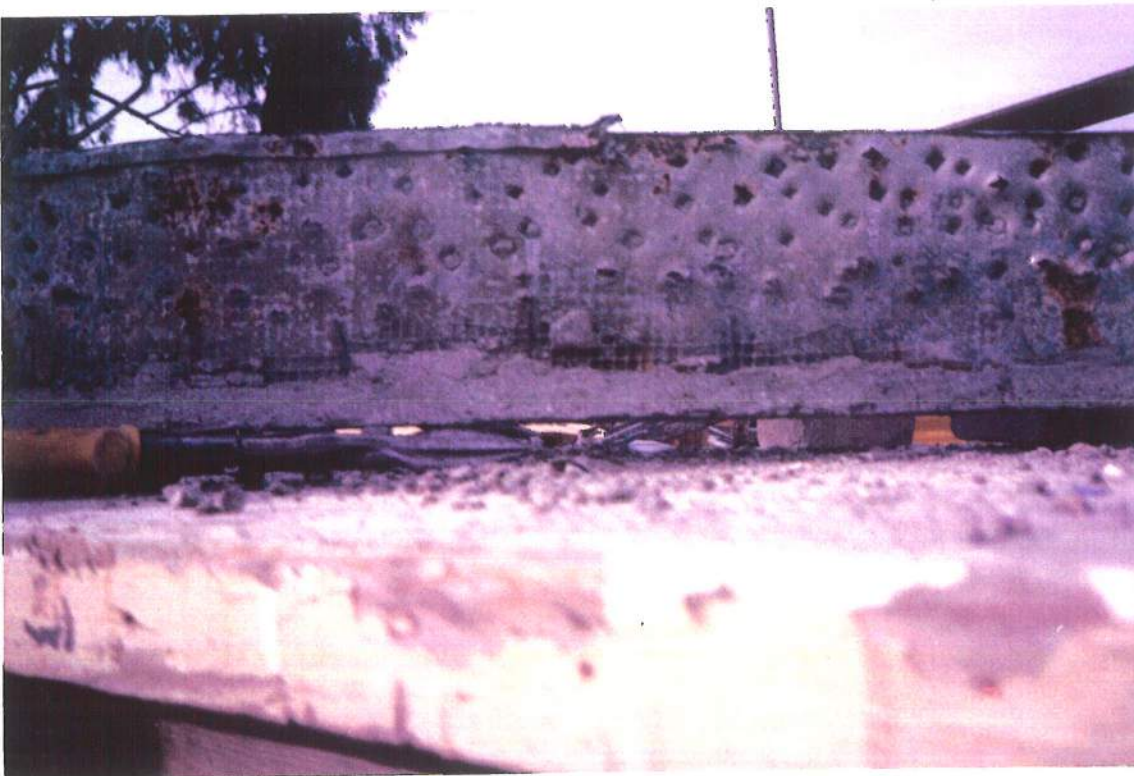
Figure 31. Damaged sheet metal rebar detail from Maj Band 01. Dec 1991. ATO B N.

Figure 31.
Damaged sheet metal rebar
detail from Maj Band 01.
Dec 1991.
ATO B N.

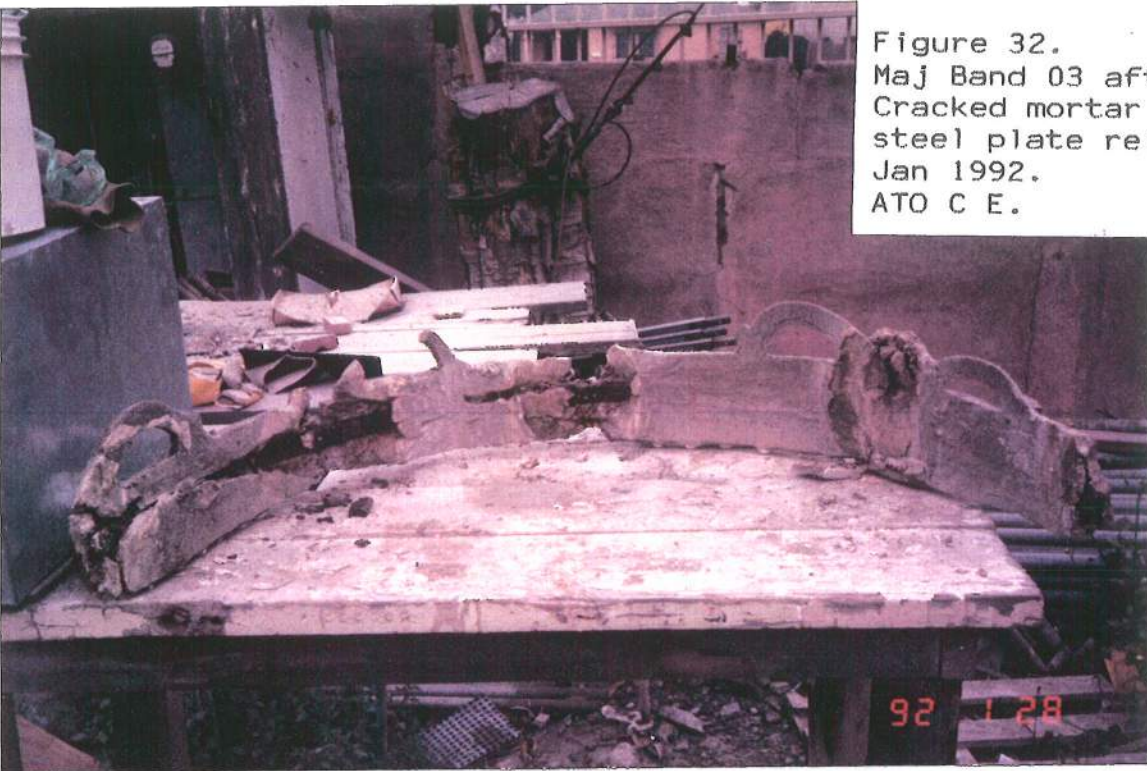
Figure 32. Maj Band 03 after removal. Cracked mortar and rusted steel plate reinforcement. Jan 1992. ATO C E.

Figure 32.
Maj Band 03 after removal.
Cracked mortar and rusted
steel plate reinforcement.
Jan 1992.
ATO C E.

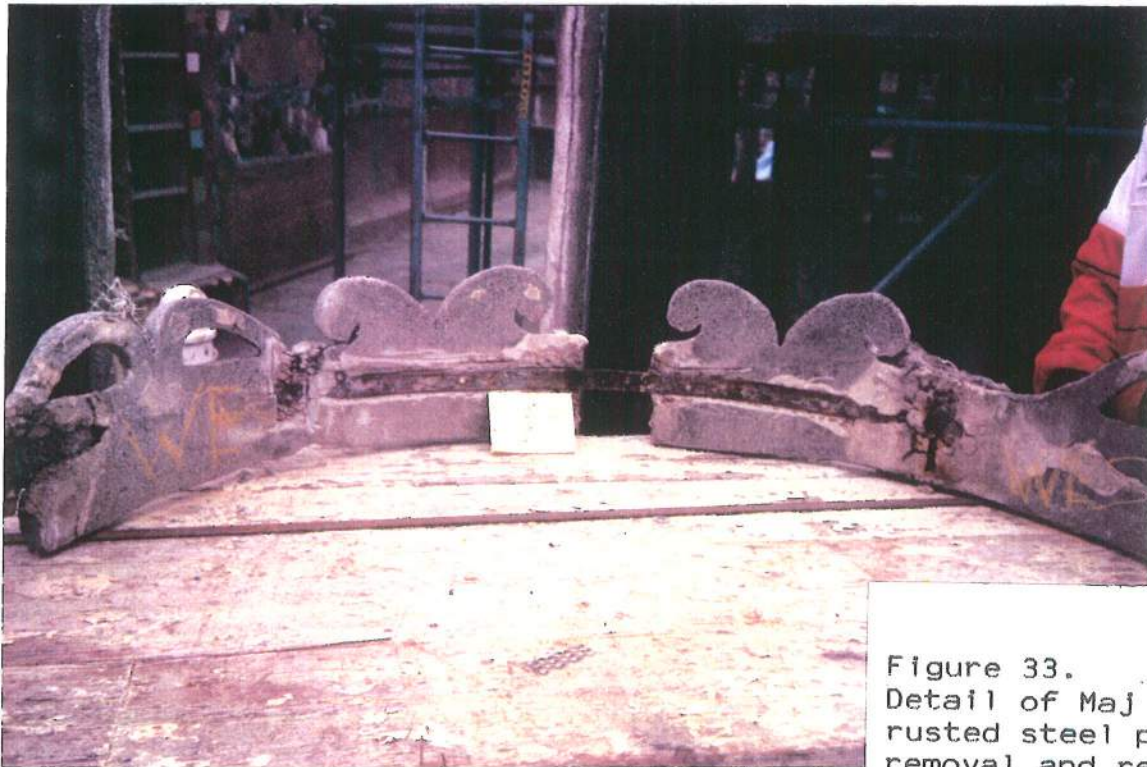
Figure 33. Detail of Maj Band 03 rusted steel plate before removal and replacement. Jan 1992. ATO C W.

Figure 33.
Detail of Maj Band 03
rusted steel plate before
removal and replacement.
Jan 1992.
ATO C W.

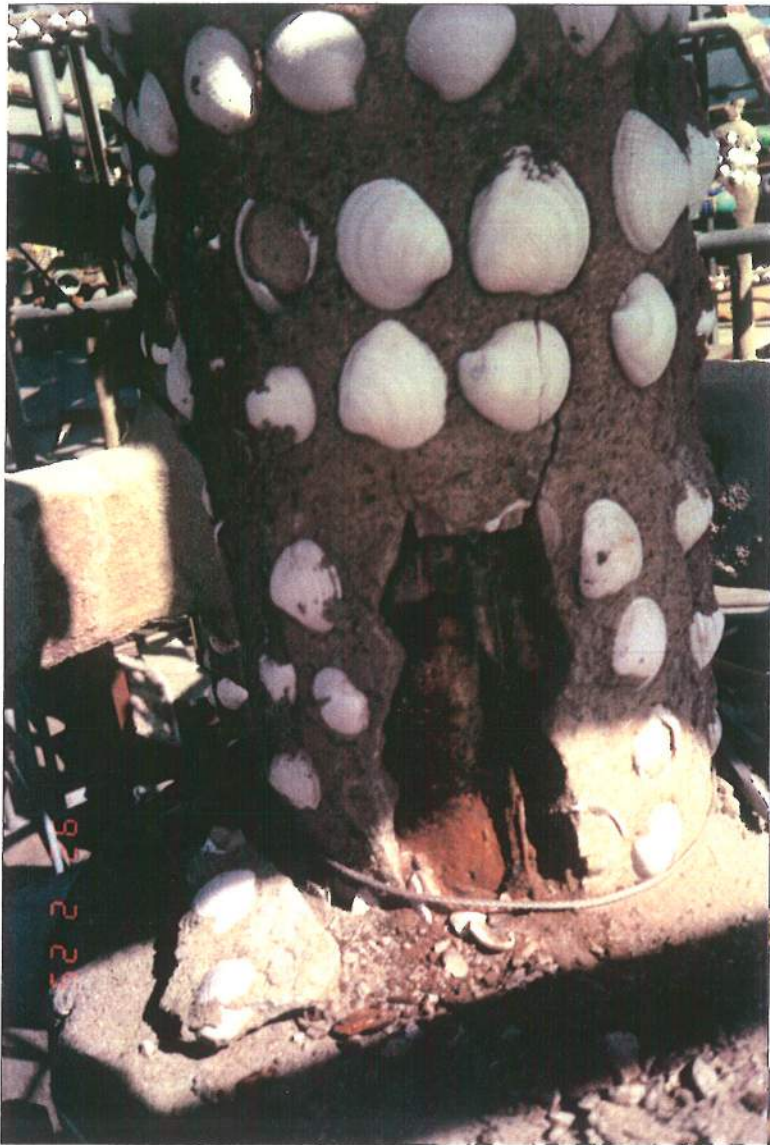
Figure 34. Damage to center column steel reinforcing outside cylinder and inside pipe. Feb 1992. ATO C W.

Figure 34.
Damage to center column
steel reinforcing outside
cylinder and inside pipe.
Feb 1992.
ATO C W.

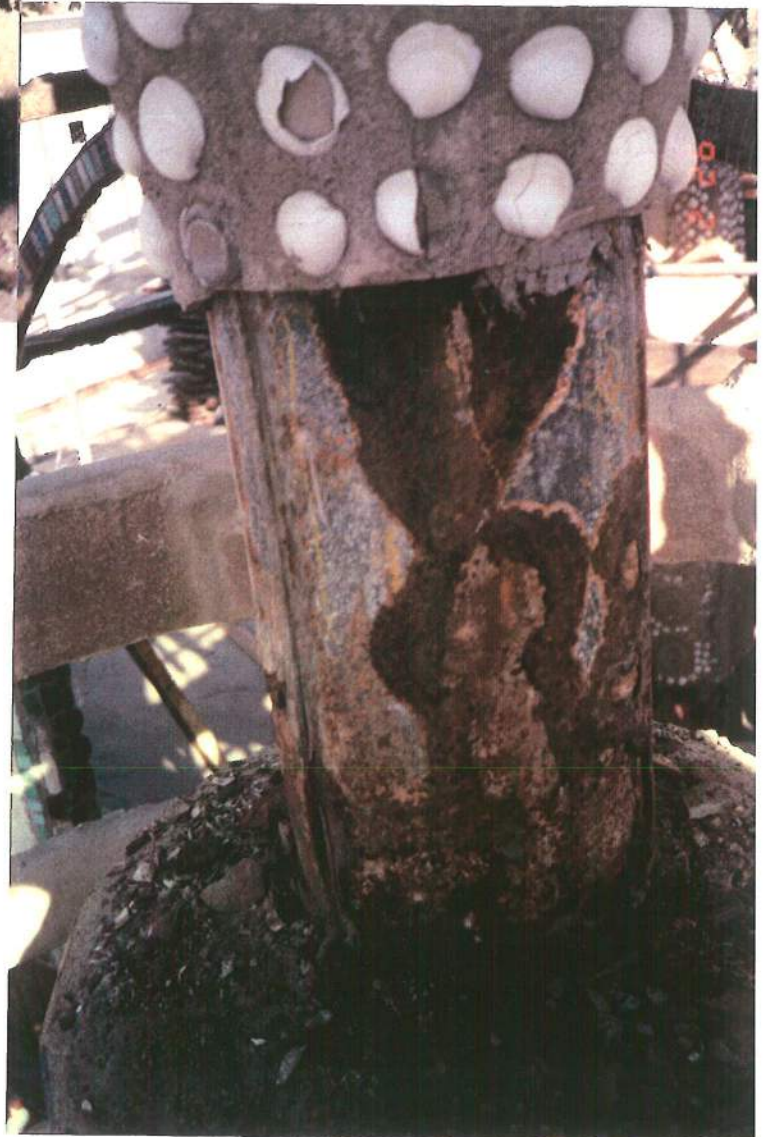
Figure 35. Detail of steel cylinder reinforcement damage. Feb 1992. ATO C E

Figure 35.
Detail of steel cylinder
reinforcement damage.
Feb 1992.
ATO C E
