THE WATTS TOWERS  
FINAL CONSERVATION REPORT

THE CANOPY

April 1995

prepared by N.J. Bud Goldstone  
under contract C89122  
for the Cultural Affairs Department, City of Los Angeles

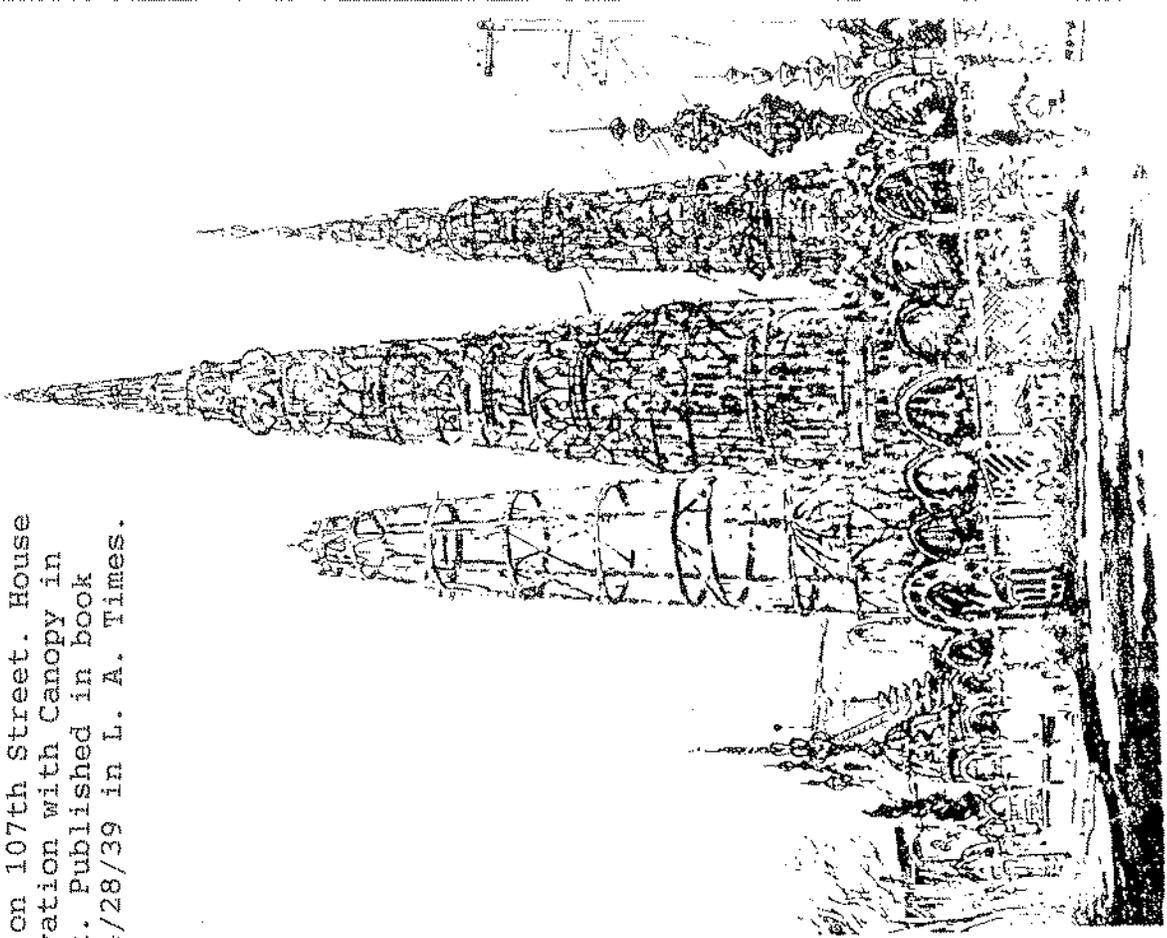
Figure 2. Artist sketch c1939 of house and Watts Towers site from southeast on 107th Street. House south elevation with Canopy in lower left. Published in book 1940 and 4/28/39 in L. A. Times.

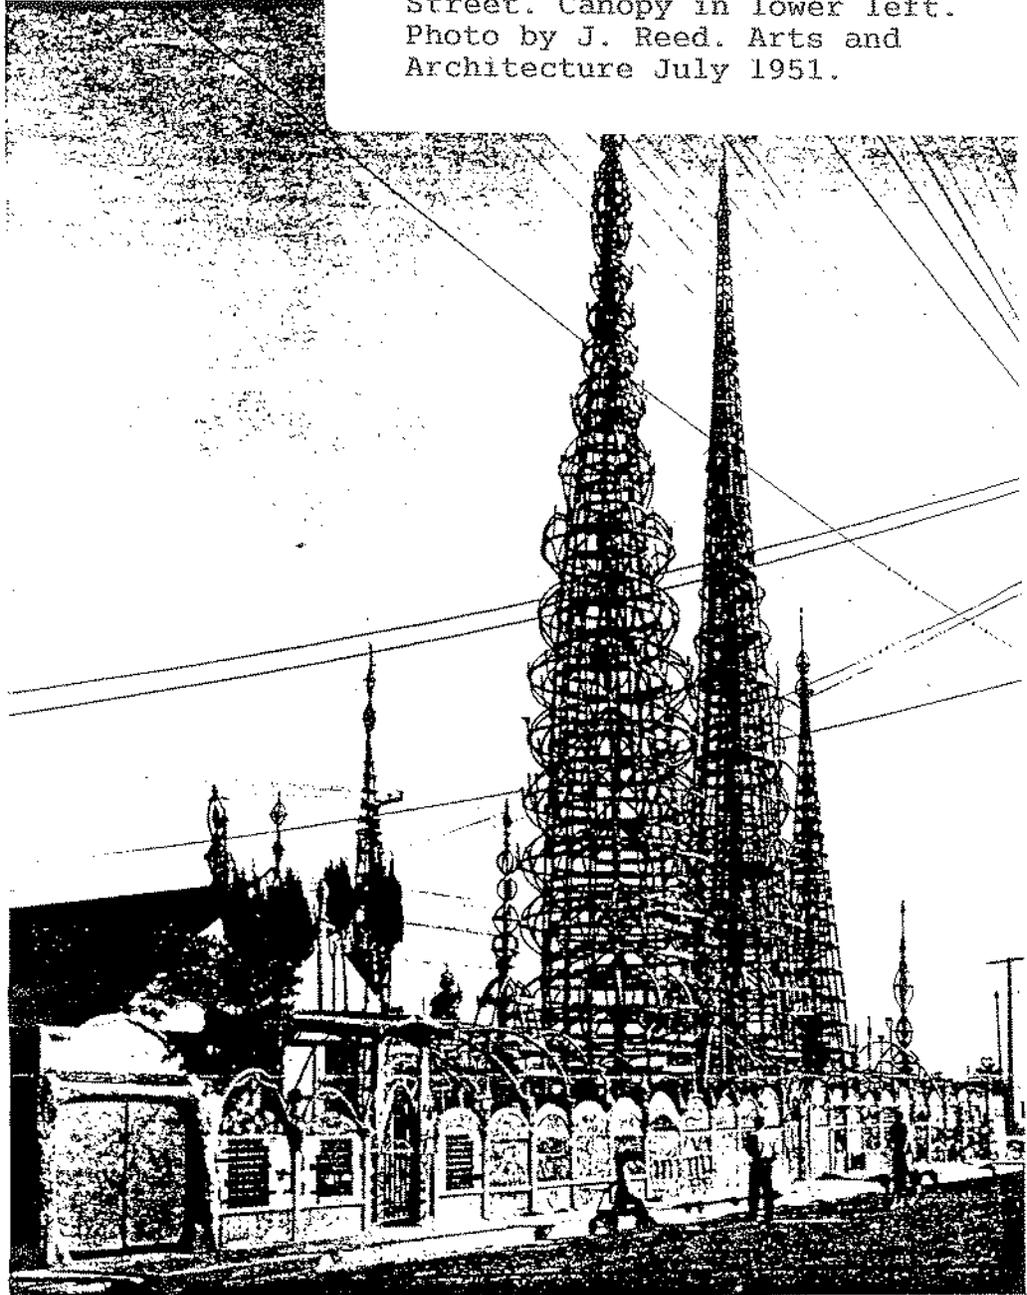
Figure 3. Photograph c1950 of House, Canopy and Watts Towers site from southwest on 107th Street. Canopy in lower left. Photo by J. Reed. Arts and Architecture July 1951.

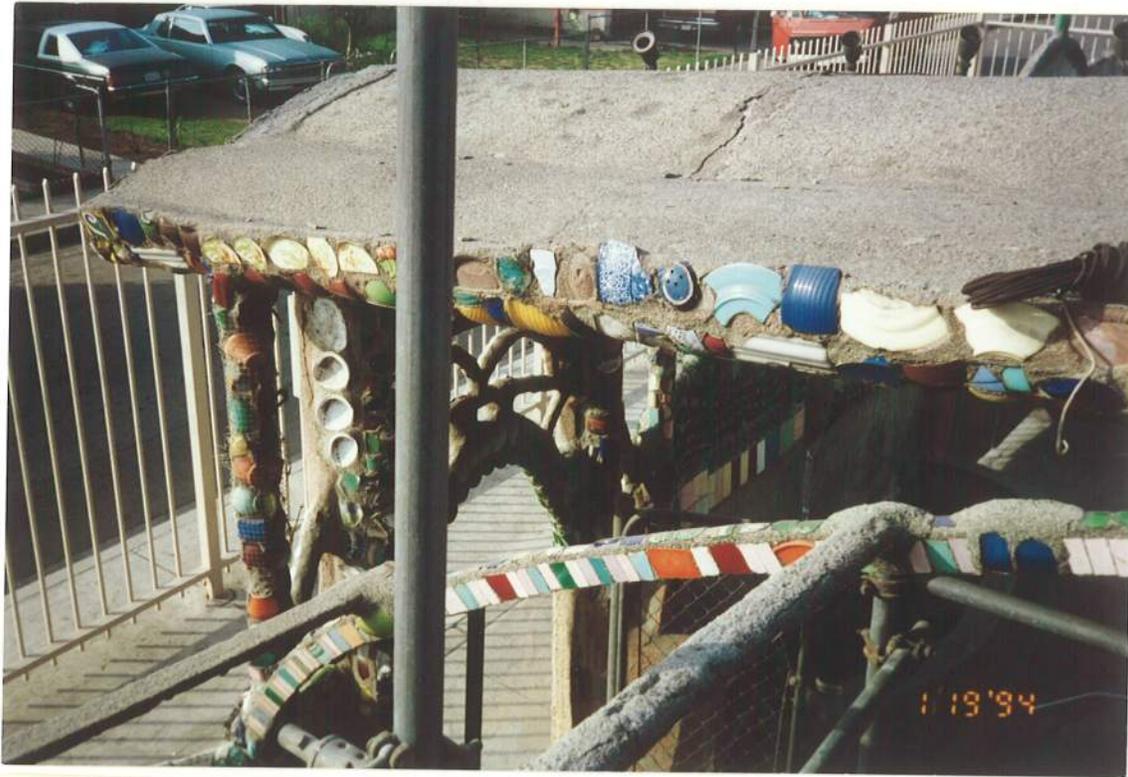
Some mortar cracking failures and exposed, rusted steel were evident in the Canopy before the January 17, 1994 Northridge earthquake and the January 1995 rains and floods. Inspection of the Canopy and its vertical supports within the South Wall after the earthquake and aftershocks showed newly opened cracks in the Canopy and in the supports. Additional damage was found on the upper surfaces of the canopy after the January 1995 rains. Primary causes of cracking before the January 1994 and January 1995 events have been vandalism, inadequate end connections to the steel reinforcements and environmental influences-wind, earthquakes and other dynamic forces from Southern Pacific trains immediately to the north and to the west, aircraft, and trucks. In late 1985 the Cultural Affairs Department took over responsibility for the site.

Figure 4. Canopy sculpture top showing cracking failures after January 17 Northridge earthquake. Looking northeast from above. January 19, 1994.

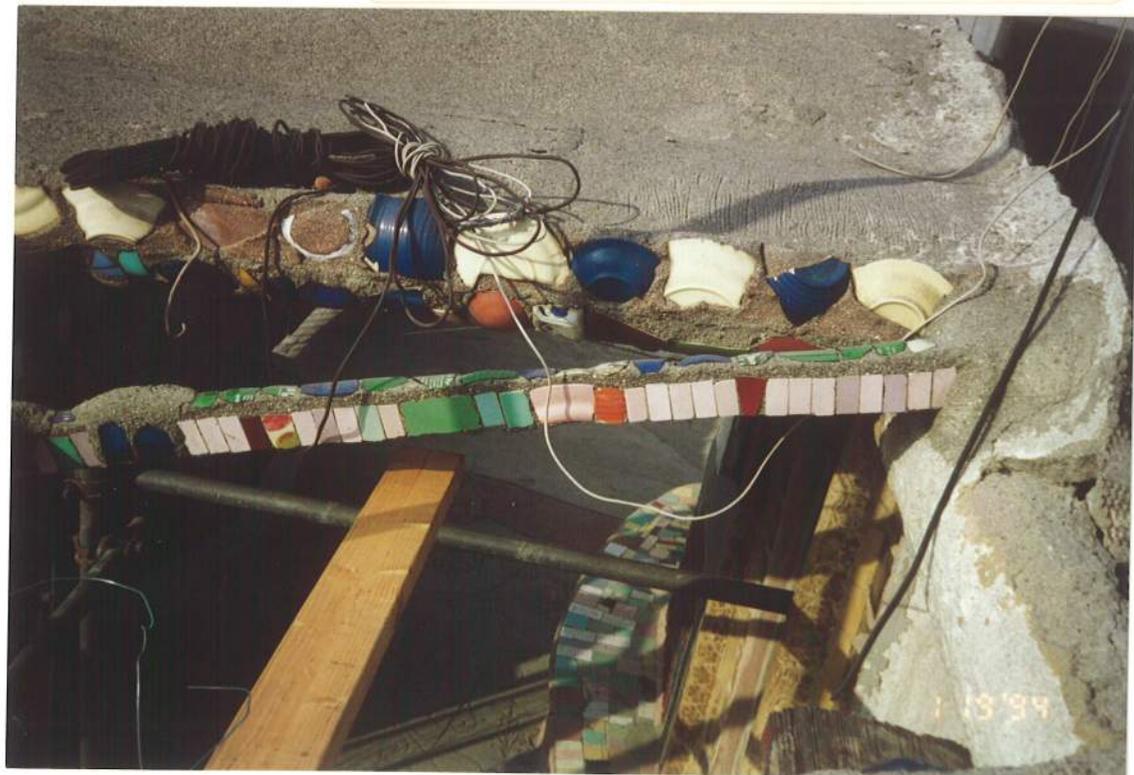
Figure 5. Canopy sculpture top after January 17 Northridge earthquake. Looking west from above. January 19, 1994.

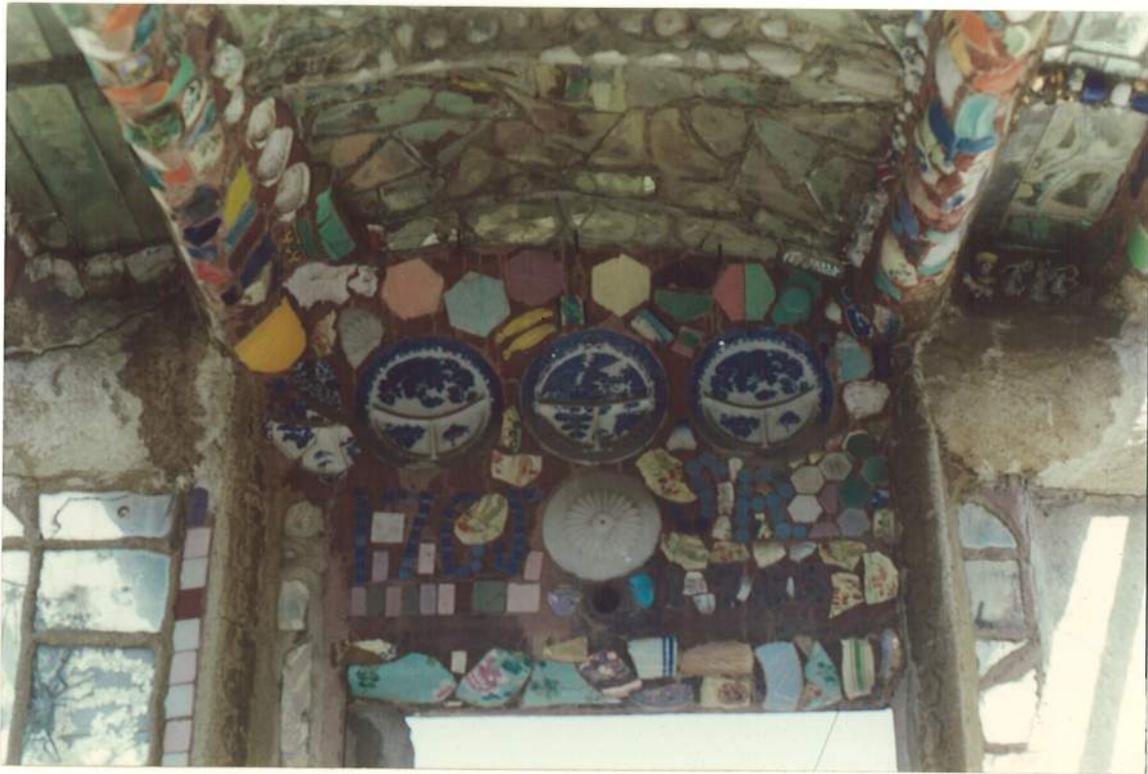
Figure 6. Canopy (top) over  
ornamentation on House Facade  
above front door. Looking north  
from entry. November 1993.
