THE WATTS TOWERS
CONSERVATION REPORT

THE HOUSE FACADE

April 1995

CONSERVATION OF THE HOUSE FACADE
WATTS TOWERS CONSERVATION PROGRAM
APRIL 1995

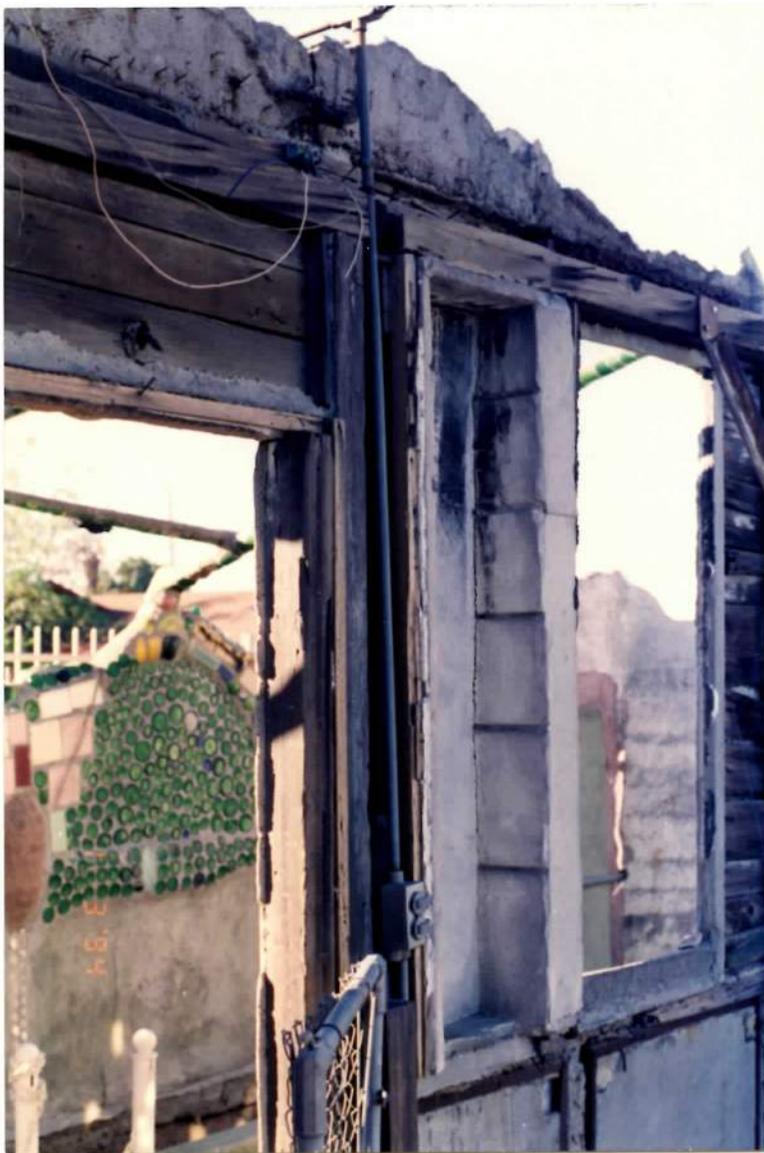
Figure 8. Inside (north)
elevation of facade. January 3,
1994.

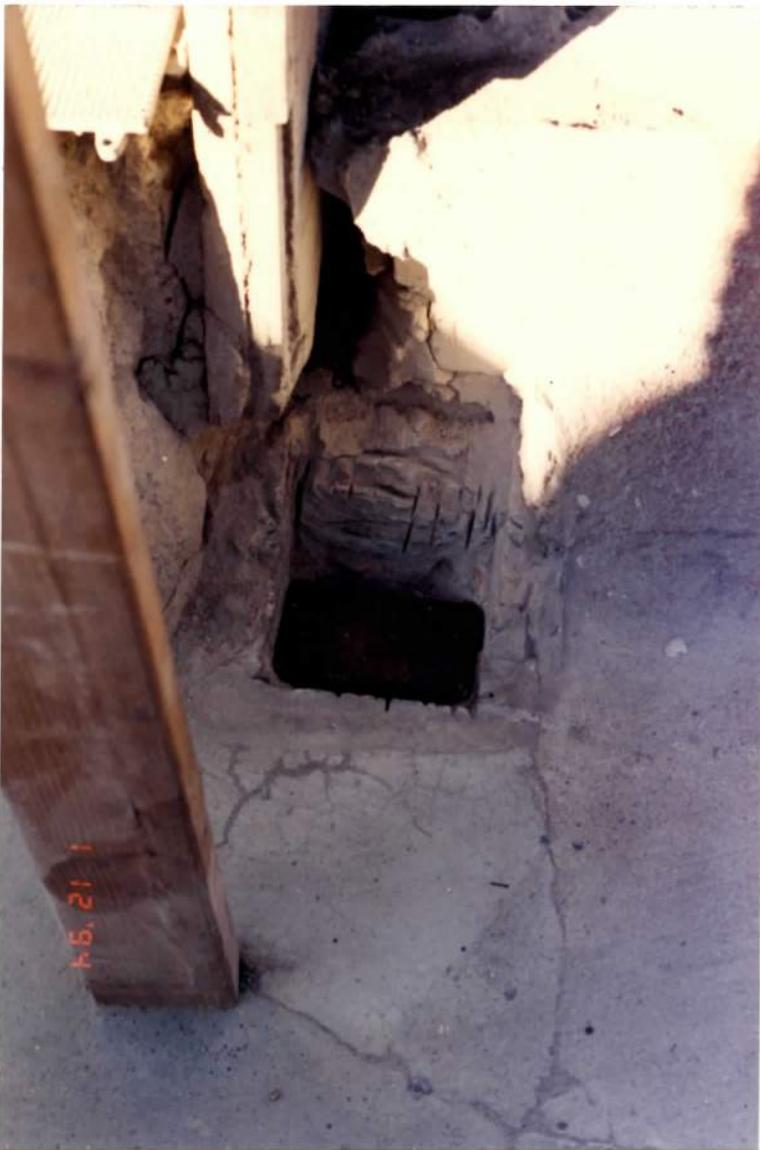
Figure 9. Inside (north) facade
portion showing deteriorated and
burned wooden panel above door
from 1955 fire, damaged door
frame, window frame. January 3,
1994.

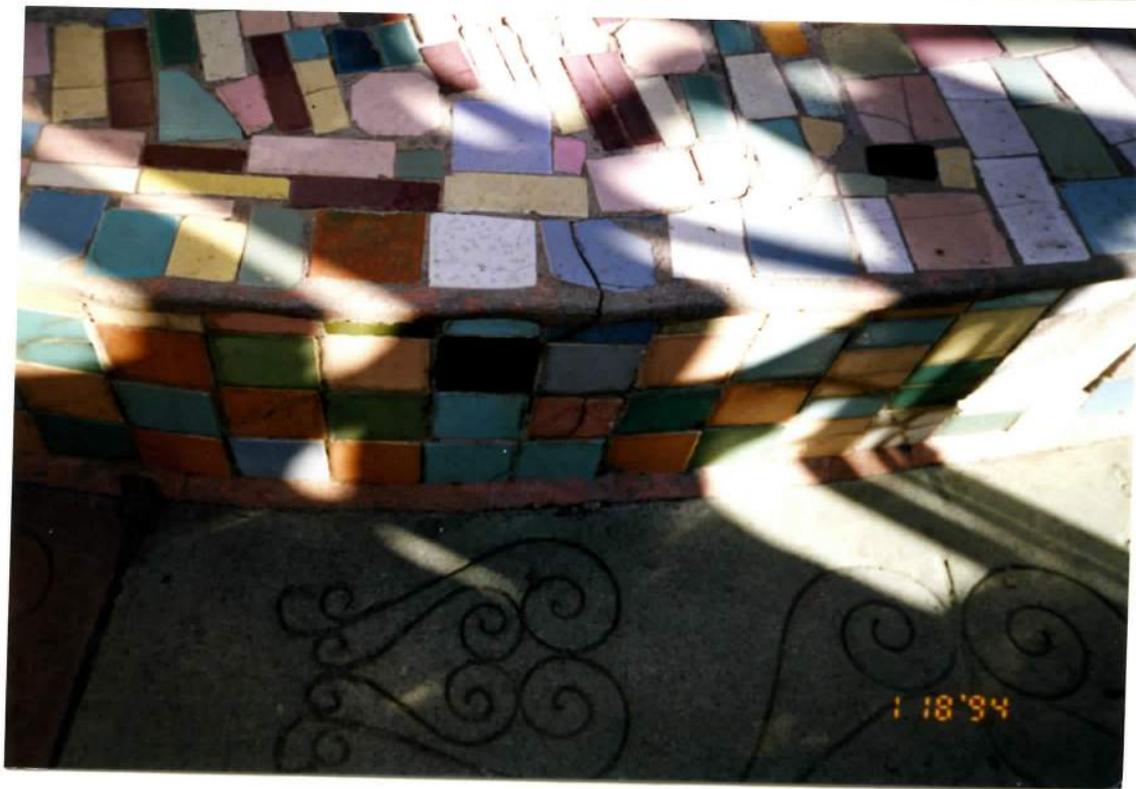
Figure 11. Facade front steps showing quake-induced crack (center on top of step) after Northridge earthquake. January 18, 1994.

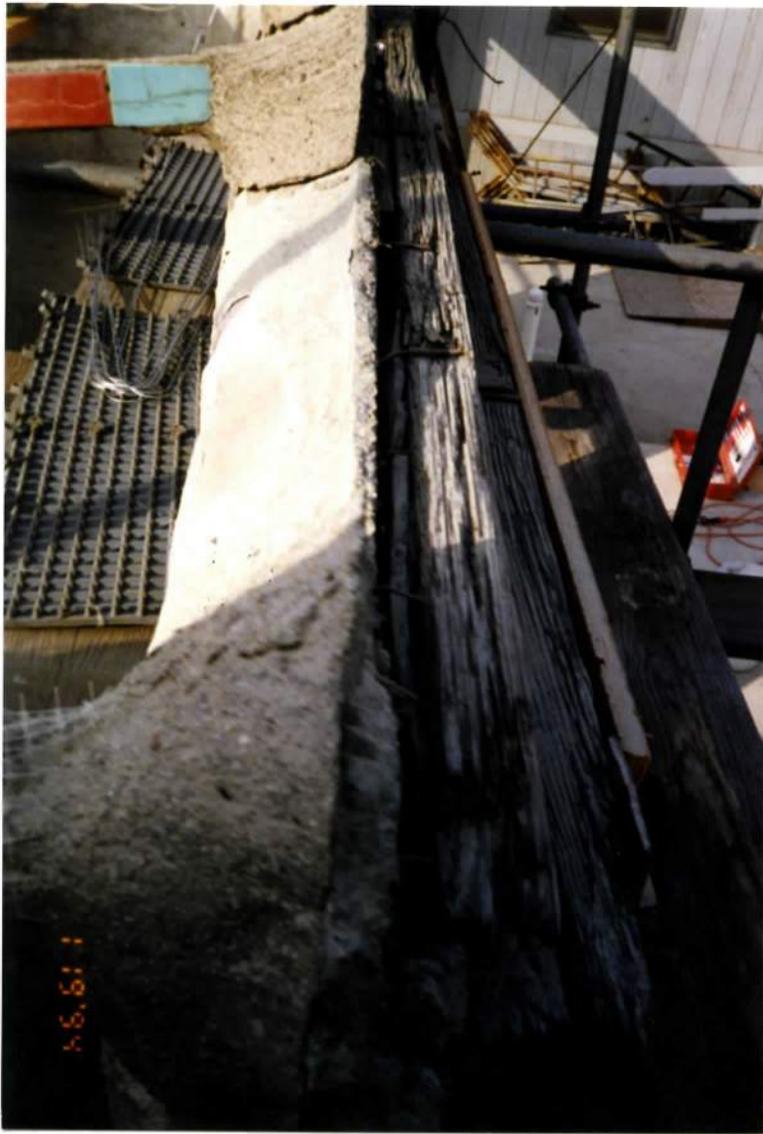
Figure 12. View looking down on top of facade note damaged top beam and overhead (top left ctr of photo). January 19, 1994.

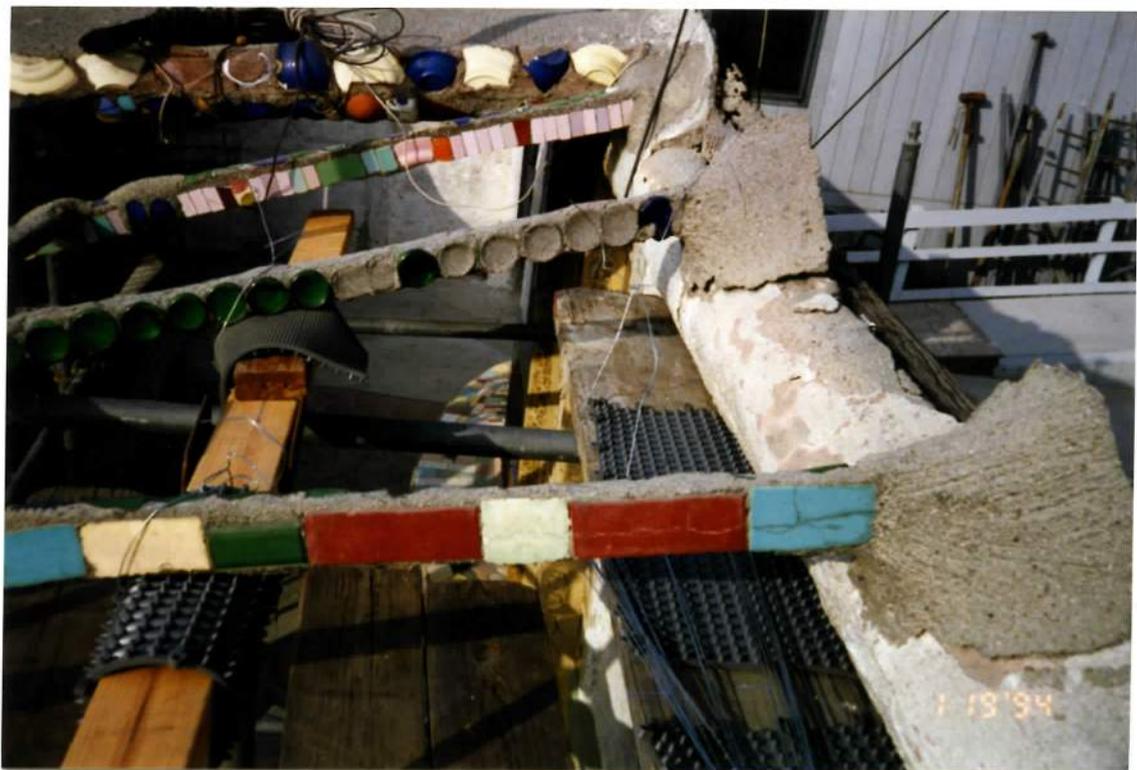
Figure 13. View looking down on top of facade showing damaged top beam and overheads (left-to-right). January 19, 1994.

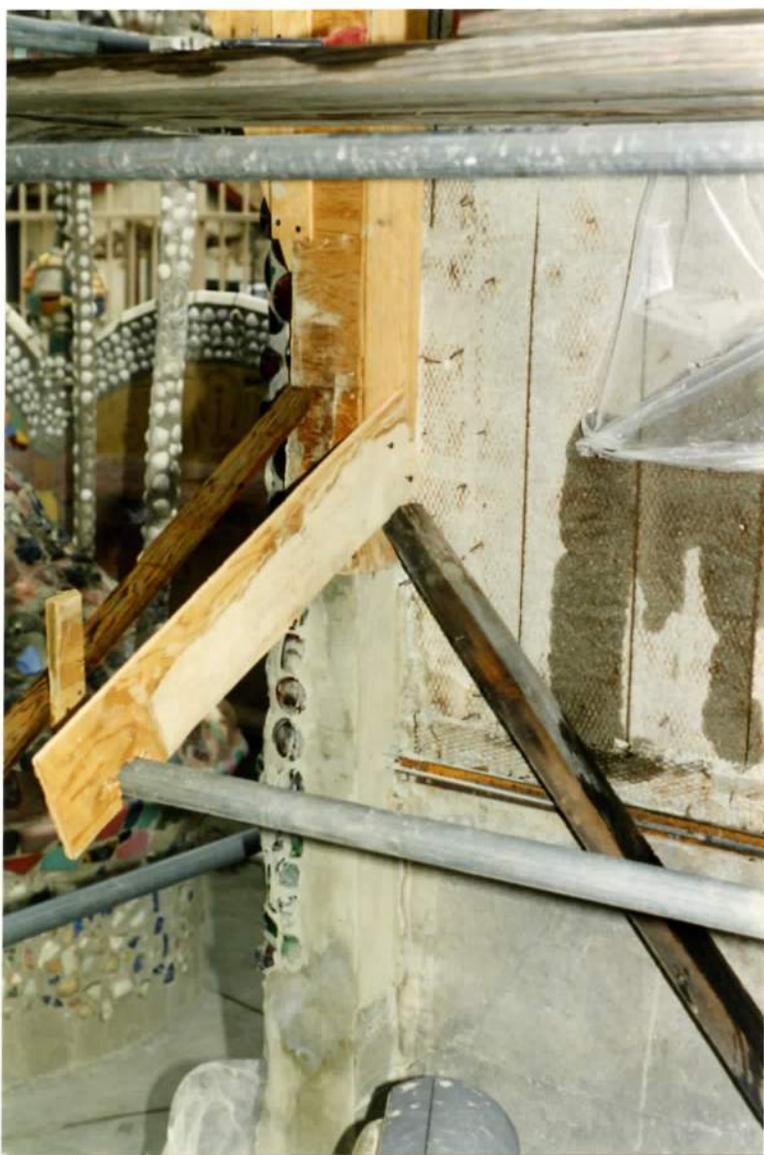
Figure 14. Removal of portion of facade top beam outside (south) before conservation. February 8, 1994.

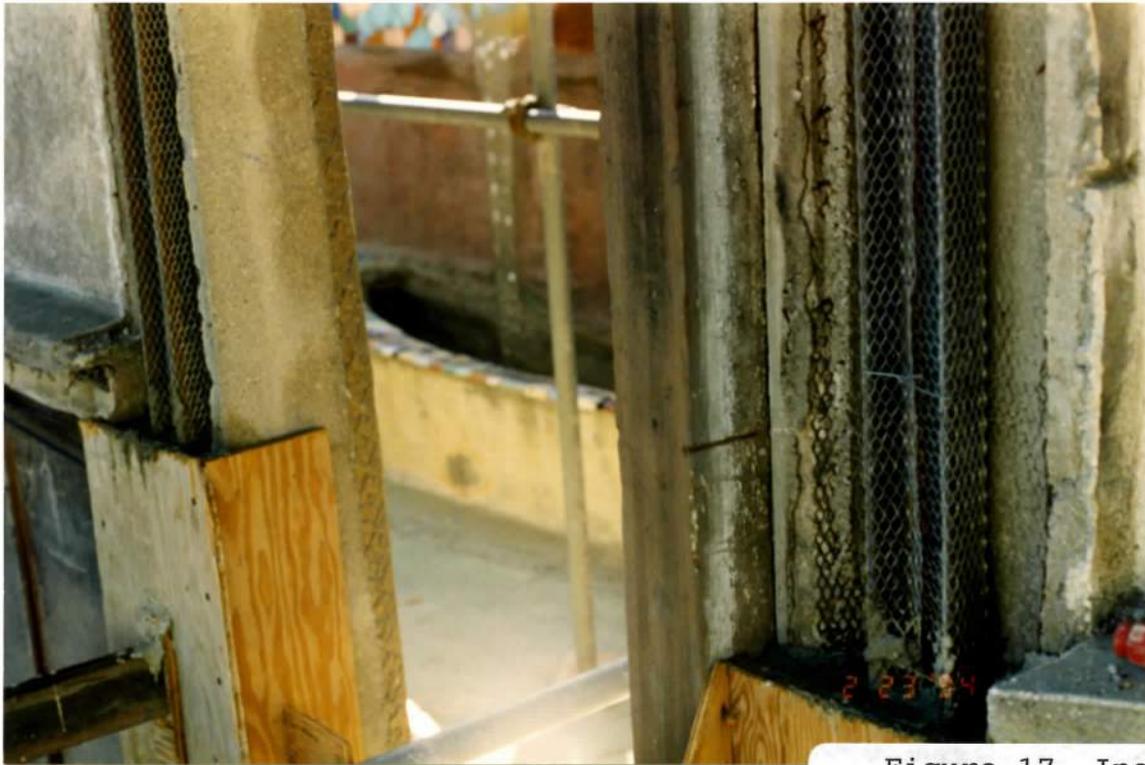
Figure 16. Inside (north) facade during conservation. Posts on both sides of door opening replaced with vertical steel channels wrapped with mesh (right) and placed in new footings. February 23, 1994.

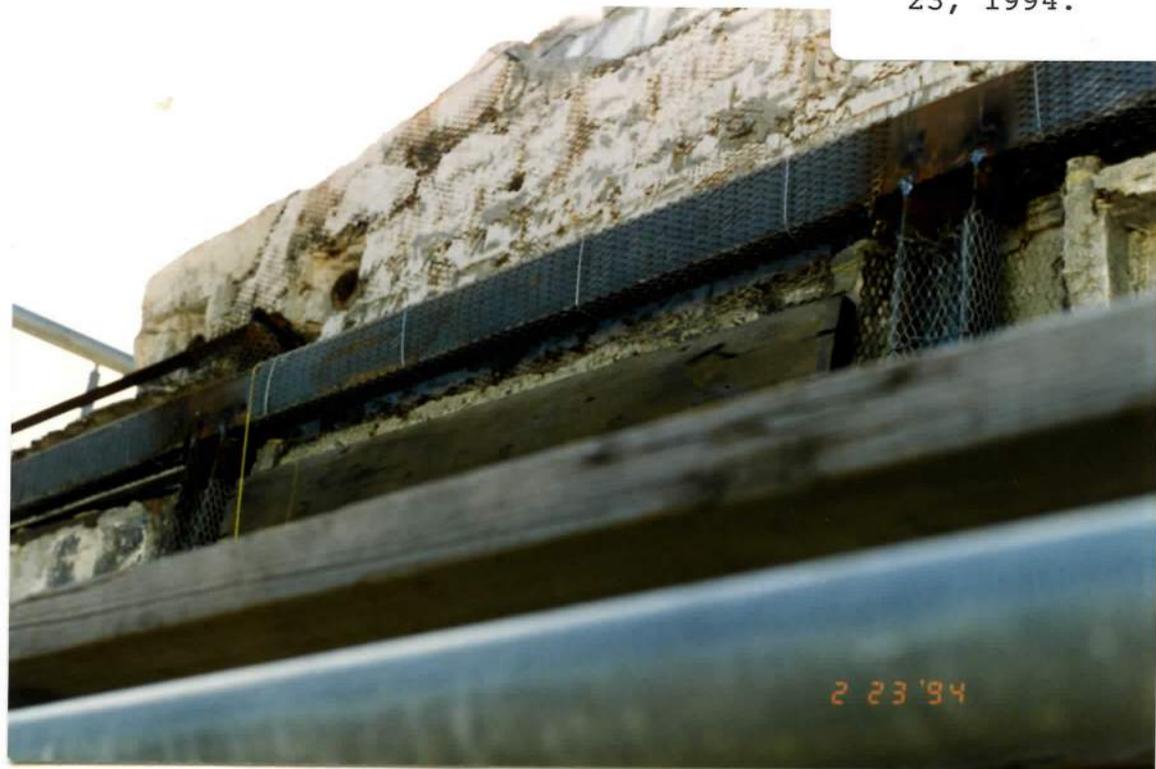
Figure 17. Inside (north) facade horizontal steel channel replacement for damaged top beam. Note top beam welded to new vertical channels on both sides of door opening. February 23, 1994.

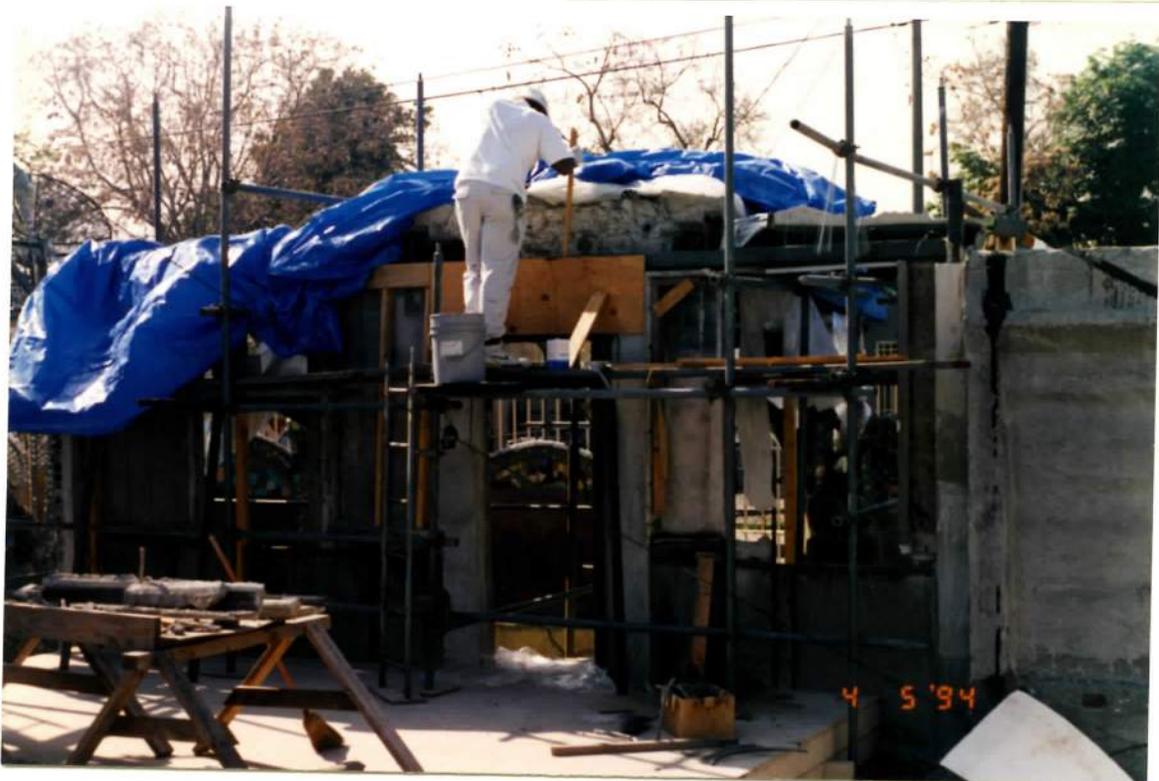
Figure 19. Inside (north) facade showing conservation work in progress. April 5, 1994.

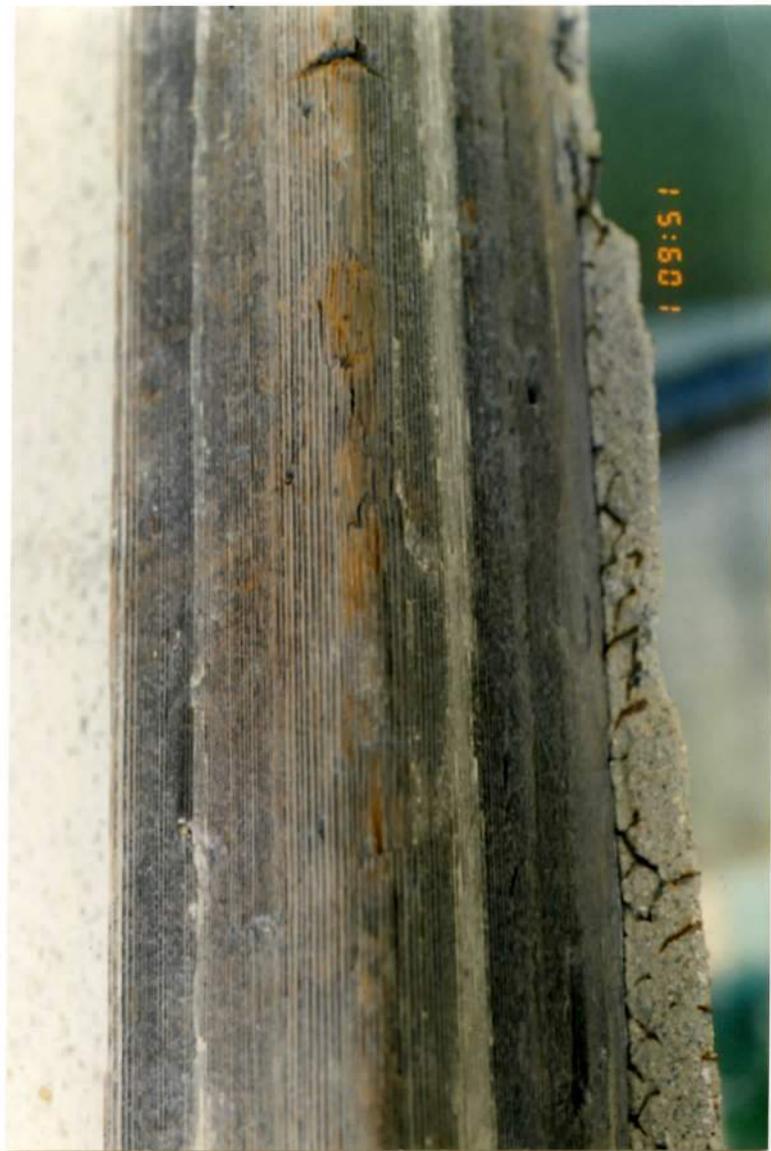
Figure 20. Wooden frame of door
inside (north) before treatment.
June 1, 1994.

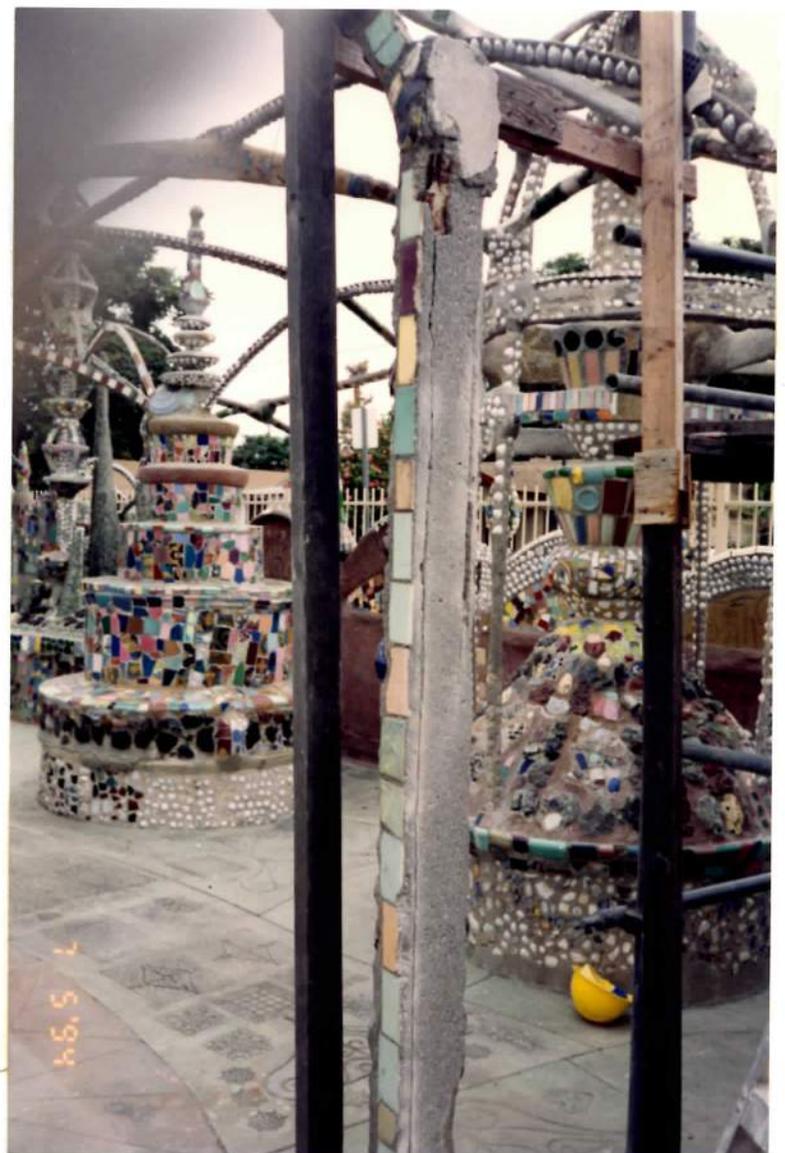
Figure 21. Post 08 east of house
foundation showing vertical
cracks and damage at top near
connection to overhead. July 5,
1994.

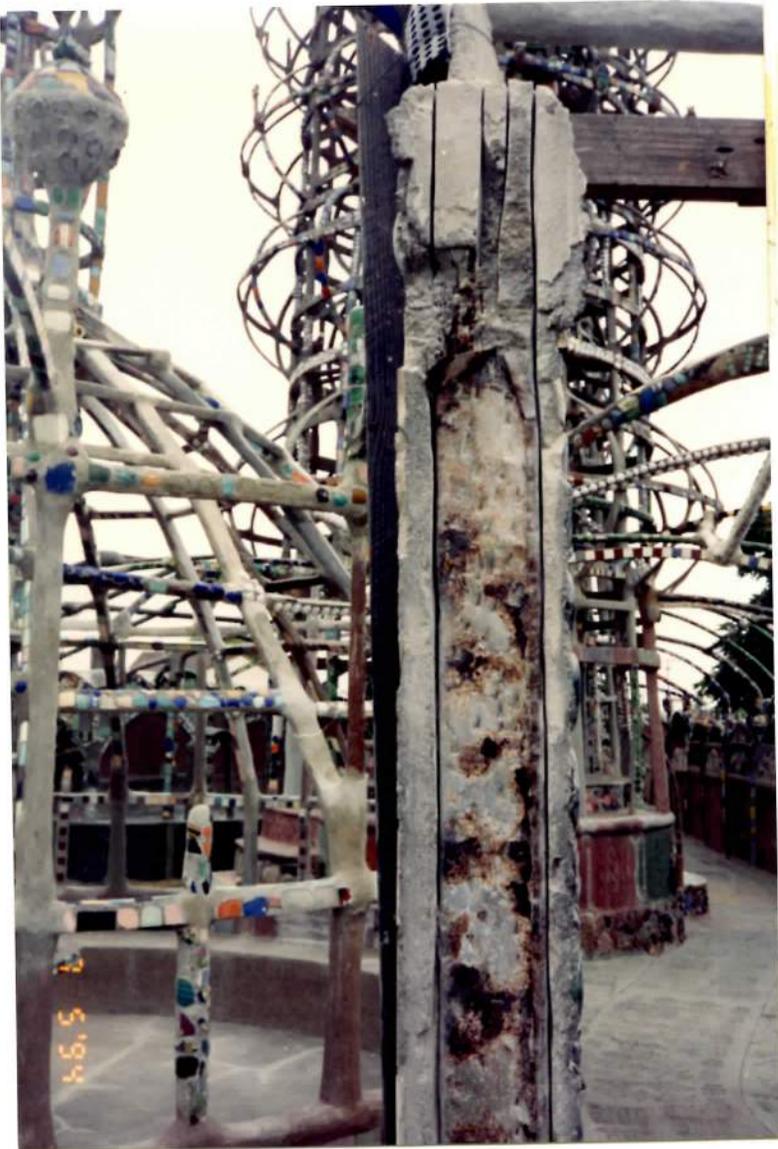
Figure 22. Post 08 east of house foundation after removal of failed reinforcement. July 5, 1994.

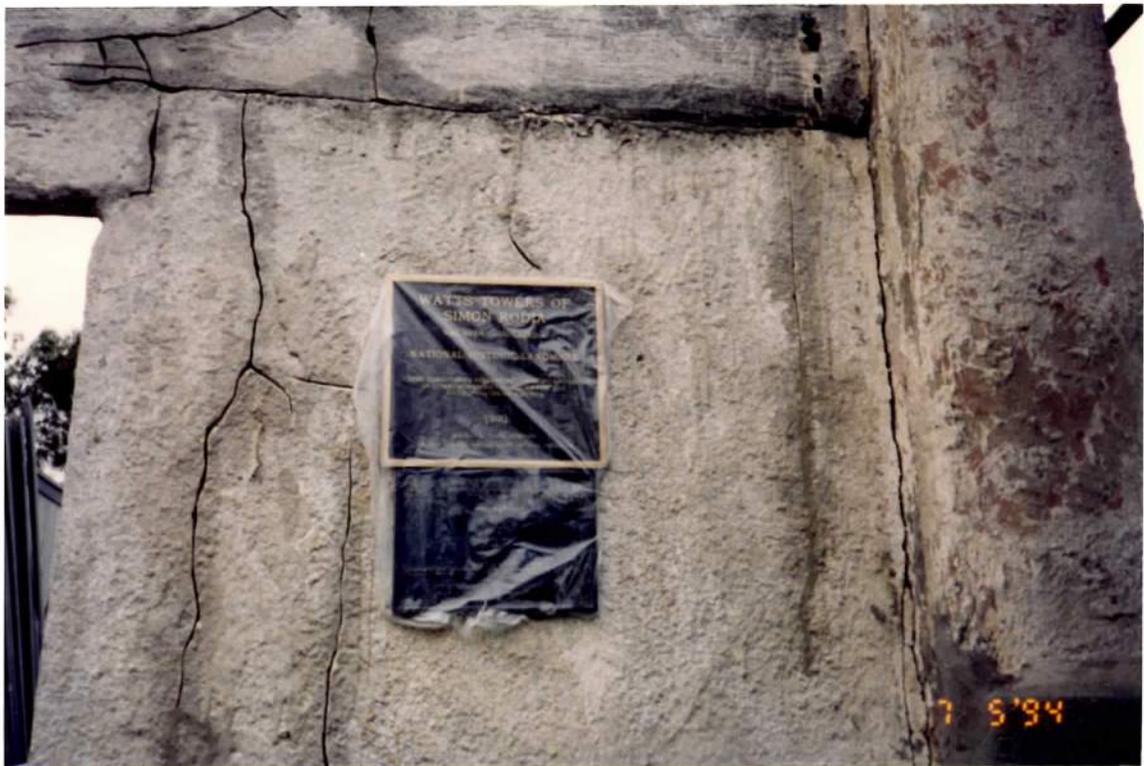
Figure 23. House facade outside (south) west end of facade during crack-filling with Jahn mortar. July 5, 1994.

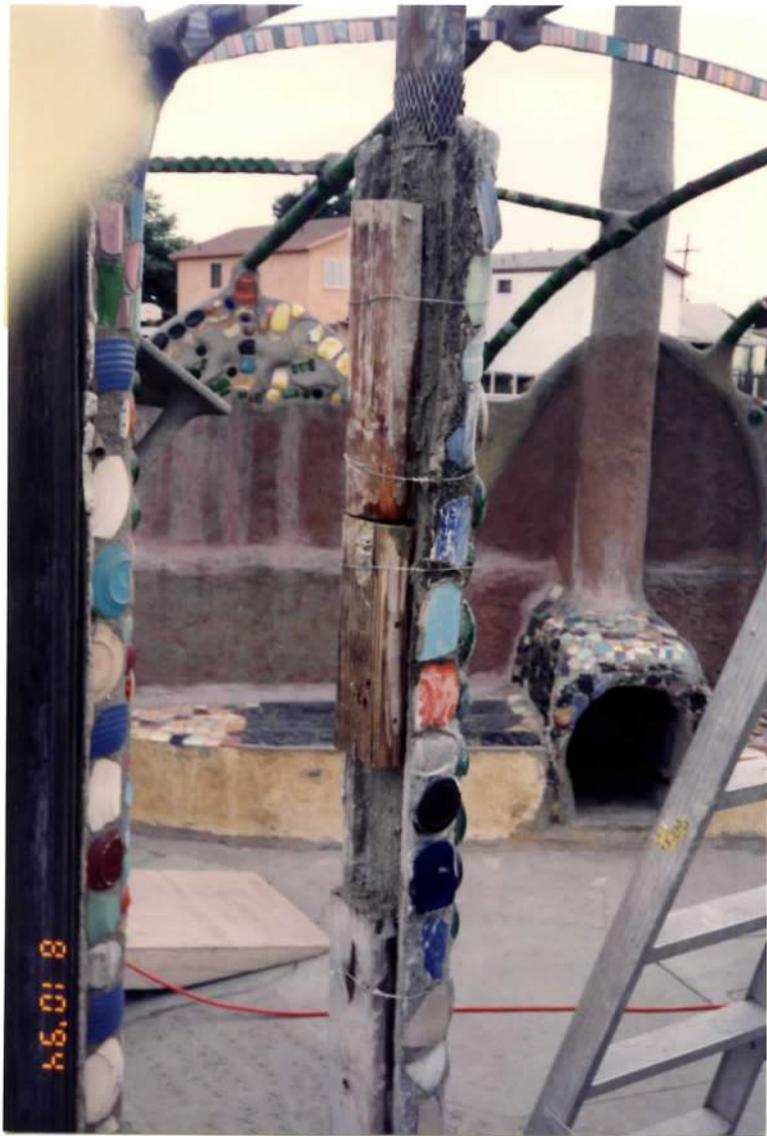
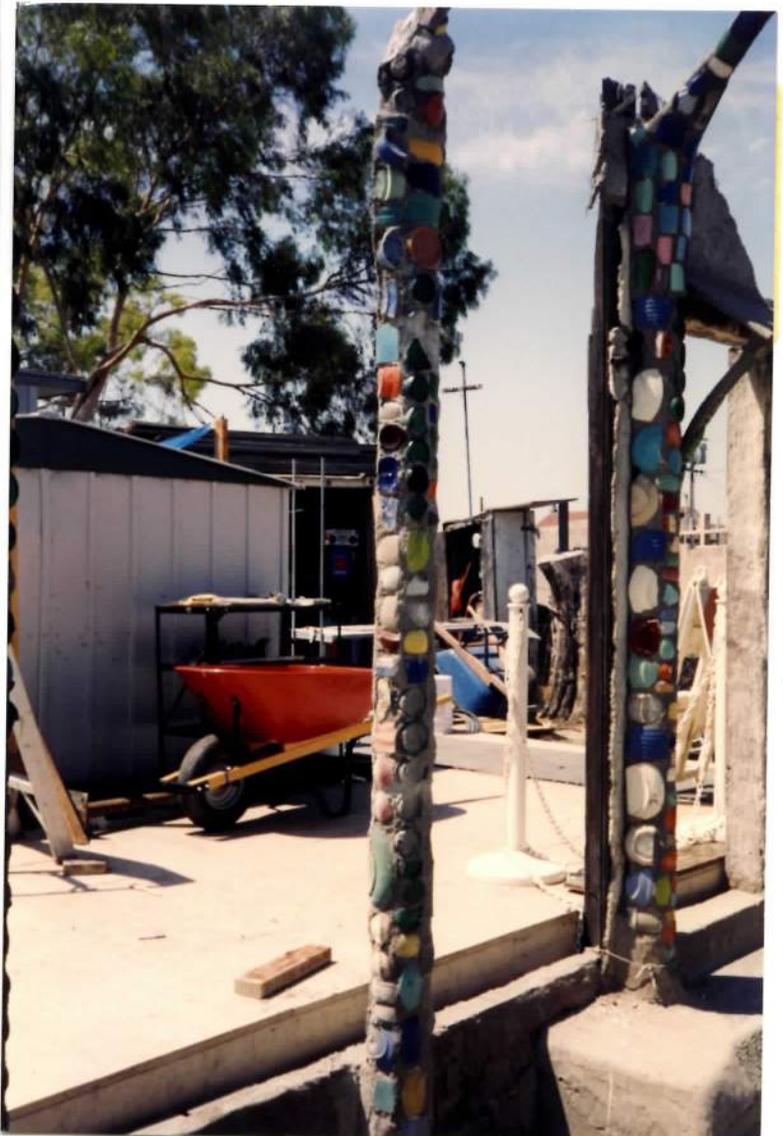
Figure 24. Post 04 east of house foundation during conservation after removal and replacement of failed reinforcement and installation in adequate foundation. August 10, 1994.

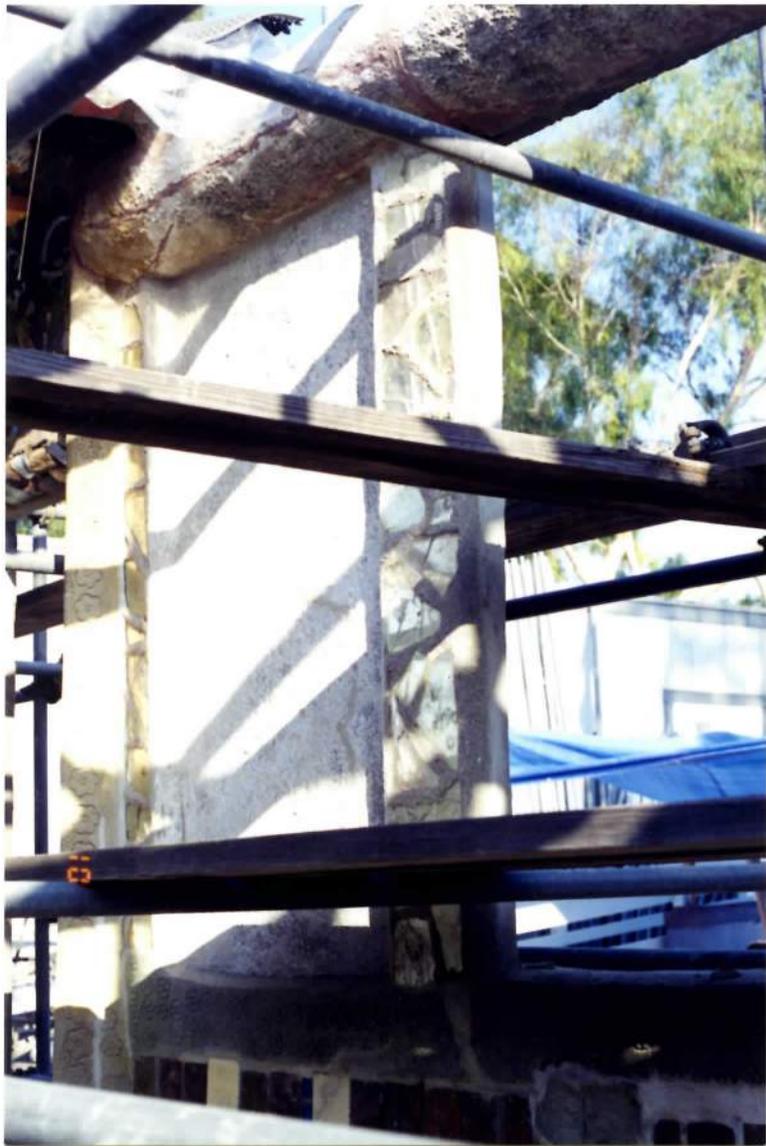
Figure 25. Post 08 (center of photo) after conservation. Note that the entire original covering has been installed over a new reinforcement cemented into a new footing and foundation. August 16, 1994.
