THE WATTS TOWERS  
PRELIMINARY CONSERVATION REPORT

THE CENTER TOWER

MAY 1997

CONSERVATION OF THE CENTER TOWER  
WATTS TOWERS CONSERVATION PROGRAM  
PRELIMINARY REPORT

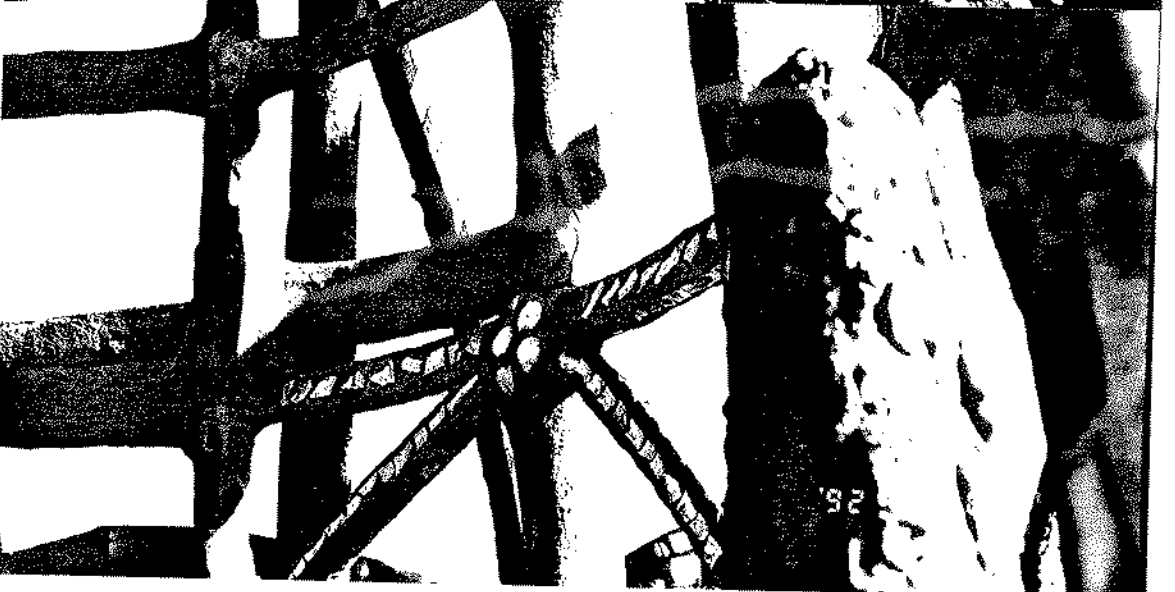
Figure 10. Center Tower cracks 8 feet above patio in joint. January 1992.

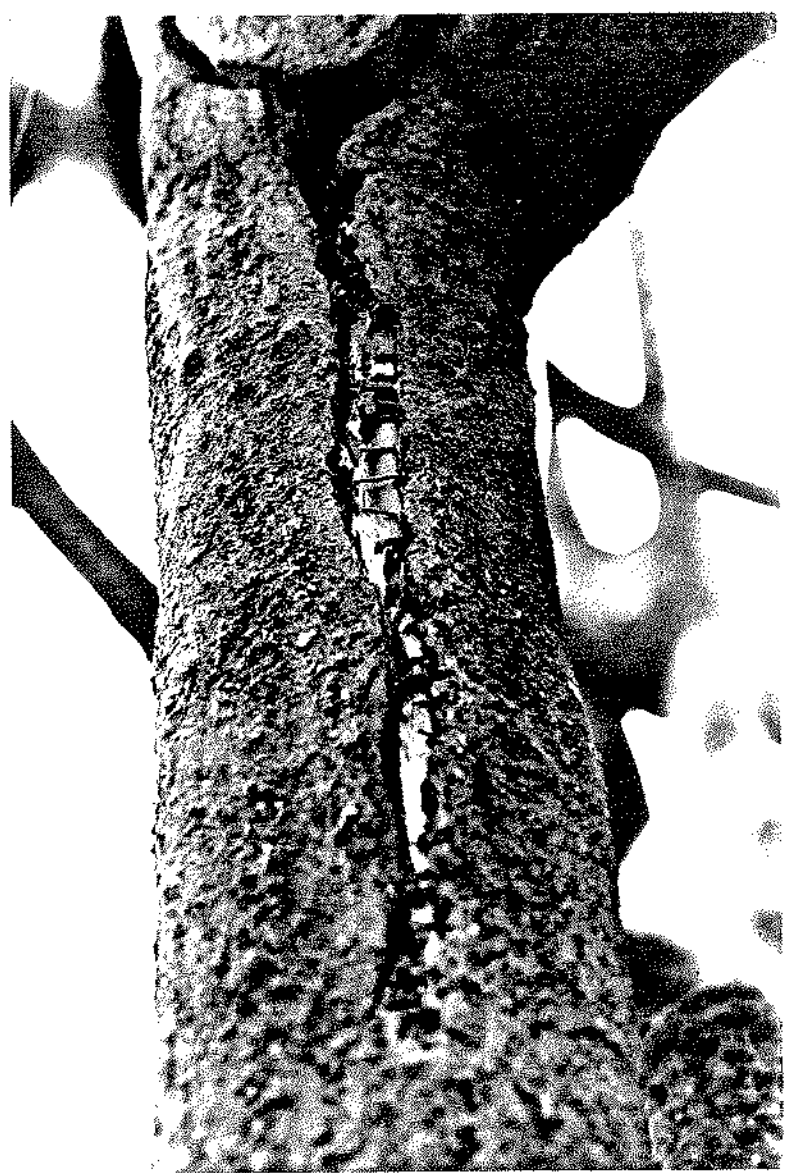
Figure 14. Center Tower crack opened to disclose ornaments covered by prior repair. January 1993.

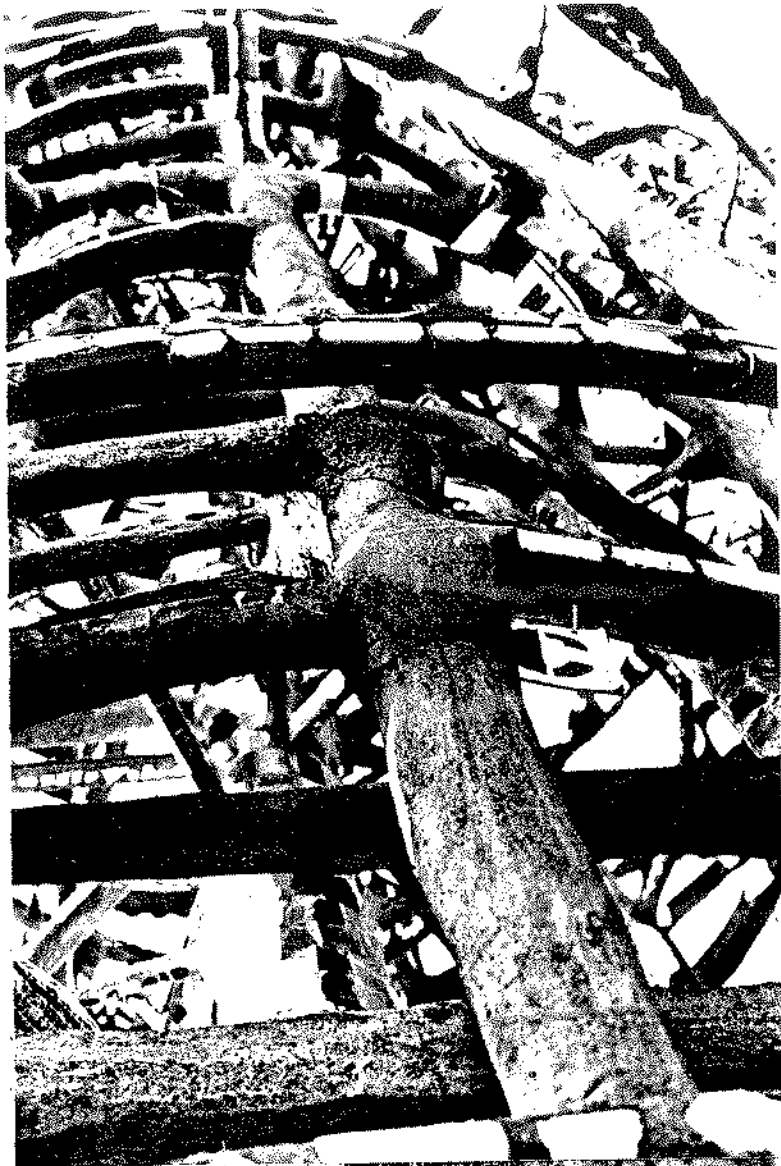
Figure 15. Center Tower crack opened to disclose ornaments covered by prior repair. January 1993.

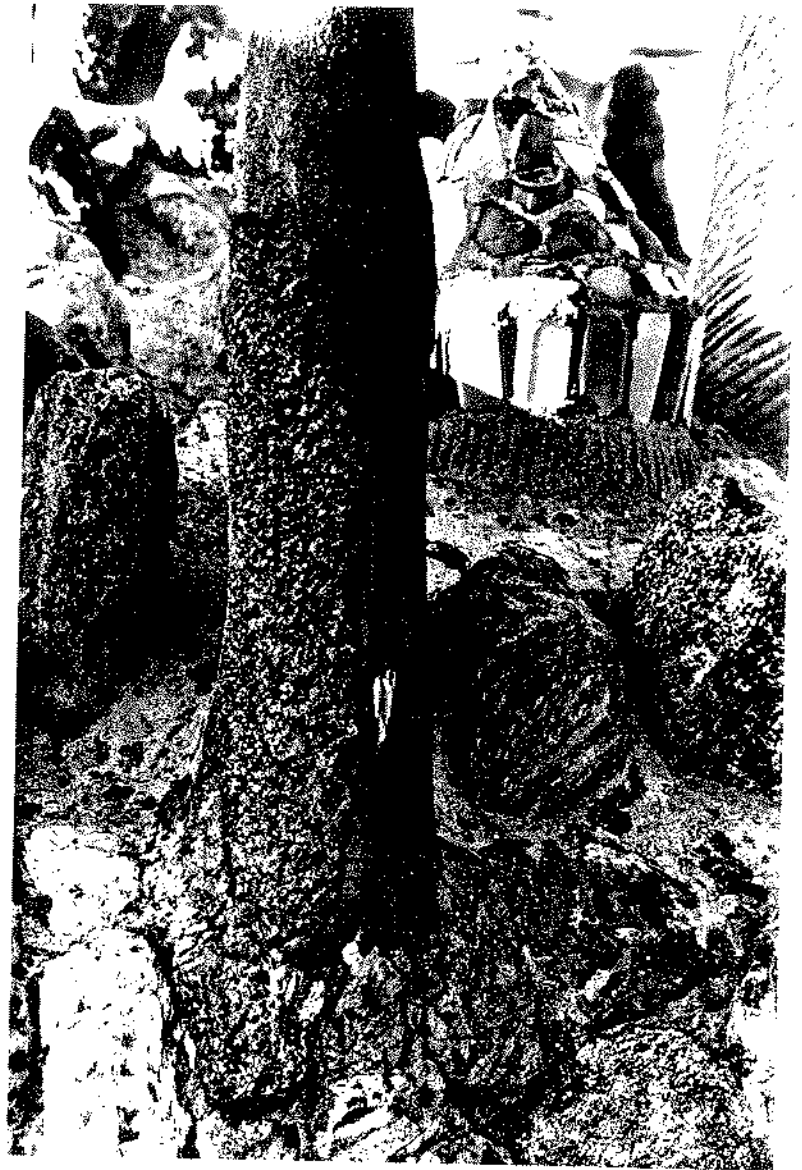
Figure 16. Center Tower column (right center) near base. Cracks above have caused water intrusion. Before temporary repairs. 1/11/93 photo.

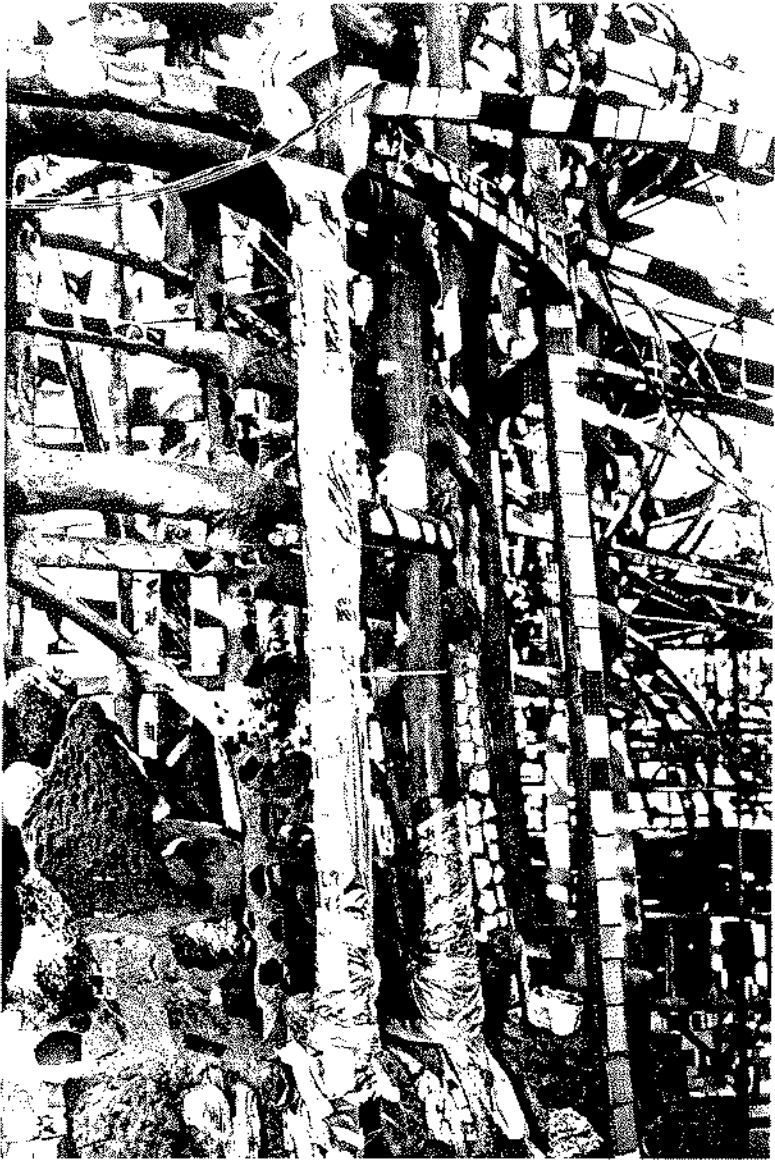
Figure 19.

Figure 10. Center Tower showing some of nine support columns wrapped with plastic to impede rain water intrusion into large cracks in mortar. 1/11/93 photo.

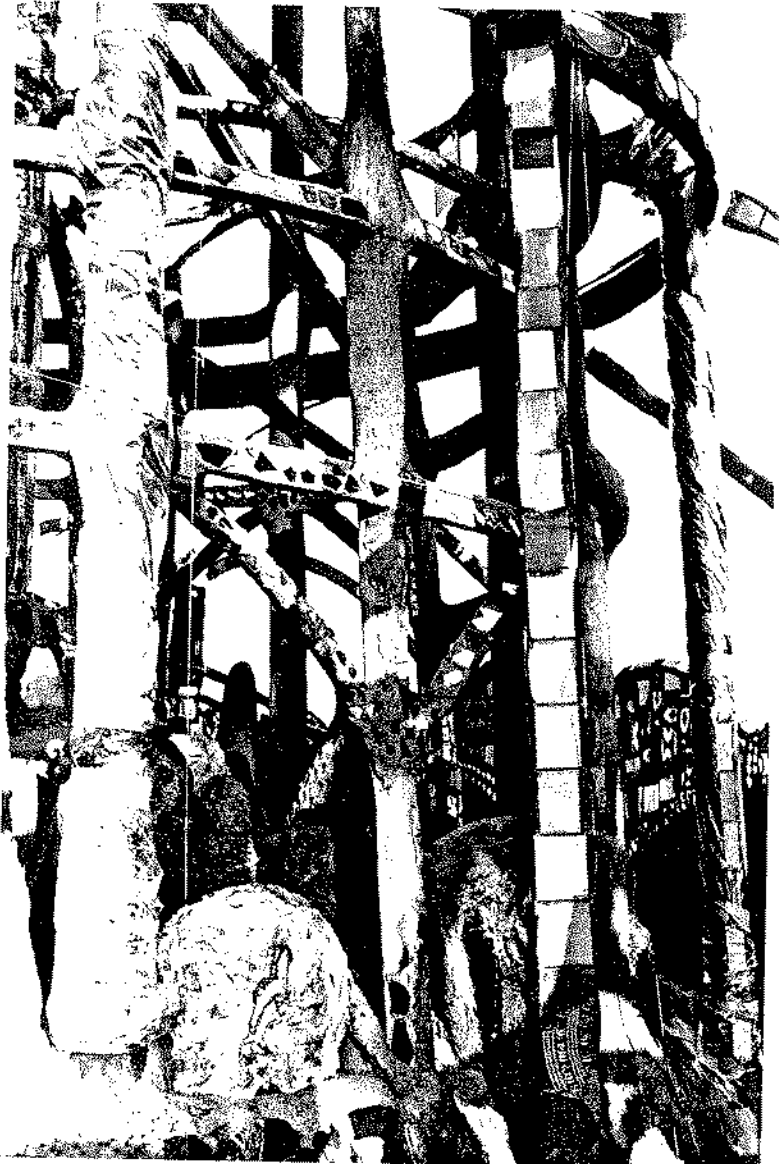
Figure 20.

Figure 11. Center Tower showing some of nine support columns wrapped with plastic to impede rain water intrusion into large cracks in mortar. 1/11/93 photo.

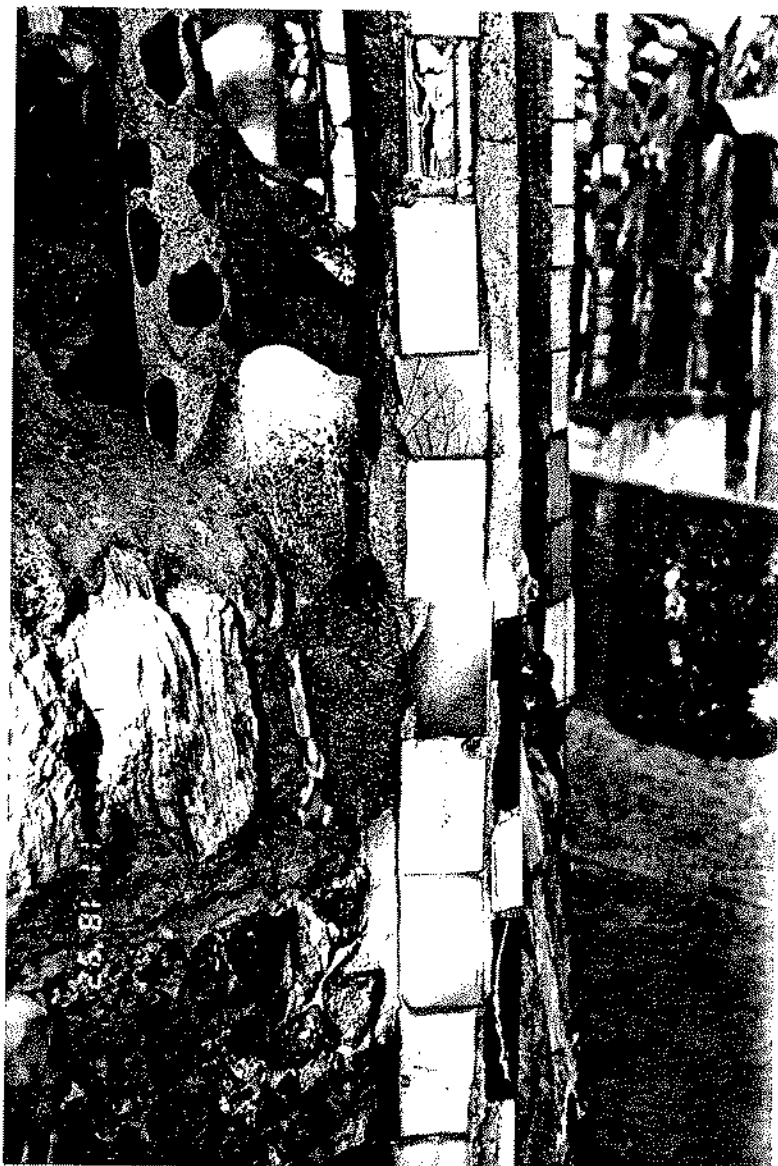
Figure 24.

Photograph 32. Center Tower cracks through 1985 State repairs to main vertical support column near base. November 18, 1992.

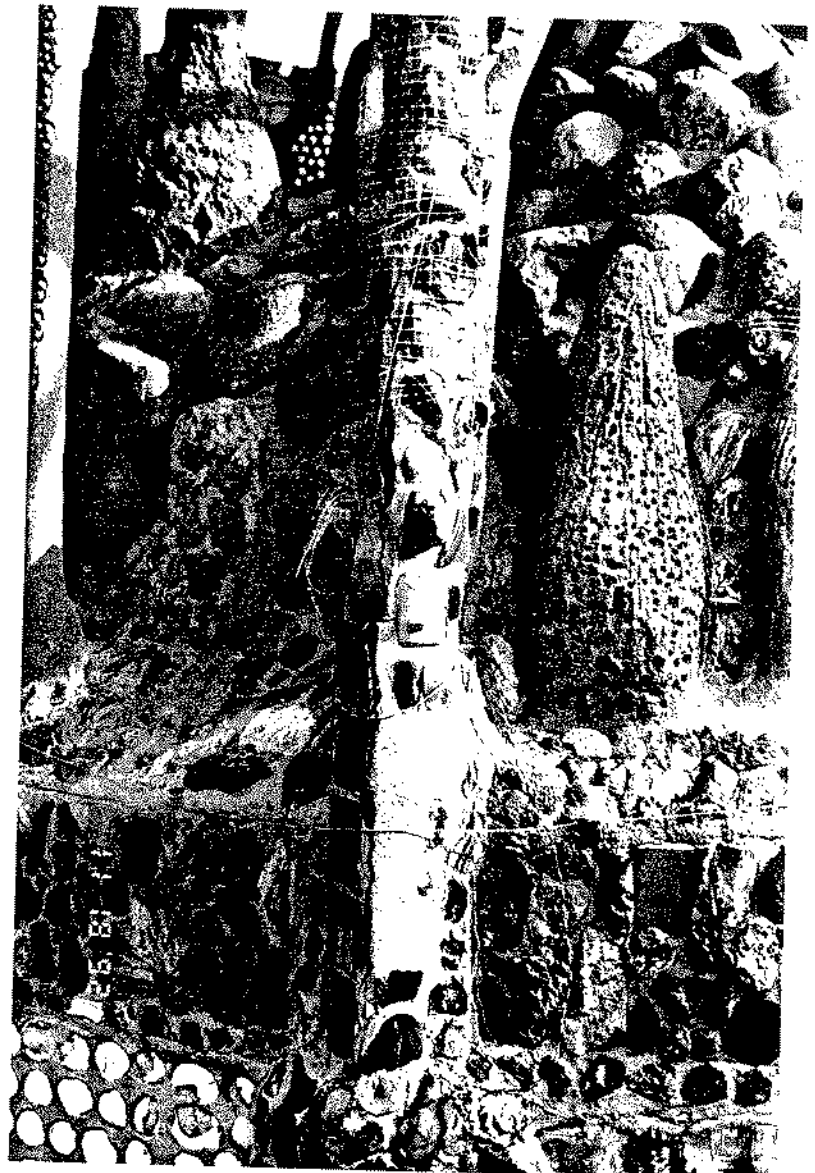
Figure 25.

Photograph 33. Center Tower cracks through 1985 State repairs to main vertical support column near base. November 18, 1992.

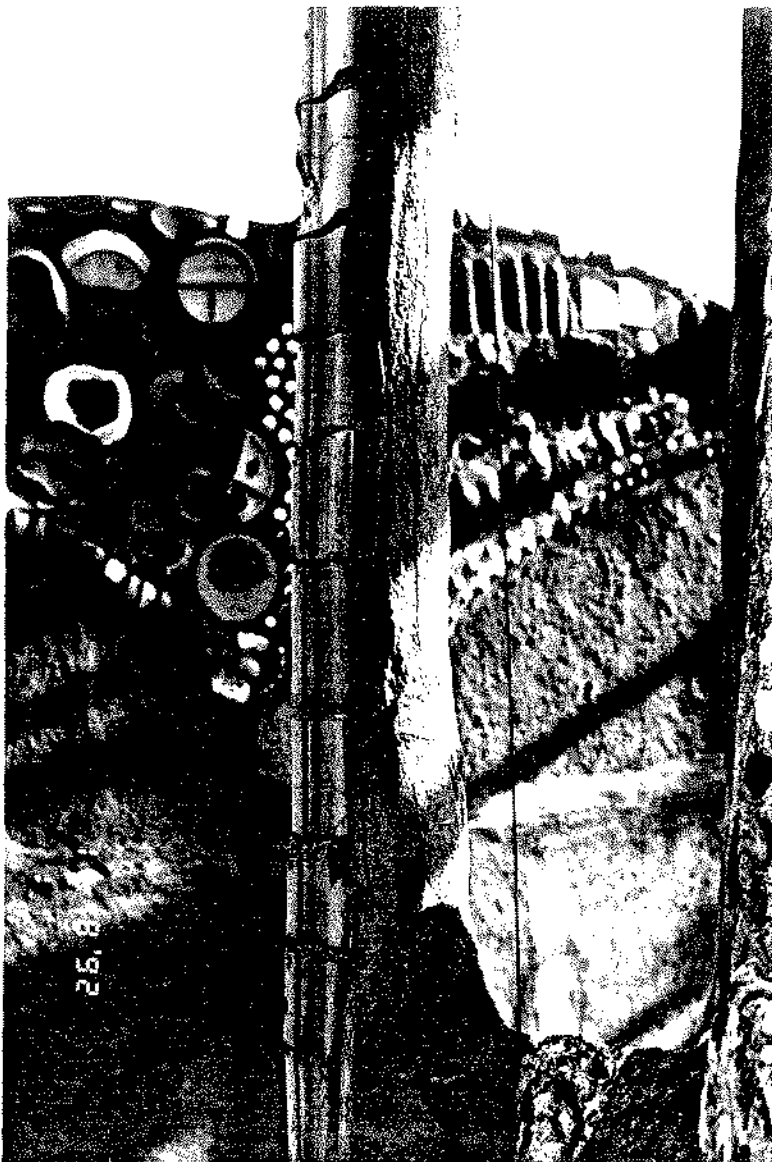
Figure 27.

Photograph 35. Center Tower cracks through 1985 State repairs to main vertical support. November 18, 1992.

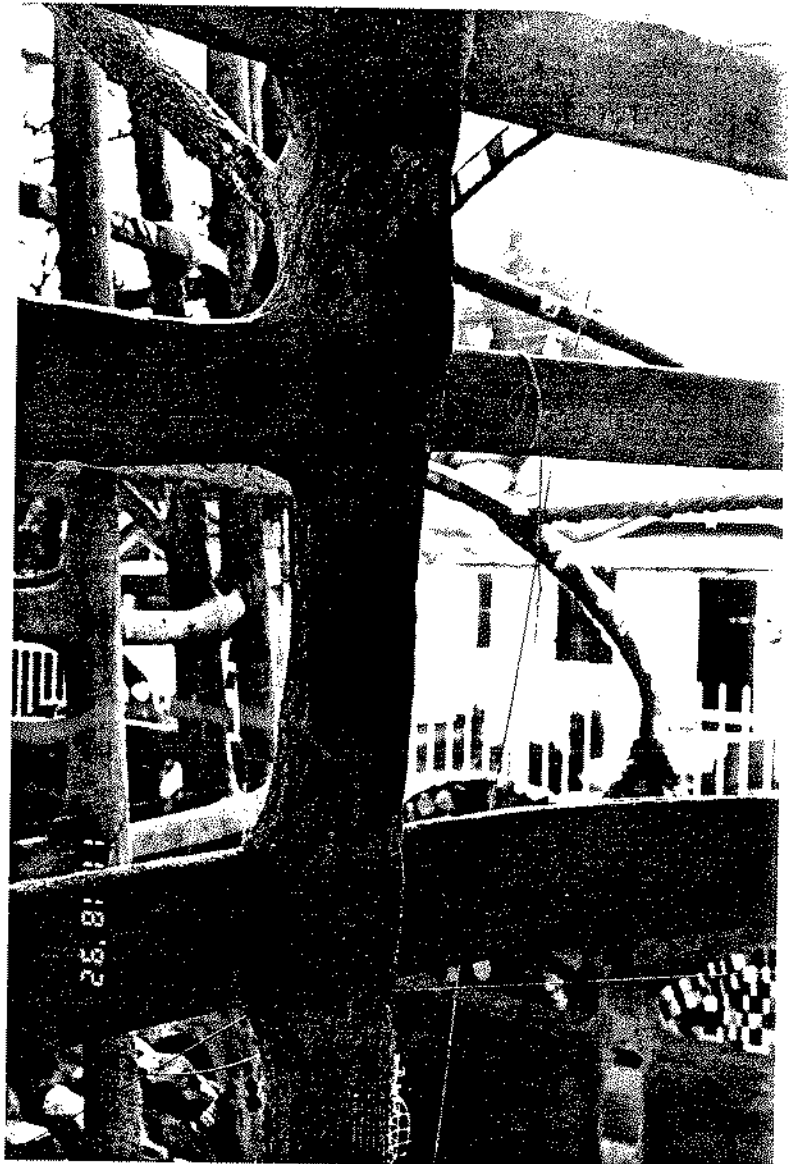
Figure 28.

Photograph 36. Center Tower cracks through 1985 State repairs to main vertical support. November 18, 1992.

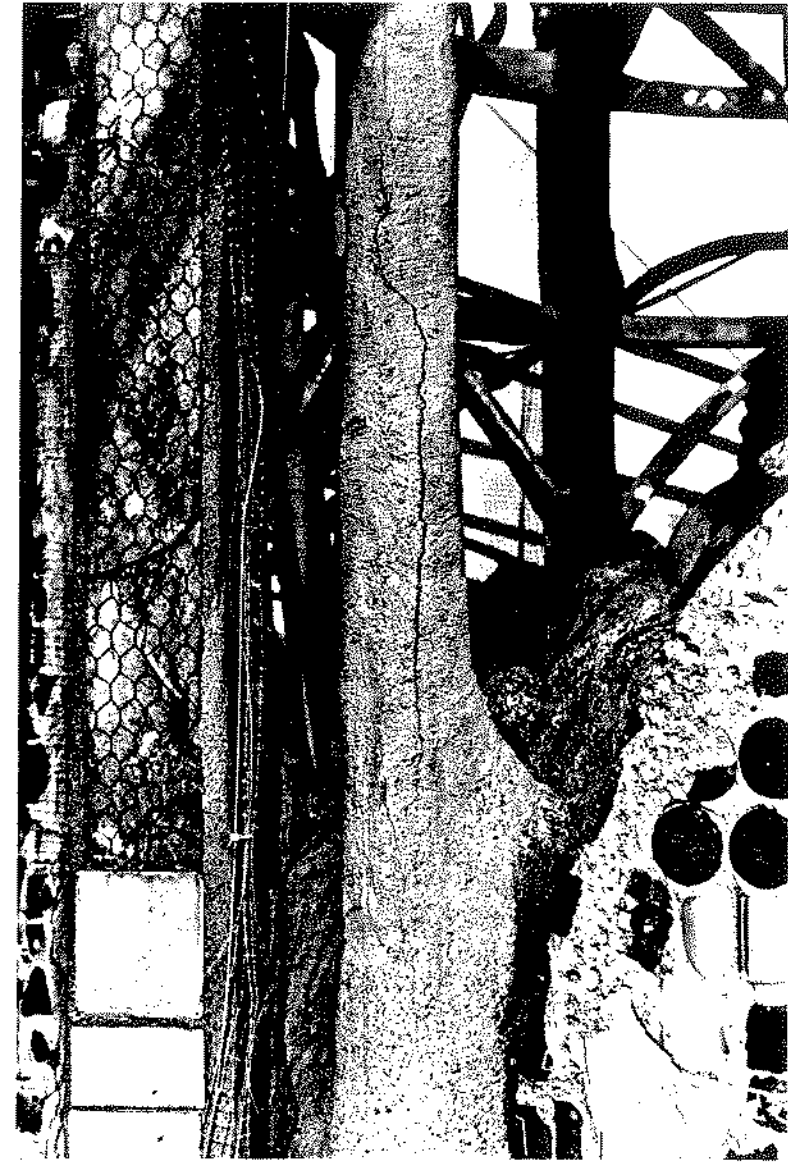
Figure 29.

Photograph 37. Center  
Tower cracks through  
1985 State repairs to  
main vertical support.  
November 18, 1992.

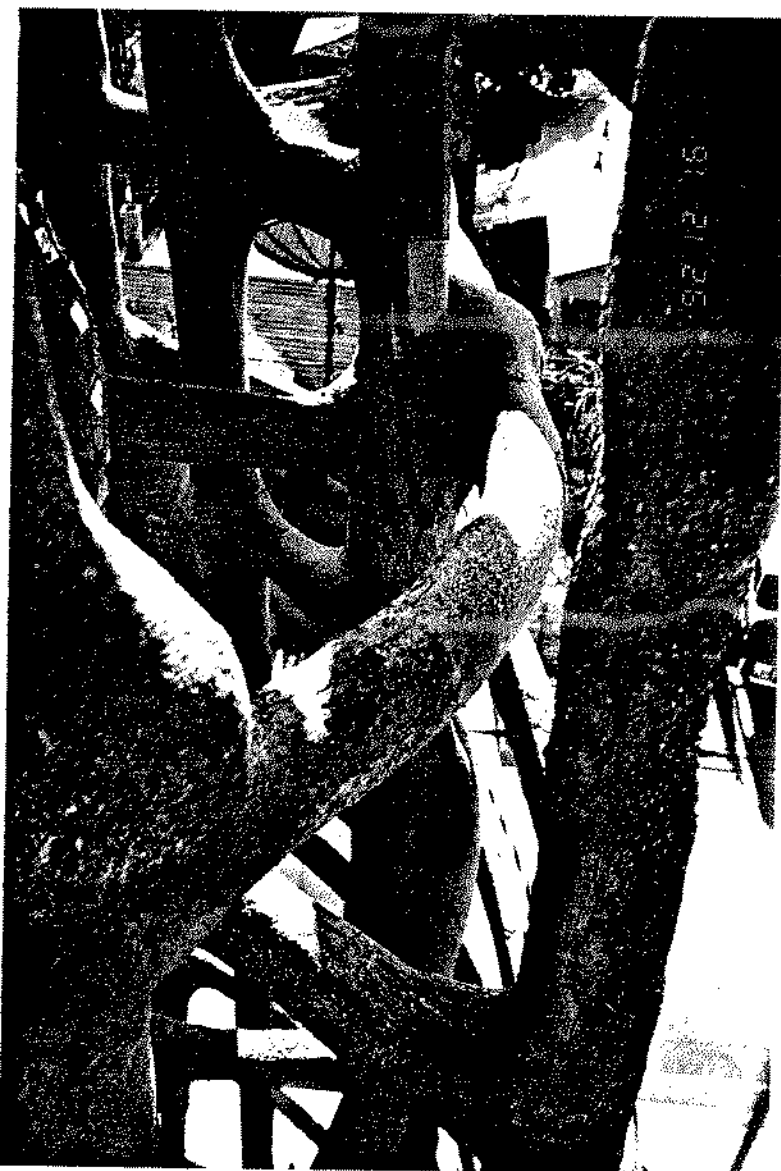
Figure 31.

Photograph 39. Center Tower crack in joint inside surface before repair from boom bucket. December 16, 1992.

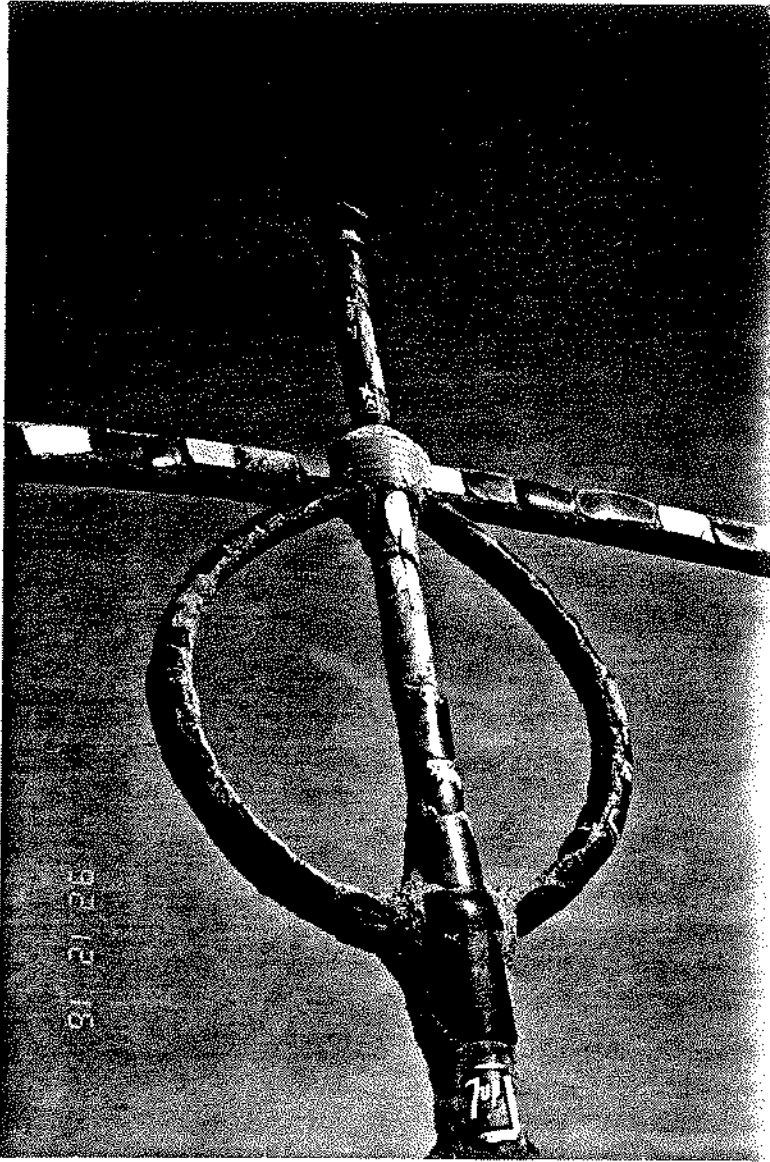
Figure 34.

Photograph 44. Crack near top of vertical column of connecting structure between East & Center towers. 50 foot elevation. December 16, 1992

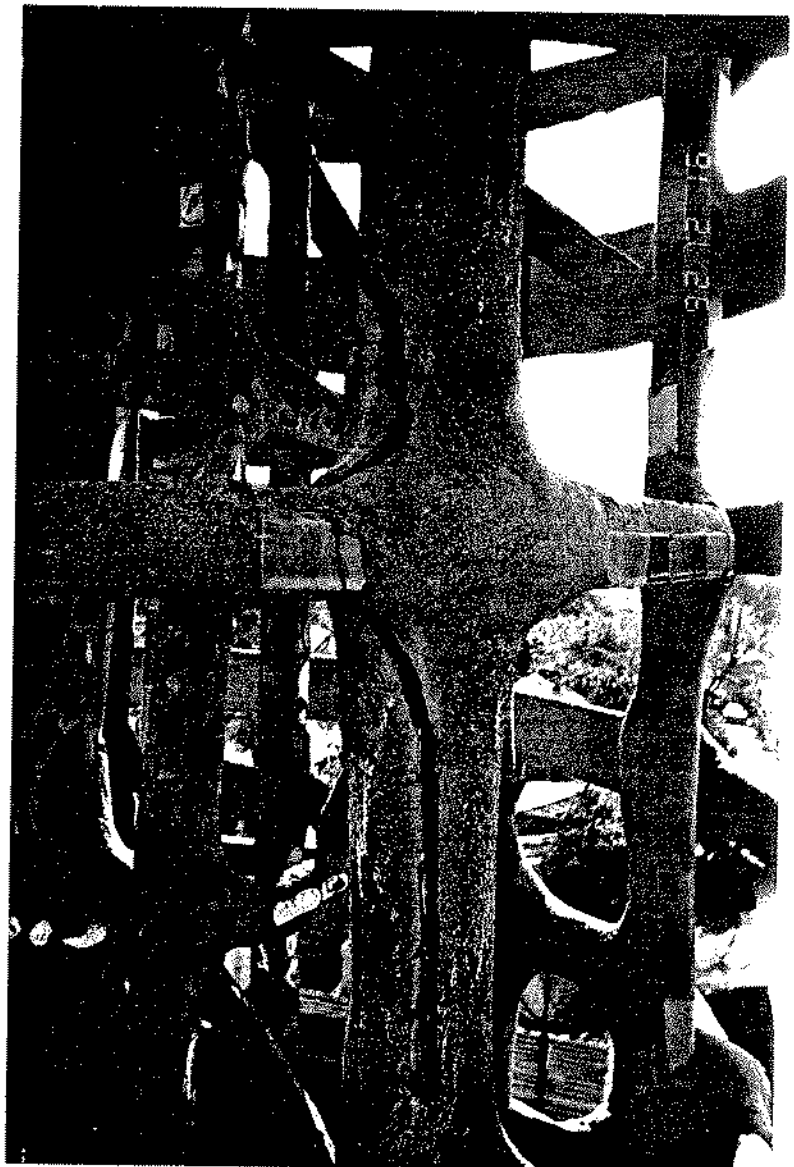
Figure 35.

Photograph 45. Crack in Center Tower vertical column and horizontal band before repair from boom bucket. December 16, 1992

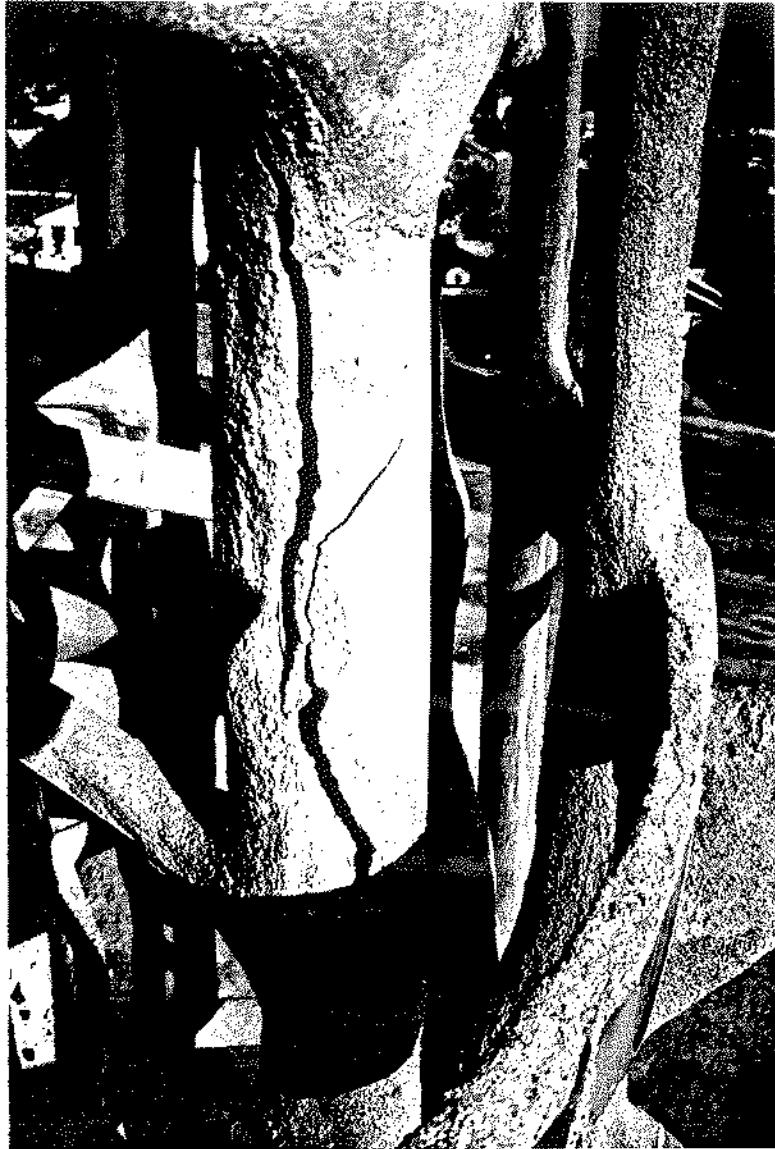
Photograph 46. Crack in Center Tower vertical column before repair from boom bucket. December 16, 1992  
Figure 36.

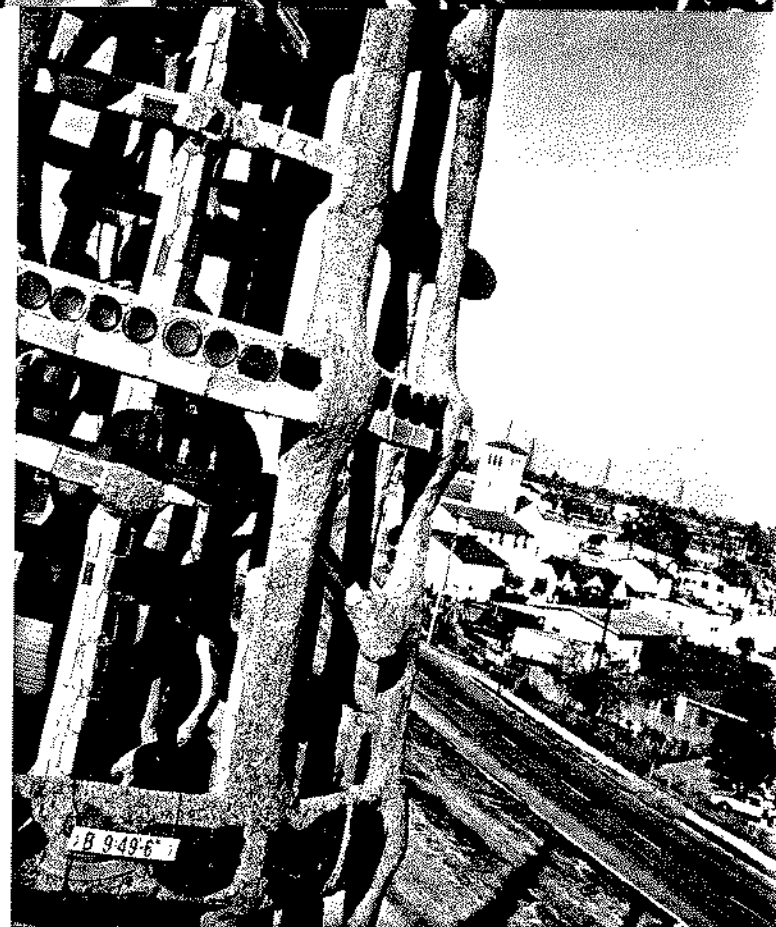
Figure 38.

Photograph 48. Crack in Center Tower vertical column before repair from boom bucket. 55 foot elevation. December 16, 1992.

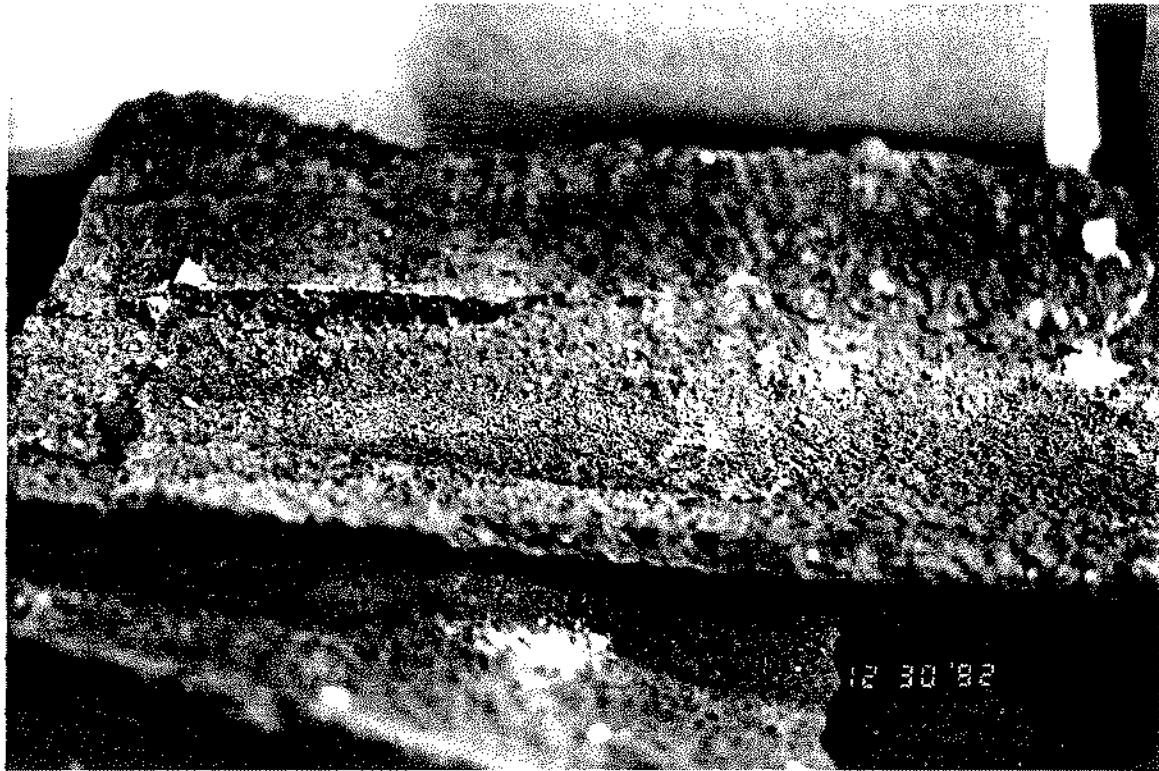
Figure 39.

Figure 01. Center Tower. State of CA repair mortar c1983 which separated from original, Rodia work. Piece shows impression of ornaments which had been covered by repair erroneously. 12/30/92 photo.

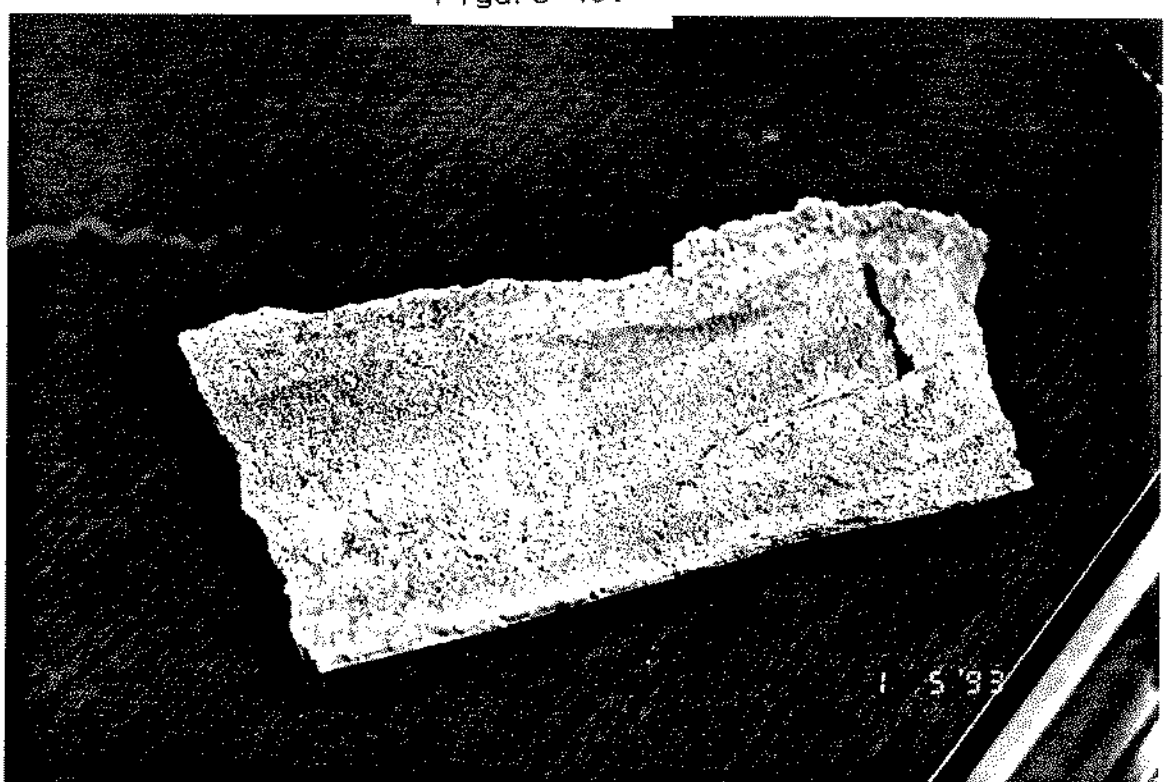
Figure 02. Center Tower. State of CA repair mortar c1983 which separated from original, Rodia work. Piece shows impression of ornaments which had been covered by repair erroneously. 1/5/93 photo. Figure 40.
