Structural Test of Hand-built Tower

Problem of conducting potentially damaging load test on world-famous art monument is solved by using unorthodox testing procedure

by N. J. Goldstone

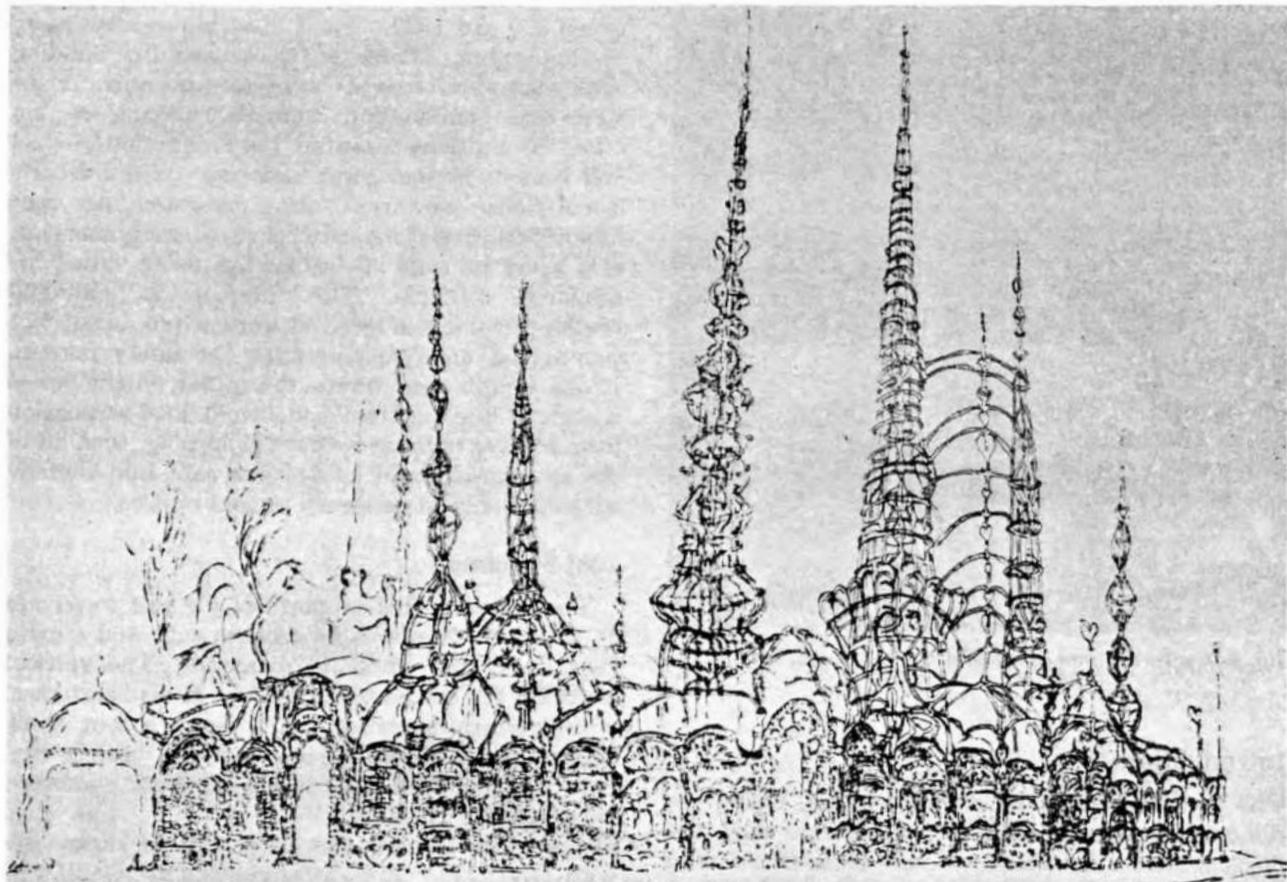
Fig. 1—Artist's rendering of seven towers at Watts, Calif.

The test specimen was an open-frame, highly redundant structure fabricated of cement, steel and chicken wire. Its members were embellished with broken glass and mosaic crockery embedded in their cement coating (see Figs. 1, 2 and 3).

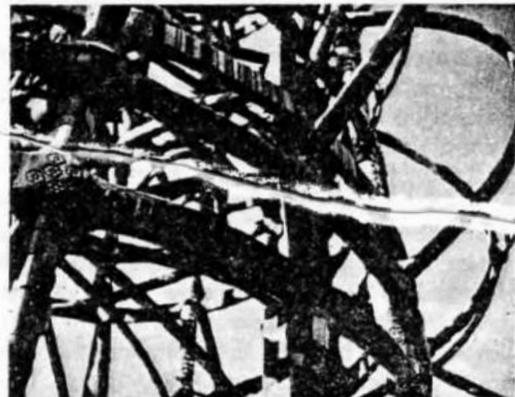
Fig. 2—Structural details of 99-ft test tower

Spoke connections extend from the legs to hubs on the central column at 47 elevations. The 752 joints where the spokes and legs intersect are connected by the 47 rings which encircle the tower. Scores of large, semicircular segments connect alternate ring-leg joints, both vertically and horizontally, over the entire structure. Sea shells, pieces of glass and ceramics, and mosaic tiles cover many of the tower members (as shown in Figs. 2 and 3).
