CONSERVATION OF THE SHIP OF MARCO POLO
WATTS TOWERS CONSERVATION PROGRAM

This is a report on the conservation work performed by the Cultural Affairs Department, City of Los Angeles between January 1986 and February 1991 on the Ship of Marco Polo, one of 17 sculptures in the Towers of Simon Rodia State Historic Park at 1765 East 107th Street. The Ship is shown in Figure 1 as it was in 1959.

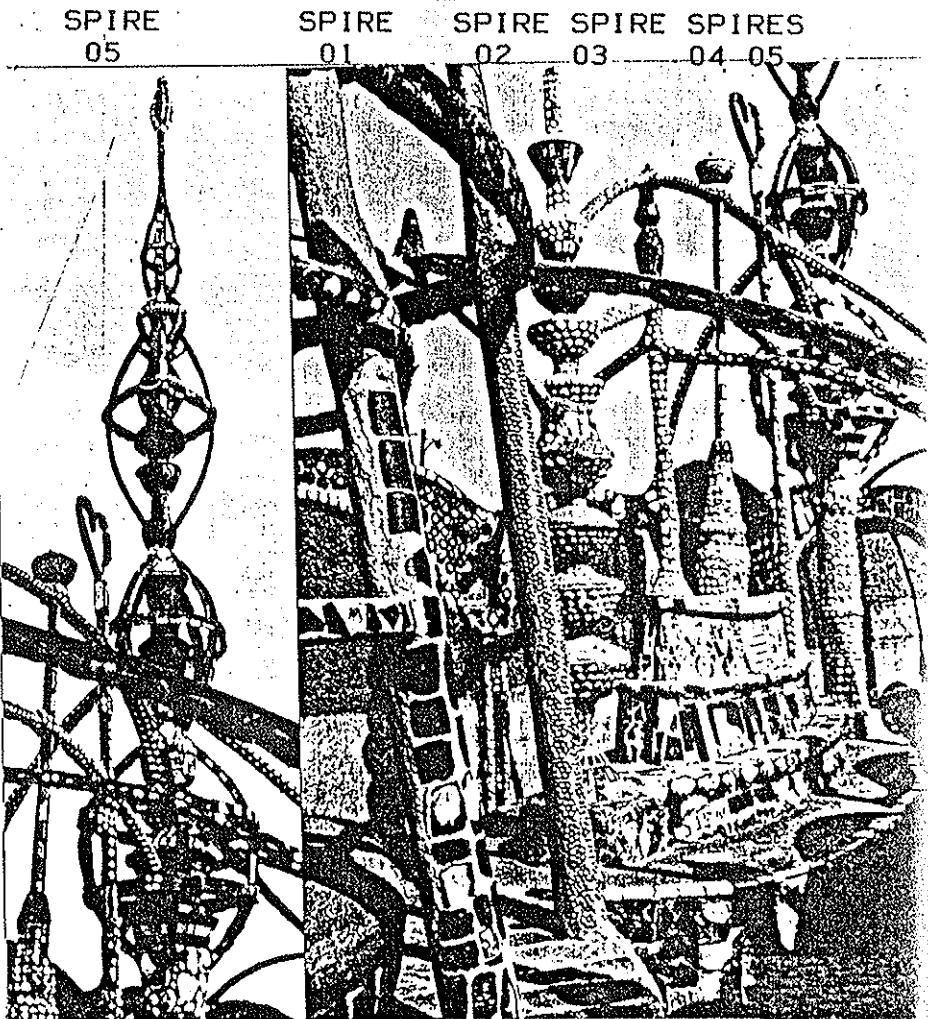
Figure 1.
Ship. Main spire in left photograph
and on right of right photograph.
(1959)

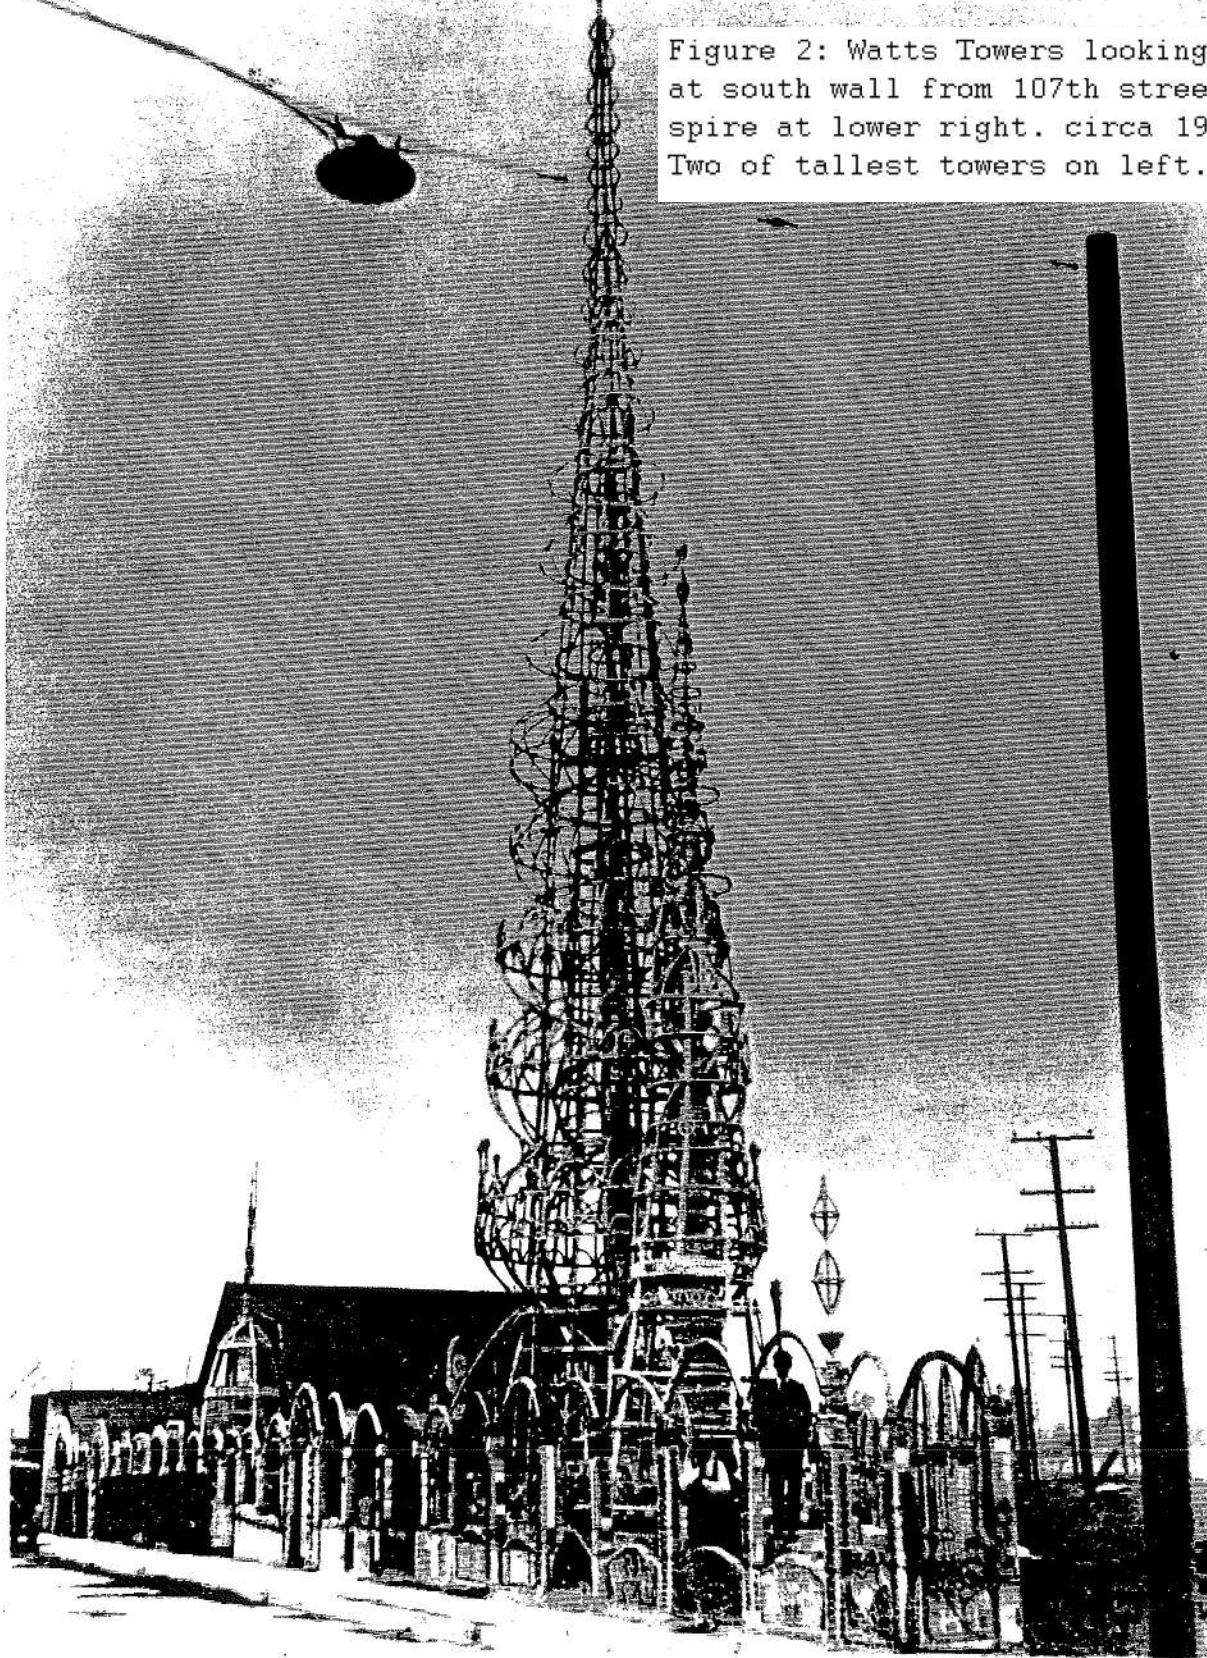
Figure 2: Watts Towers looking northwest at south wall from 107th street. Main spire at lower right. circa 1936 Two of tallest towers on left.

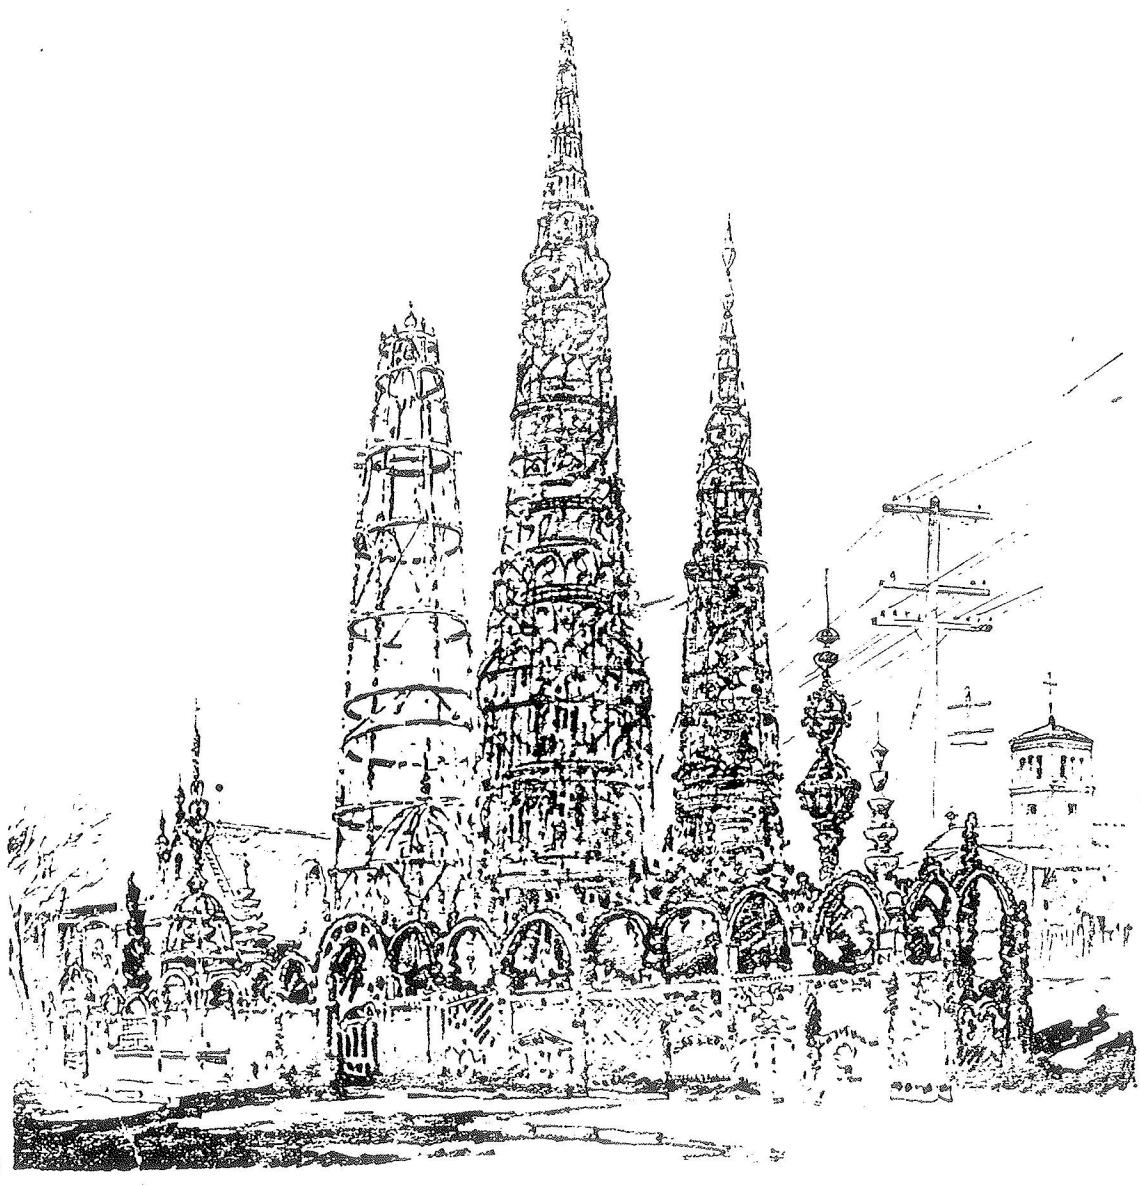
The Ship, under construction in about 1936, was a sculpture with a main spire about 15 feet high (Figure 2). A 1940 artist's drawing shows a much taller and larger main spire at that time, rising to its final height of 28 feet (Figure 3).

Figure 3: Artist's drawing looking north at south wall. Main spire on lower right. circa 1940.
2 tallest towers on left.

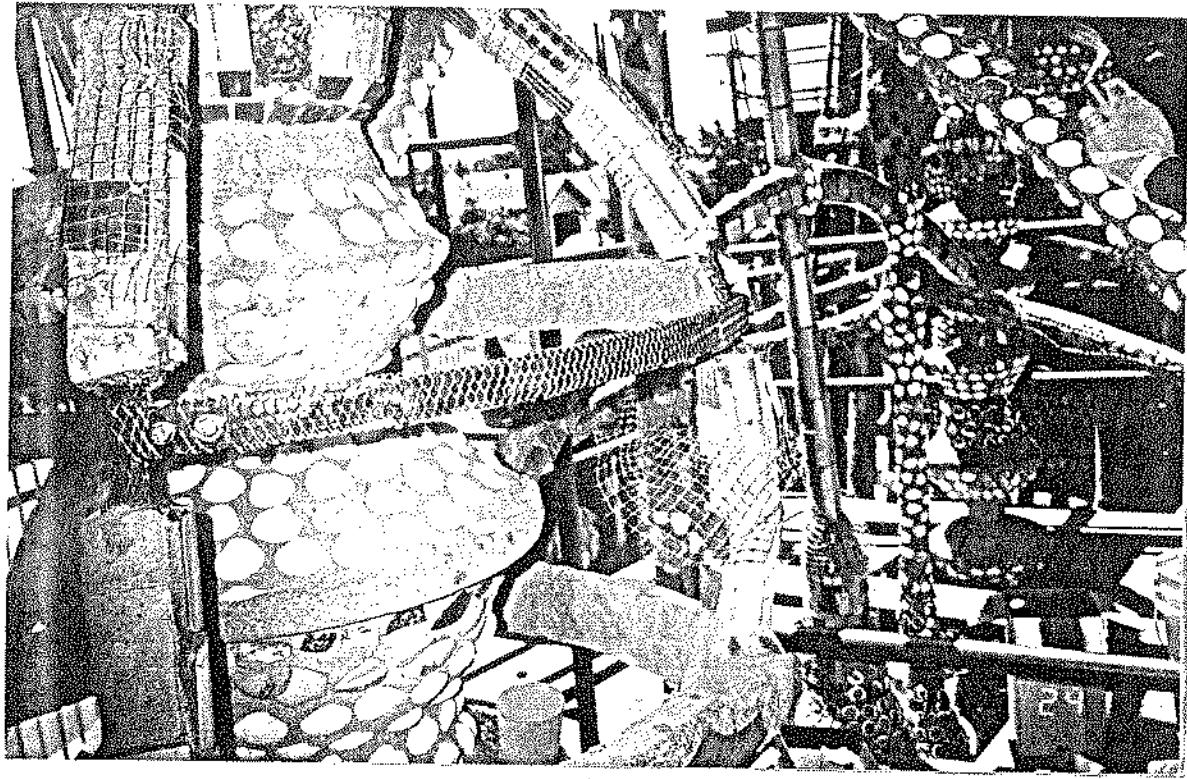
Figure 22. Main spire horizontal ring 02, July 1990 during conservation work, from northeast.

Main spire band 02 showing new mesh around new steel reinforcement, and connections to arcs.
